**MANNING
RIVER
ESTUARY &
CATCHMENT**

RAPID SITE ASSESSMENT 2020

Swanson, R. 2020. Manning River Estuary and Catchment RAPID SITE ASSESSMENT. A snapshot of stream condition in the Manning River Estuary and its catchment from the ground-truthing program. Environment, Energy and Science. NSW Government, Sydney.

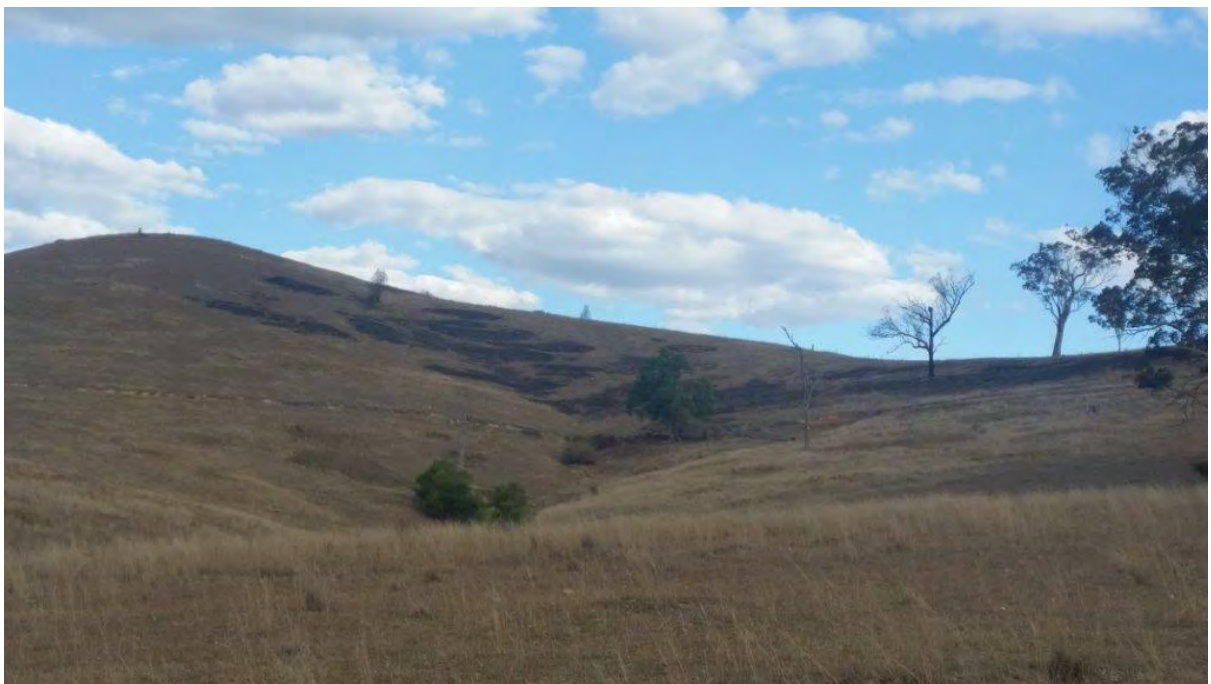
Photo 10 Nowendoc subcatchment 74 – bare slopes, burnt pasture

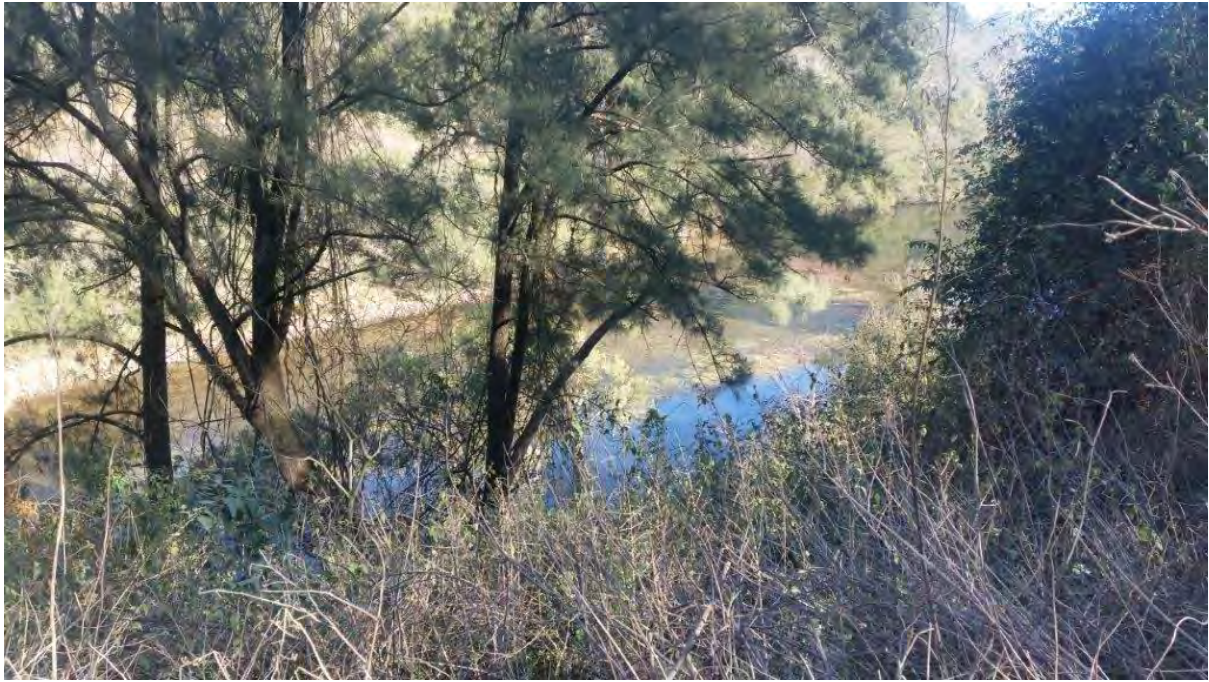
Photo 11 Rowleys River downstream of site 74-01. Excessive algal and macrophyte (Azolla) growth.

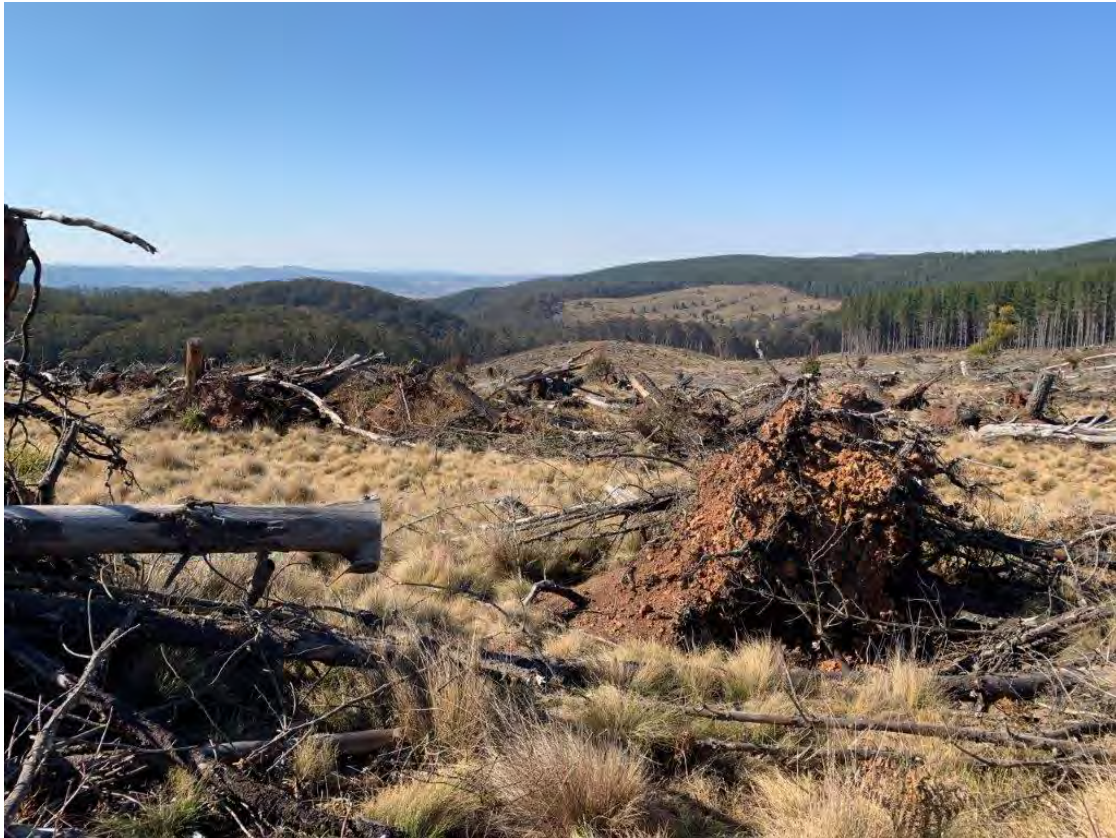
Photo 13 Myall Creek catchment. Cleared land (foreground) and plantation forests (background)

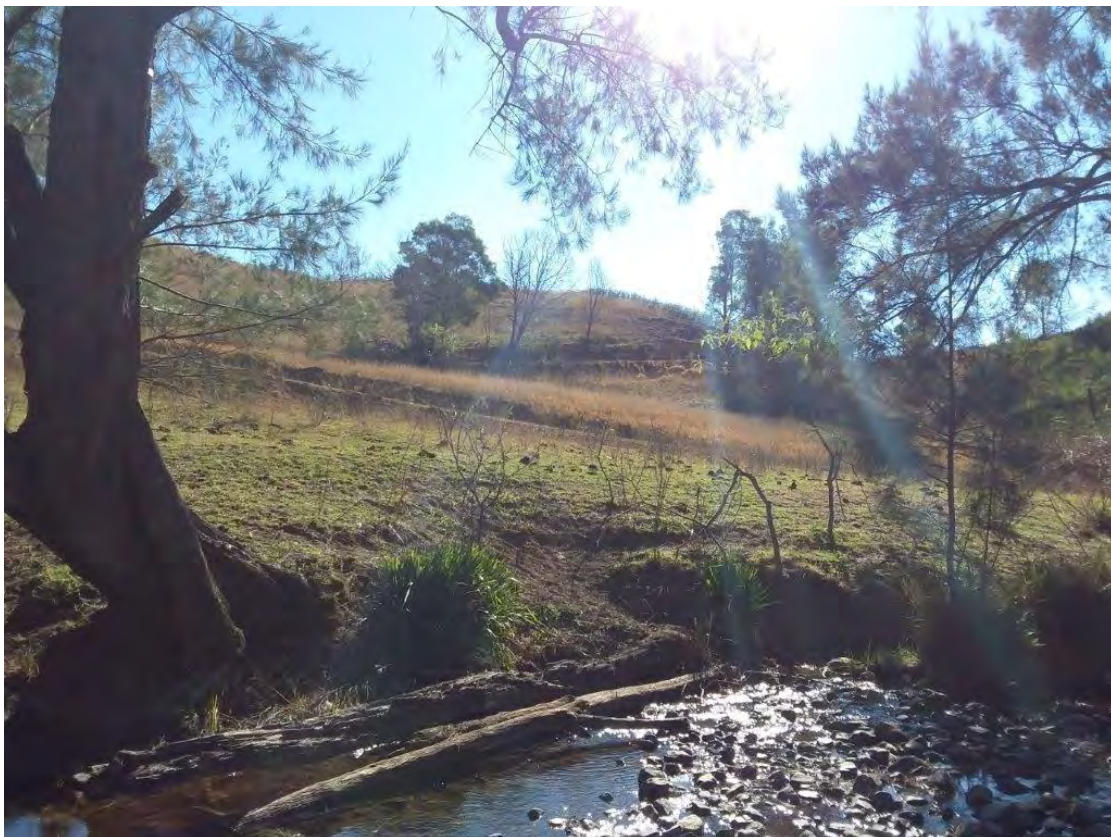
Photo 14 Myall Creek, site 76-01. Manure on banks, cattle access.

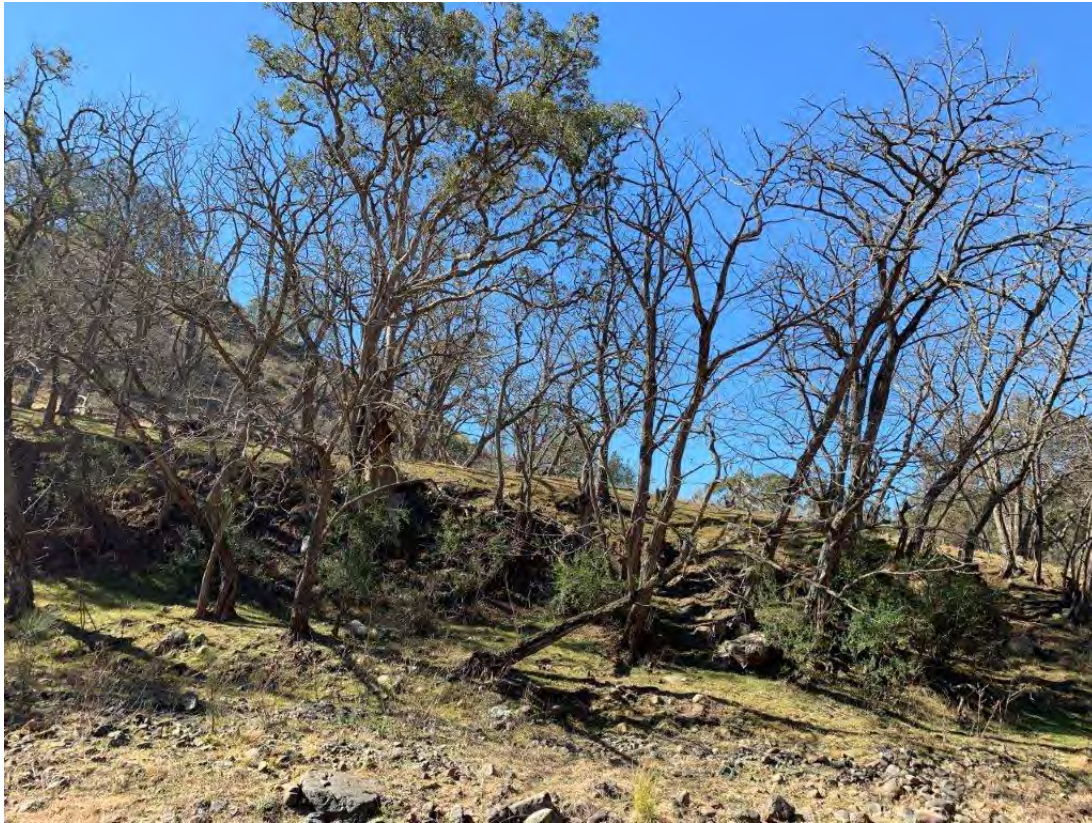
Photo 17 Barnard Catchment, Unnamed Creek on Glenrock Station, site 77-04. Note dead riparian vegetation due to lack of rain and no groundwater fed springs

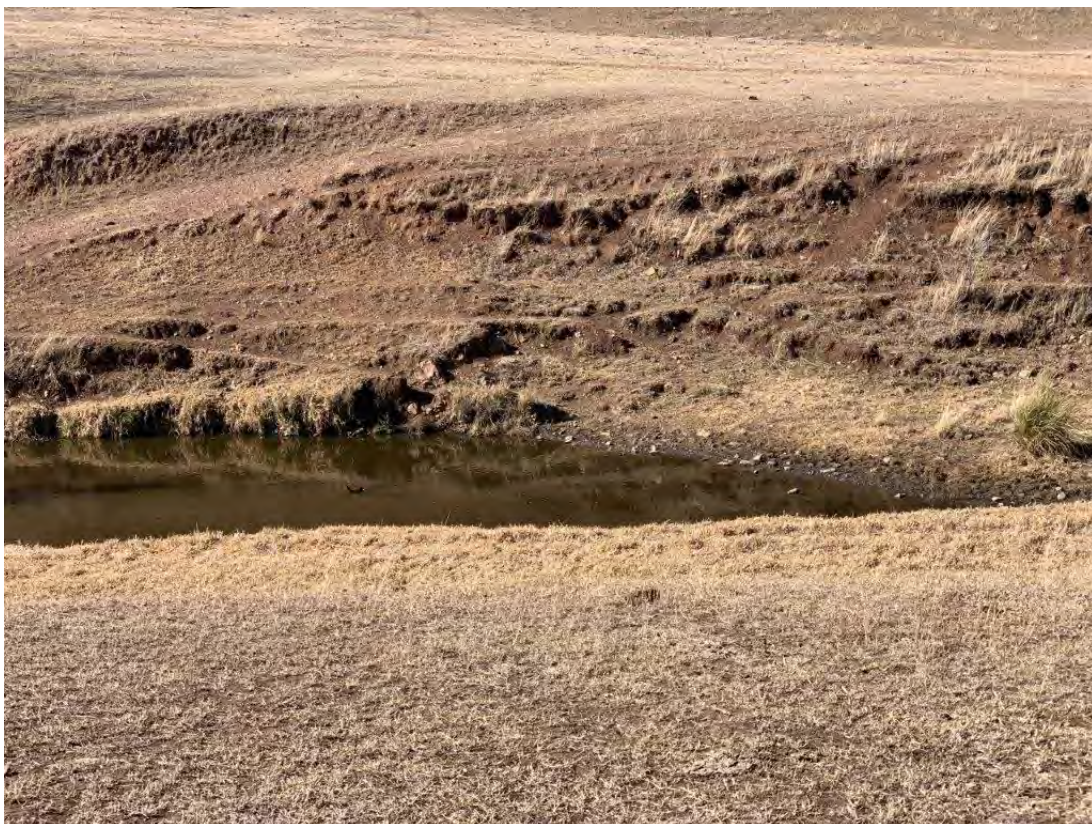
Photo 18 Barnard River catchment - Schofield Creek (Hunter Rd), site 77-05. Banks completely denuded of vegetation

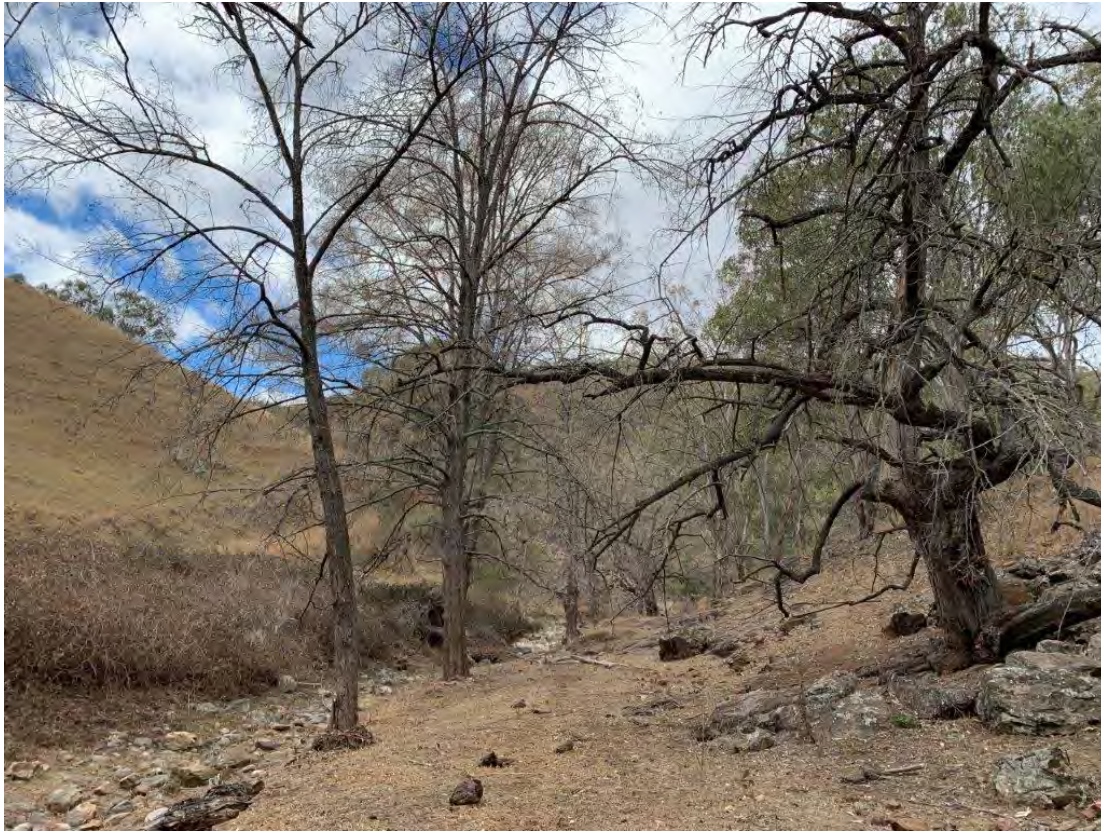
Photo 19 Barnard River catchment, Orham Creek (site 81-01). Bare banks and hillslopes and dead riparian vegetation due to no flow or groundwater fed springs

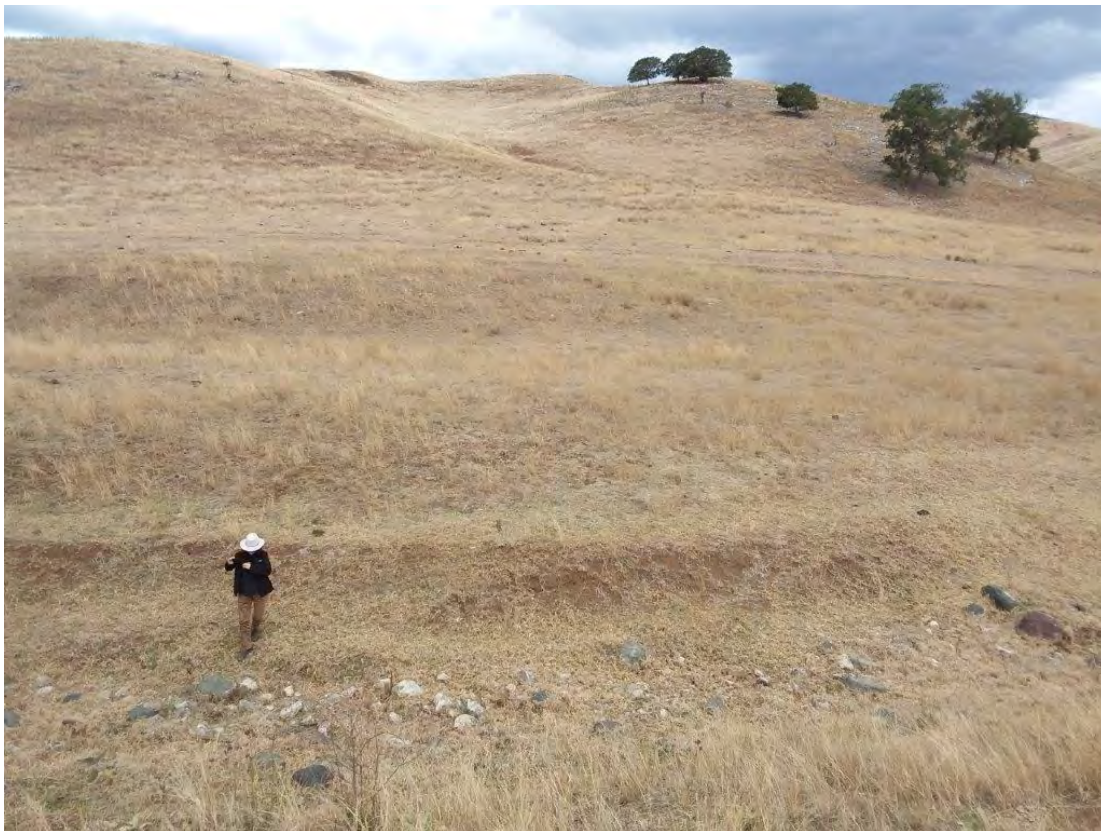
Photo 20 Barnard River catchment, Orham Creek (site 81-01), Glenrock. Extensive and often complete clearing of all native vegetation on hillslopes and riparian zones.

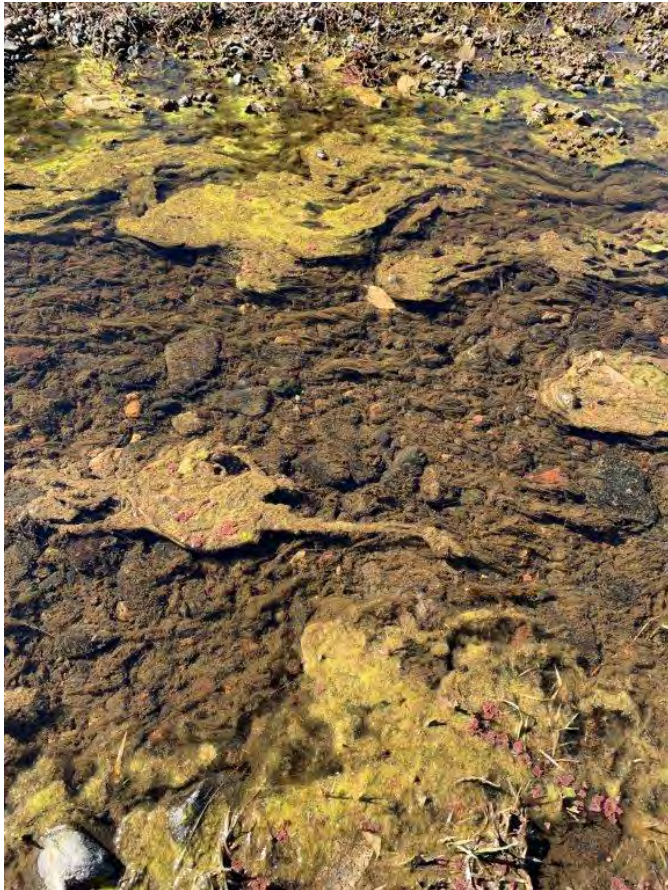
Photo 21 Barnard River at Corroboree Flat (site 82-01). Excessive algal growth.

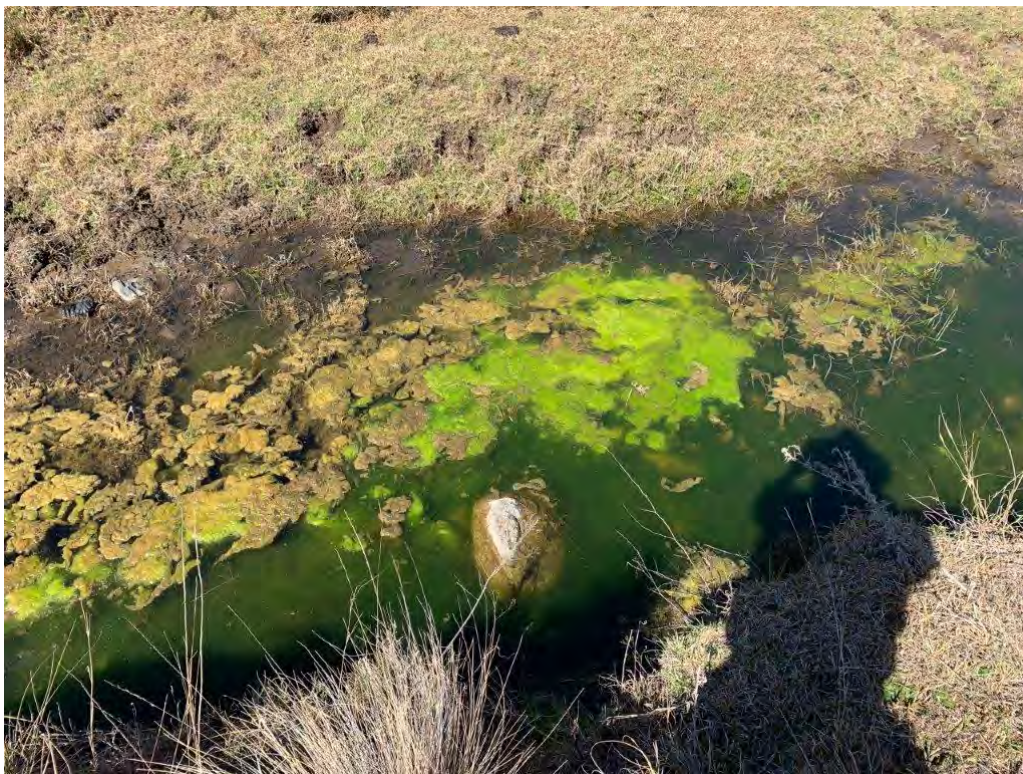
Photo 22 Barnard River catchment - Curricabark River, site 83-01. Excessive algal growth and pugging on spring banks with no riparian vegetation

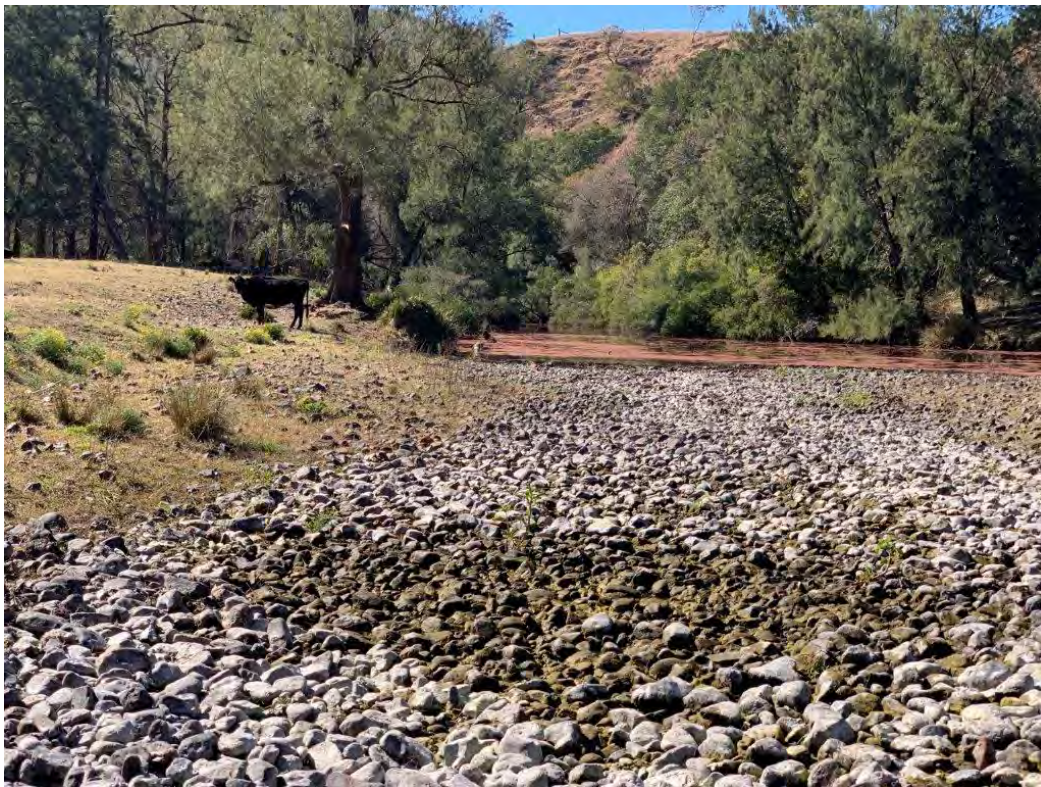
Photo 24 Barnard River crossing, site 84-03. Note eroding hillslope, excessive macrophyte (*Azolla*) growth and cattle access and no flow conditions.

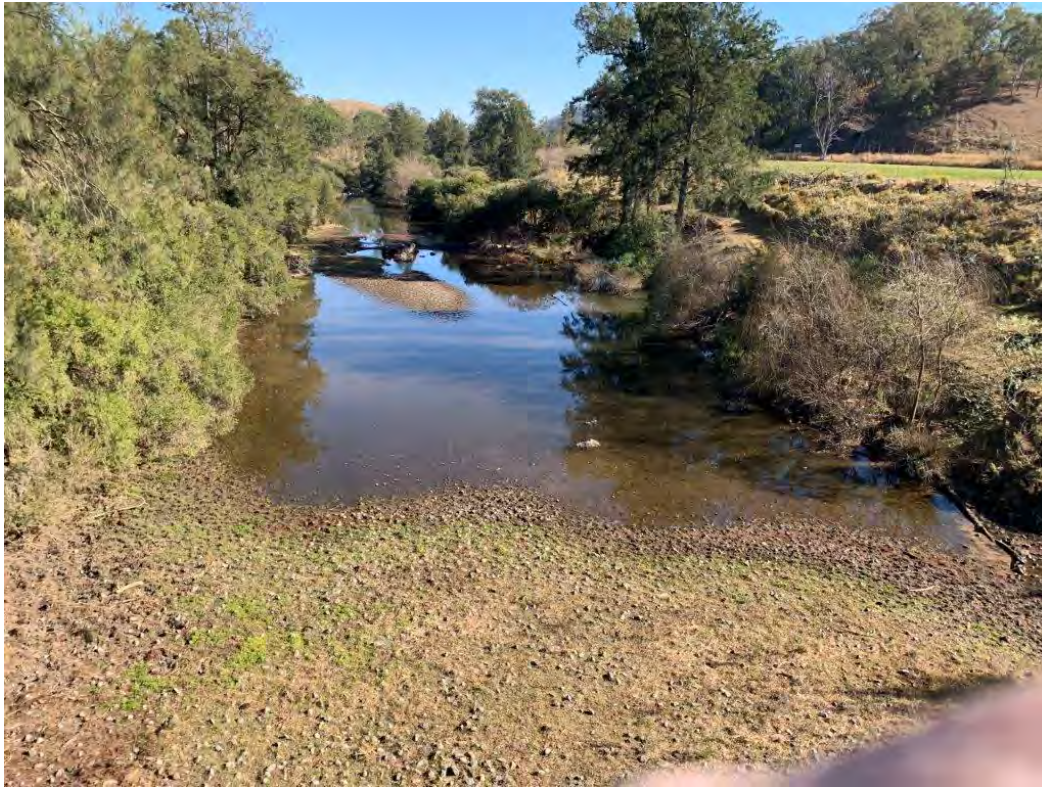
Photo 25 Barnard River upstream of Brett Reserve, site 84-04. No flow conditions.

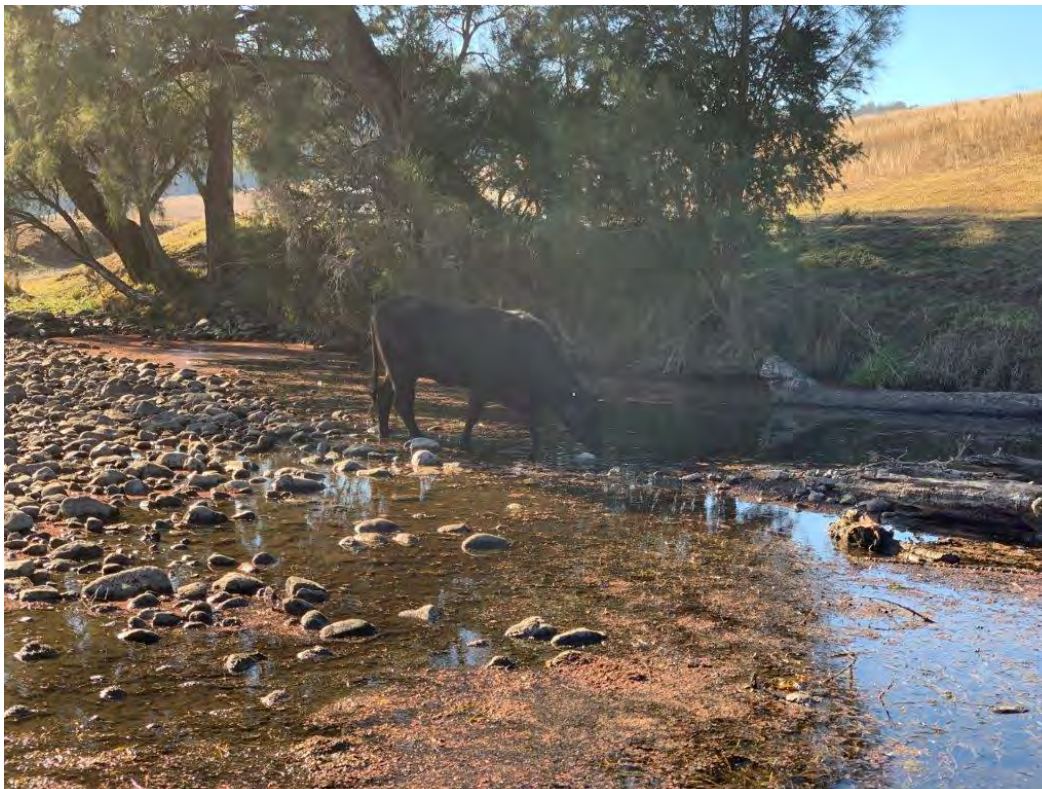
Photo 26 Barnard River at Brett Reserve, 84-05. No flow, excessive macrophyte (*Azolla*) growth, cattle accessing river for water. Dry bare slopes and banks

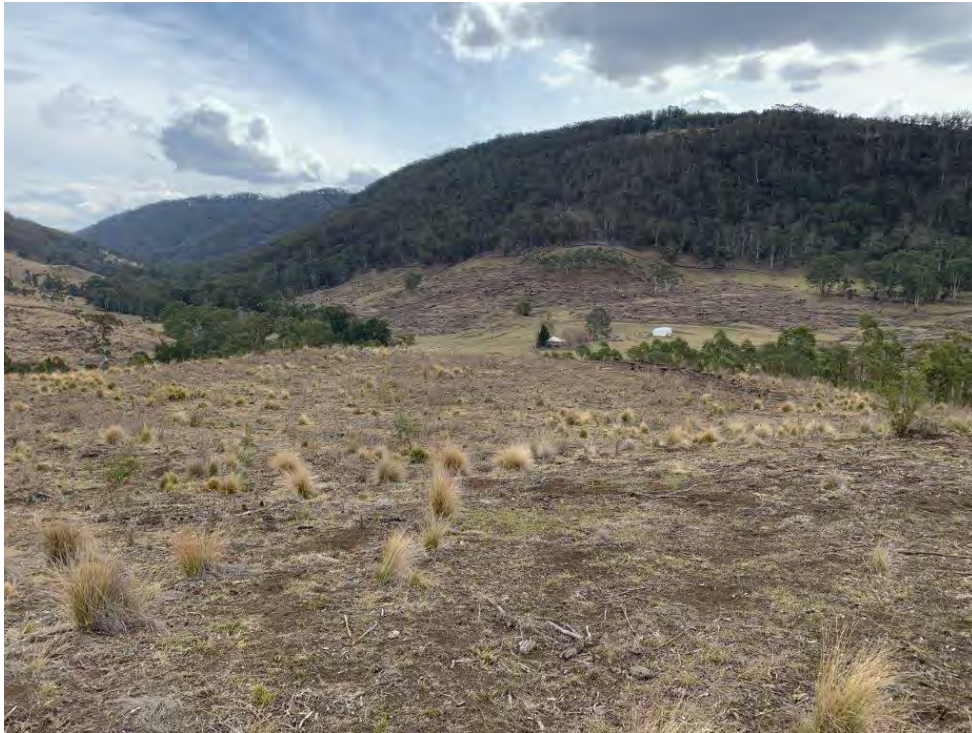
Photo 27 Upper Manning River catchment. Historically Long Swamp was cleared for plantation forestry. Currently clearing forestry for pasture/farming infrastructure

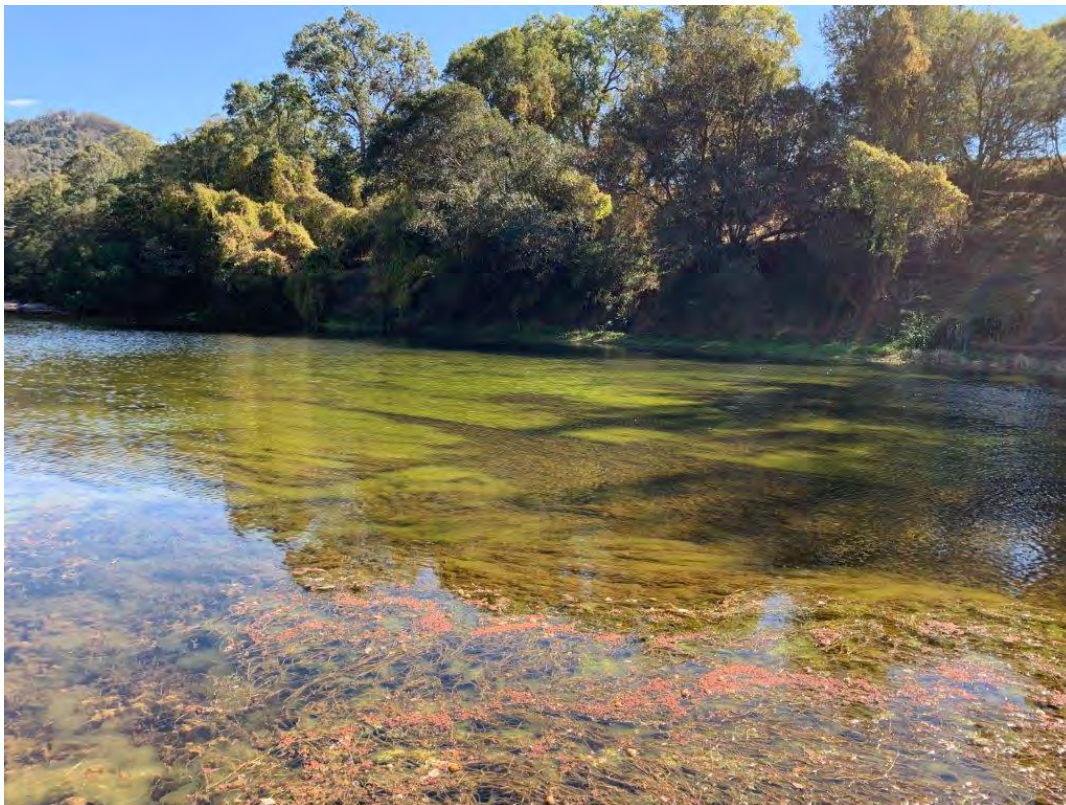
Photo 57 Gloucester River. Macrophyte beds, Azolla and excessive filamentous algal growth indicate high nutrient loads.

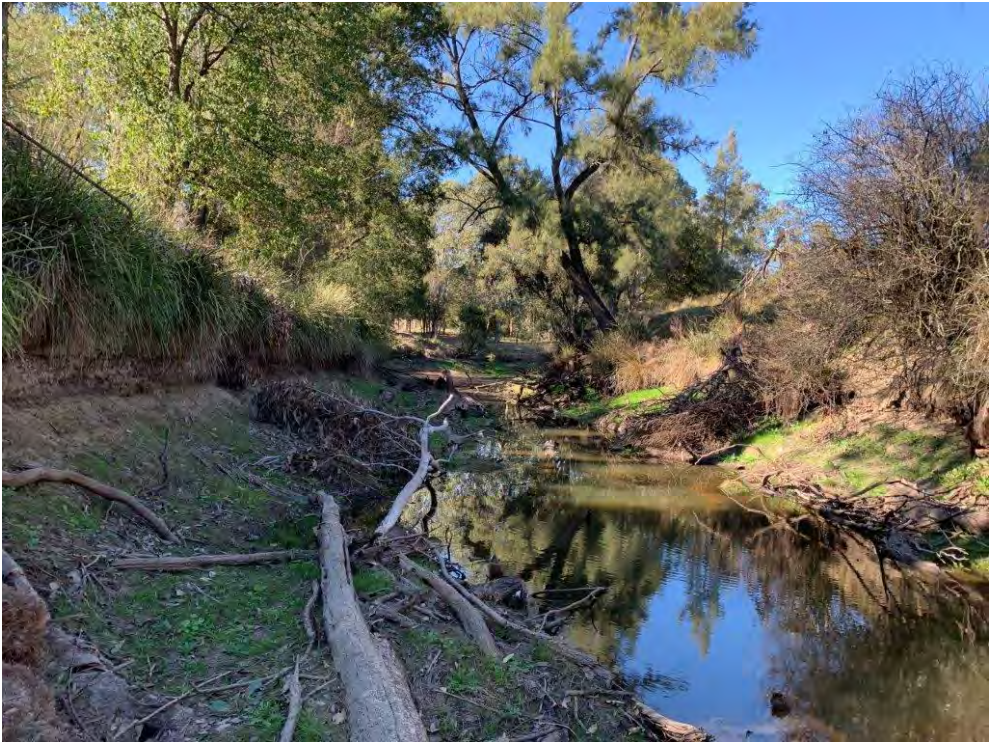
Photo 62 Avon River - Jacks Road crossing, site 121-04. Very poor bank condition, isolated pools with poor water quality

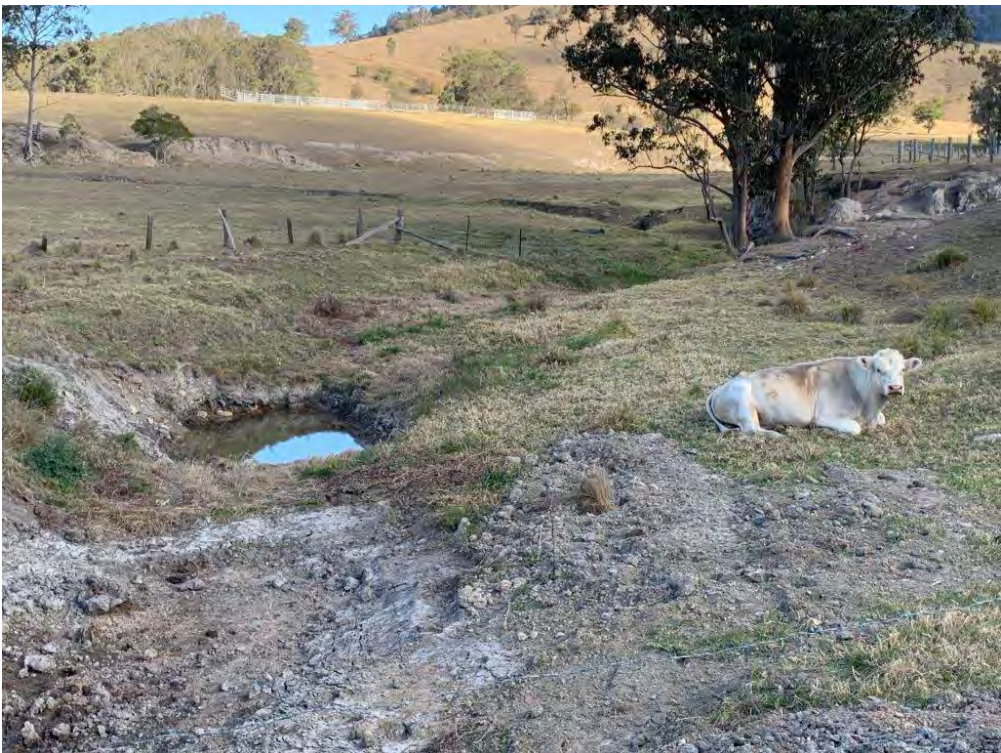
Photo 63 Avon River catchment – unnamed creek, site 123-03. Cattle access and minimal riparian vegetation. Gully erosion and bare eroding hills.

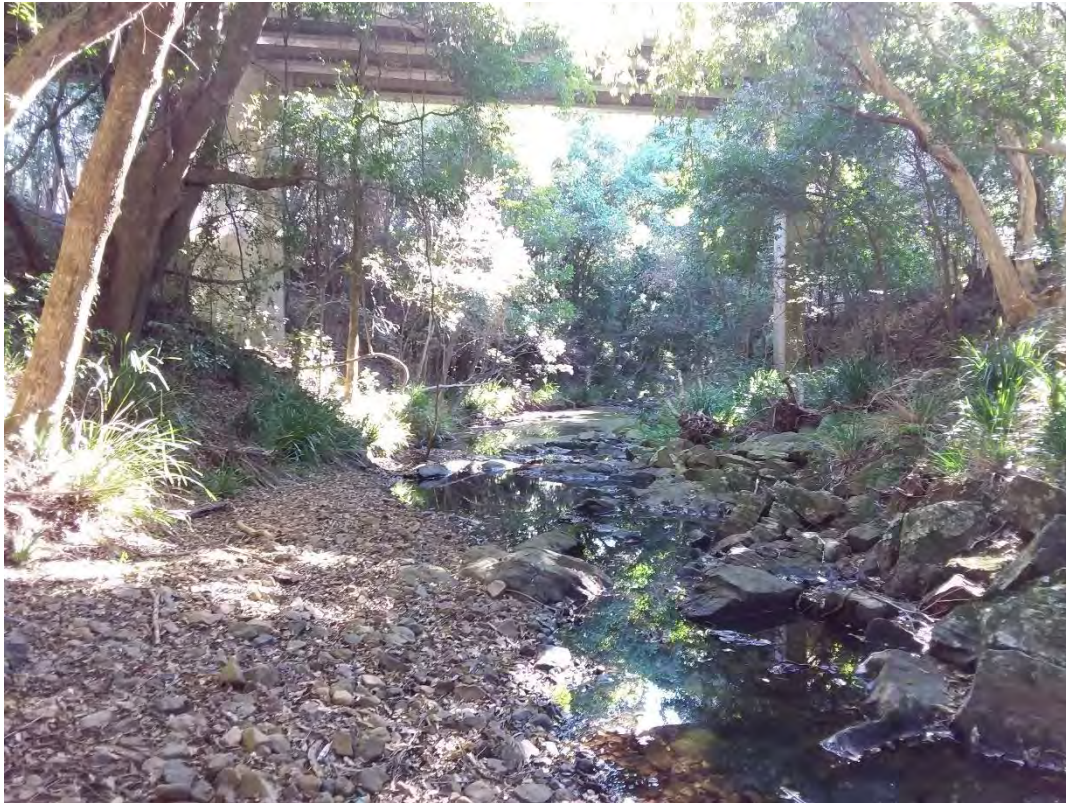
Photo 64 Burrell Creek catchment, Bo Bo Creek, Gloucester Rd crossing site, 112-02. Good riparian vegetation. No flow, isolated pools.

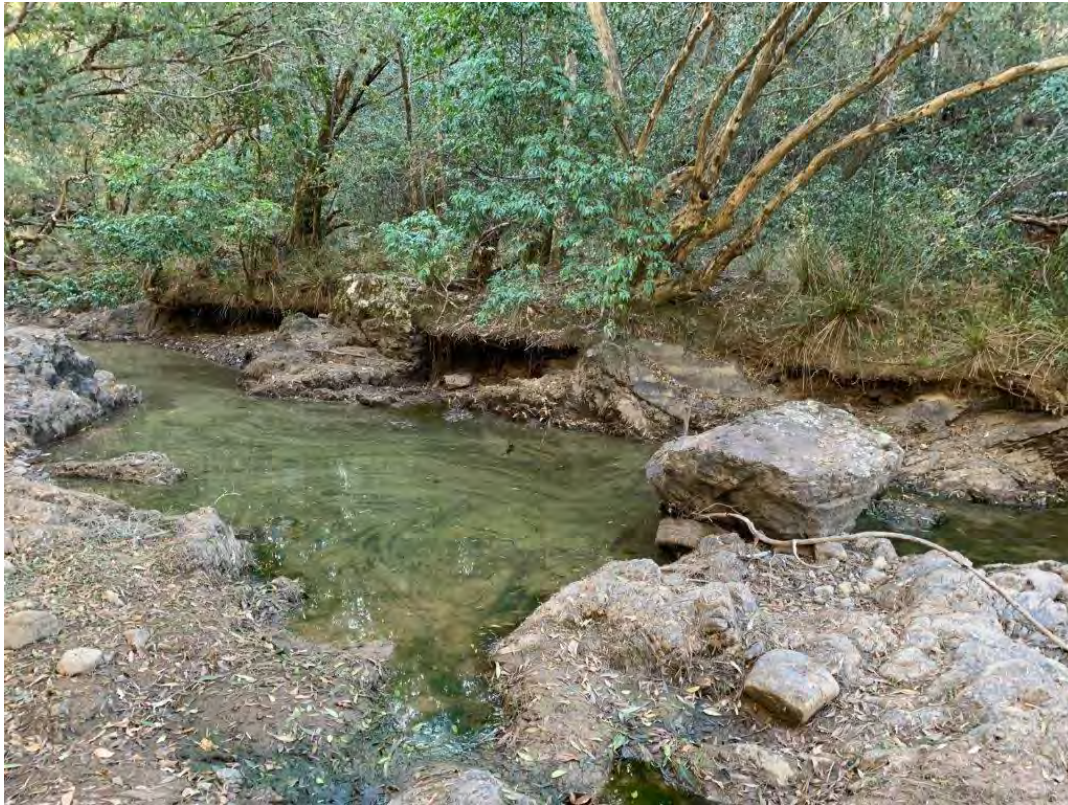
Photo 66 Burrell Creek - Kimbriki Rd crossing 112-01. Good stream structure and riparian zone. Nutrient-rich isolated pools. Algal bloom decomposing on surface

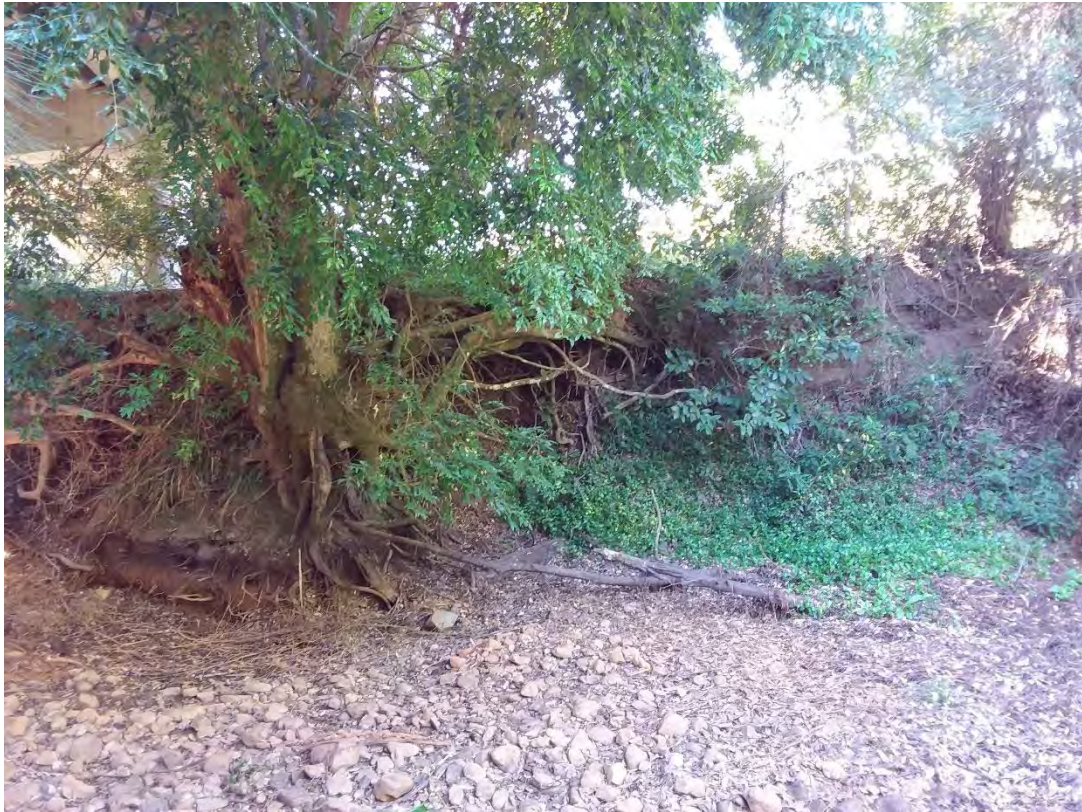
Photo 68 Burrell Creek - Bo Bo Creek Buckets Way crossing, site 113-05. Eroding vertical banks and exotic shrub and ground cover vegetation.

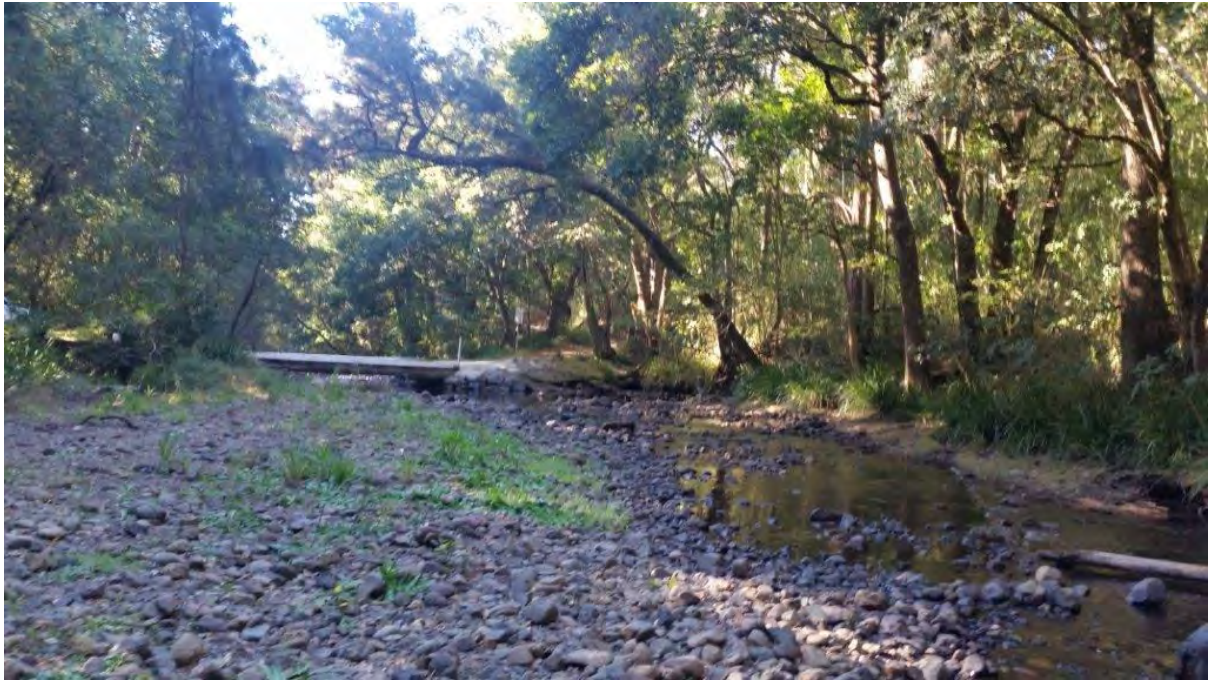
Photo 69 Dingo Creek at Millers Rd crossing, site 86-15. Very low flow. Good riparian vegetation in upper catchment sites.

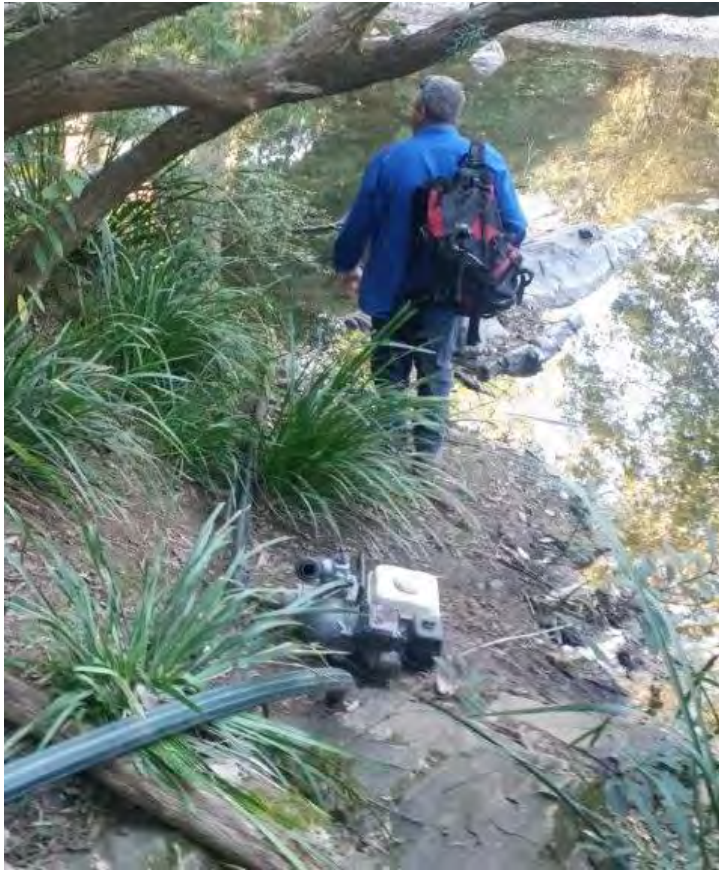
Photo 71 Dingo Creek – Wherrol Flat Bridge, site 97-07. Very low flow, extraction of water for domestic use noted frequently. Steep banks with good canopy layer but exotic shrub layer and no ground cover.

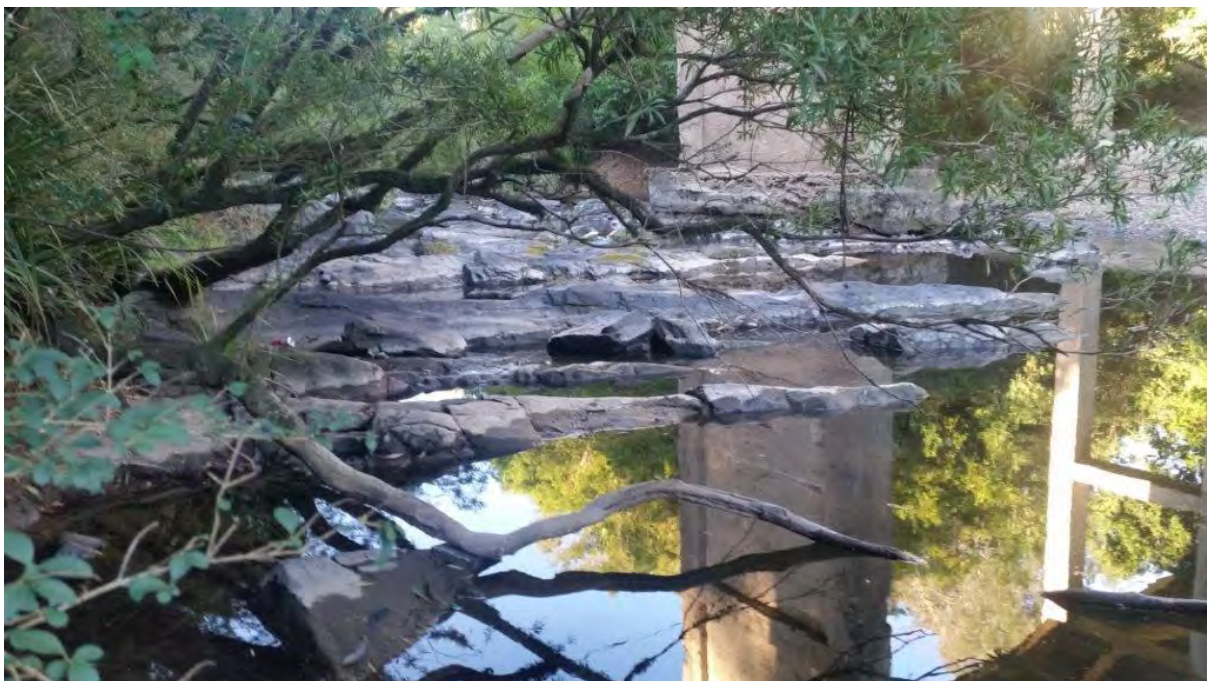
Photo 72 Dingo Creek – Wherrol Flat Bridge, site 97-07. Bedrock substrate, very low flow.

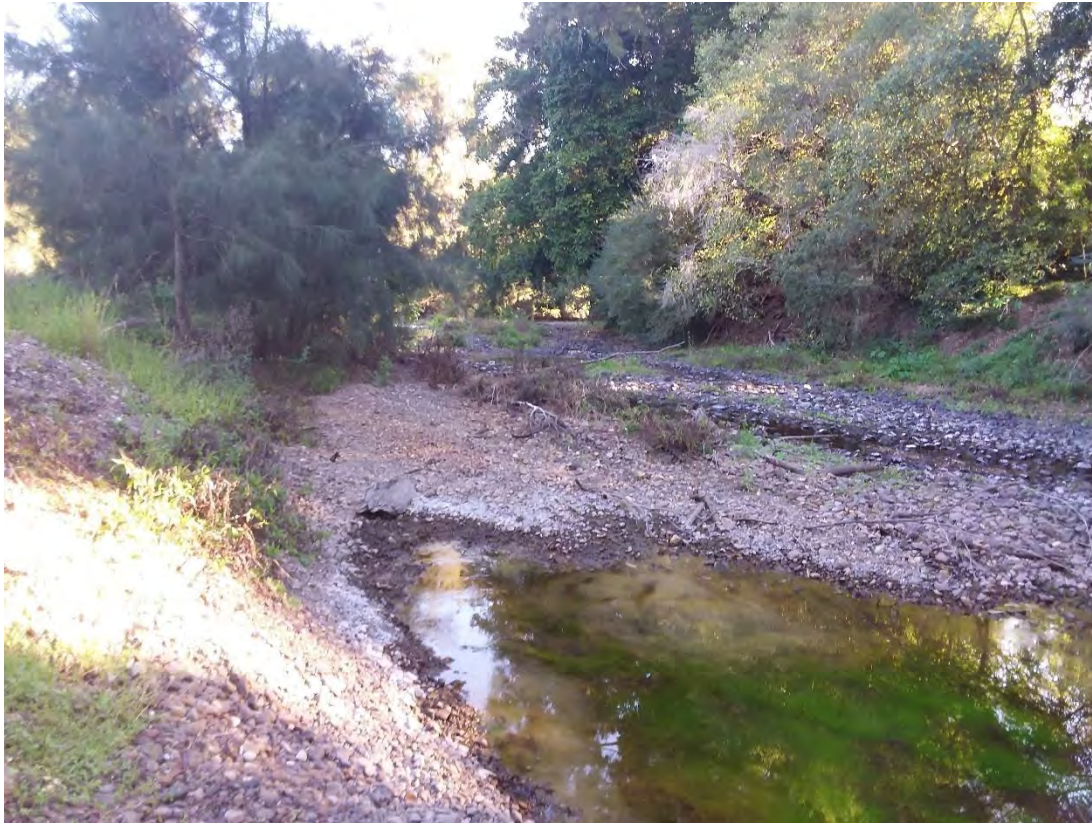
Photo 73 Dingo Creek, site 97-06, adjacent to Ashlea Farm (beef cattle). Very low flow, high nutrient load indicated by excessive algal growth in isolated pools.

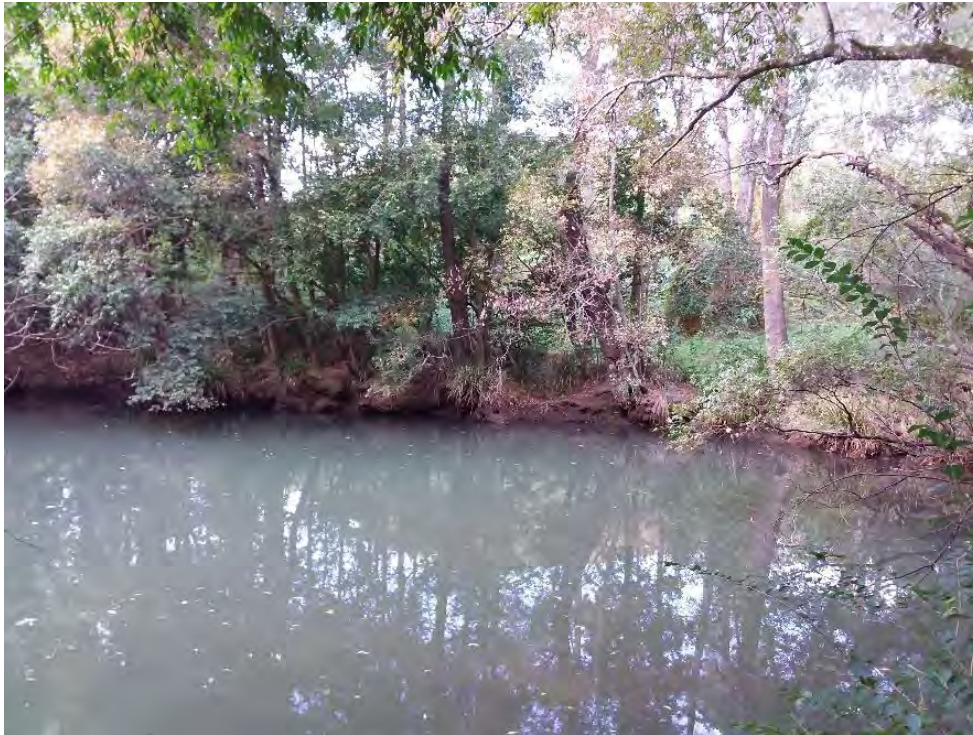
Photo 77 Cedar Party Creek at Wingham Bridge, site 95-03. Cloudy water (pH 6.8) but good riparian vegetation.

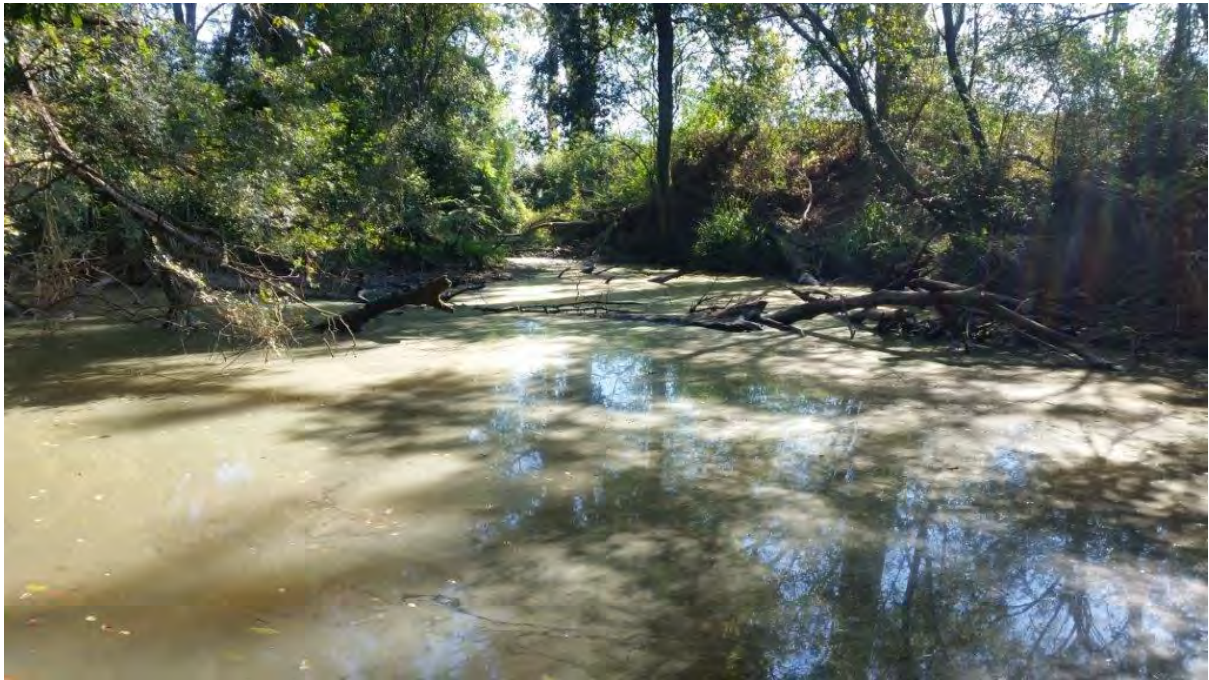
Photo 83 Lansdowne River, site 88-10. Adjacent to dairy farm, turf farm and poultry farm. Large isolated pool with surface scum indicative of algal bloom

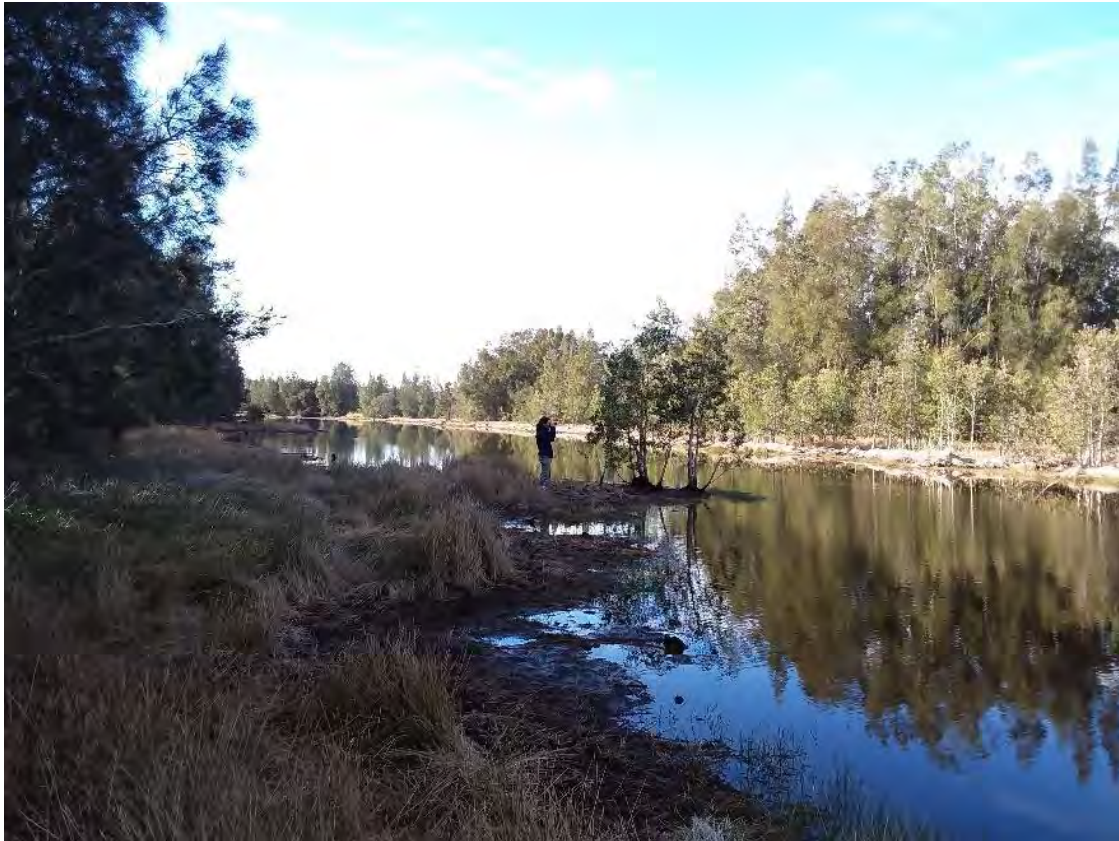
Photo 93 Cattai Creek wetlands, site 93-04. Water very acidic at time of sampling ($\text{pH} < 4$) as creek was completely dry until recent rainfall.
