**MANNING
RIVER
ESTUARY &
CATCHMENT**

RAPID SITE ASSESSMENT 2020

Swanson, R. 2020. Manning River Estuary and Catchment RAPID SITE ASSESSMENT. A snapshot of stream condition in the Manning River Estuary and its catchment from the ground-truthing program. Environment, Energy and Science. NSW Government, Sydney.

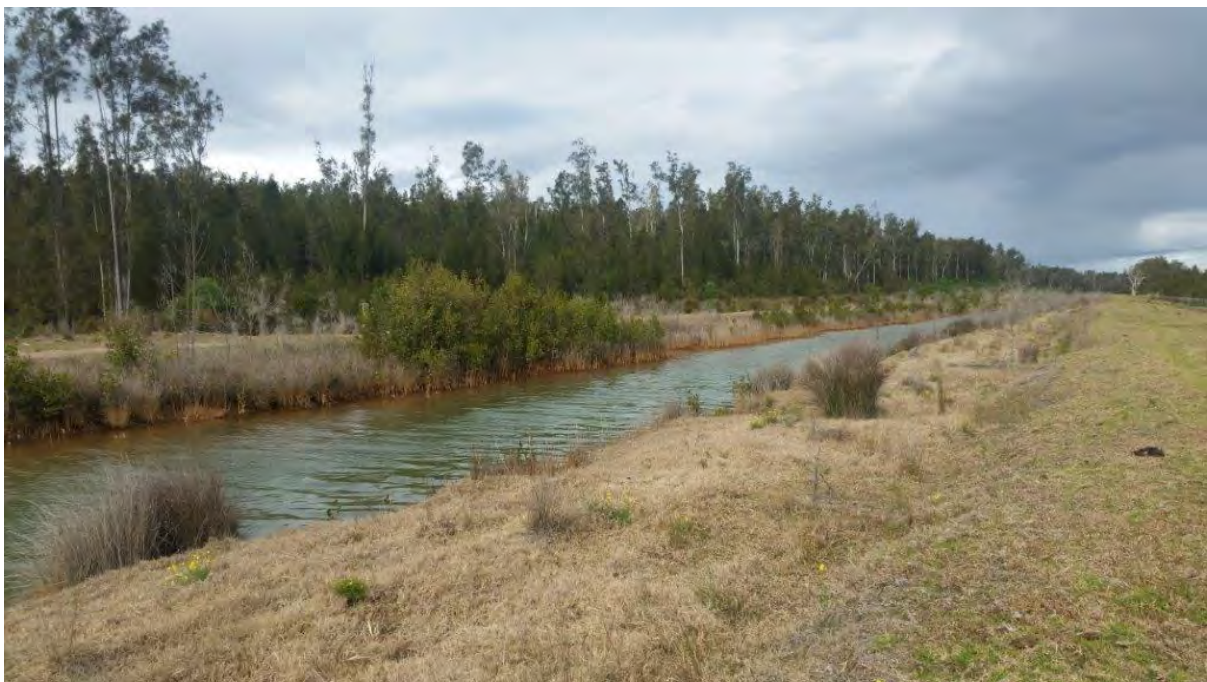
Photo 94 Cattai Creek catchment - Pipe Clay Canal, site 93-01B. Turquoise hue to water (aluminium) and rust coloured sediment (iron) from acid sulphate soils. Manure and cattle grazing on banks.

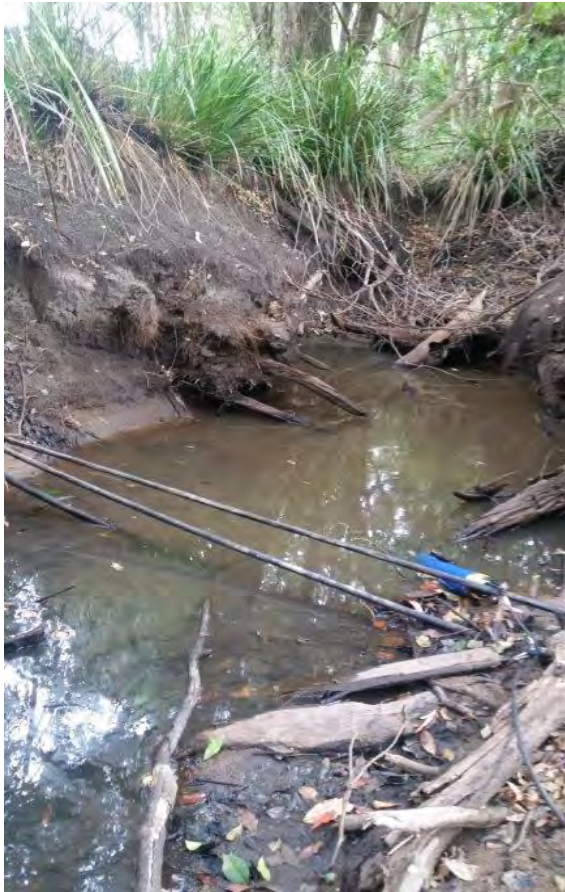
Photo 95 Cattai Creek catchment - Holey Flat Creek, site 93-06. No flow, banks in very poor condition. Water extraction plumbing.

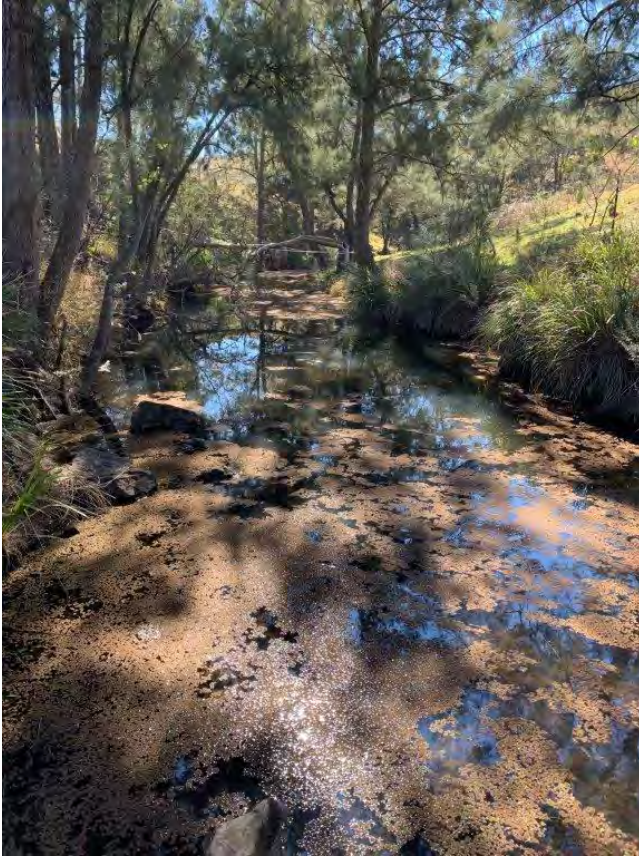
Photo 97 Manning River catchment – Bakers Creek at Bakers Creek Rd, site 106-2. High nutrients evident by prolific floating fern (Azolla). Typha near bridge.

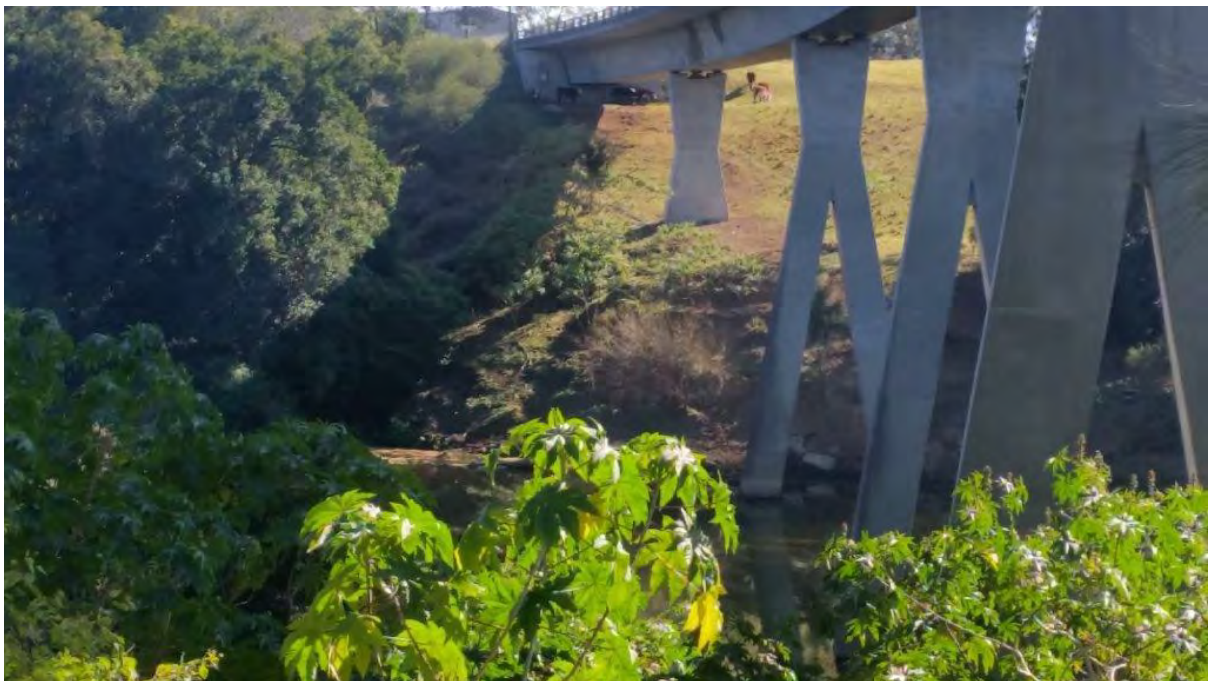
Photo 104 Manning River at Killawarra Bridge, site 104-1 (Pilot run). Cattle accessing river on left bank impacting on bank condition. Riparian vegetation on left bank dominated by exotic species. Filamentous algae and macrophytes in river.

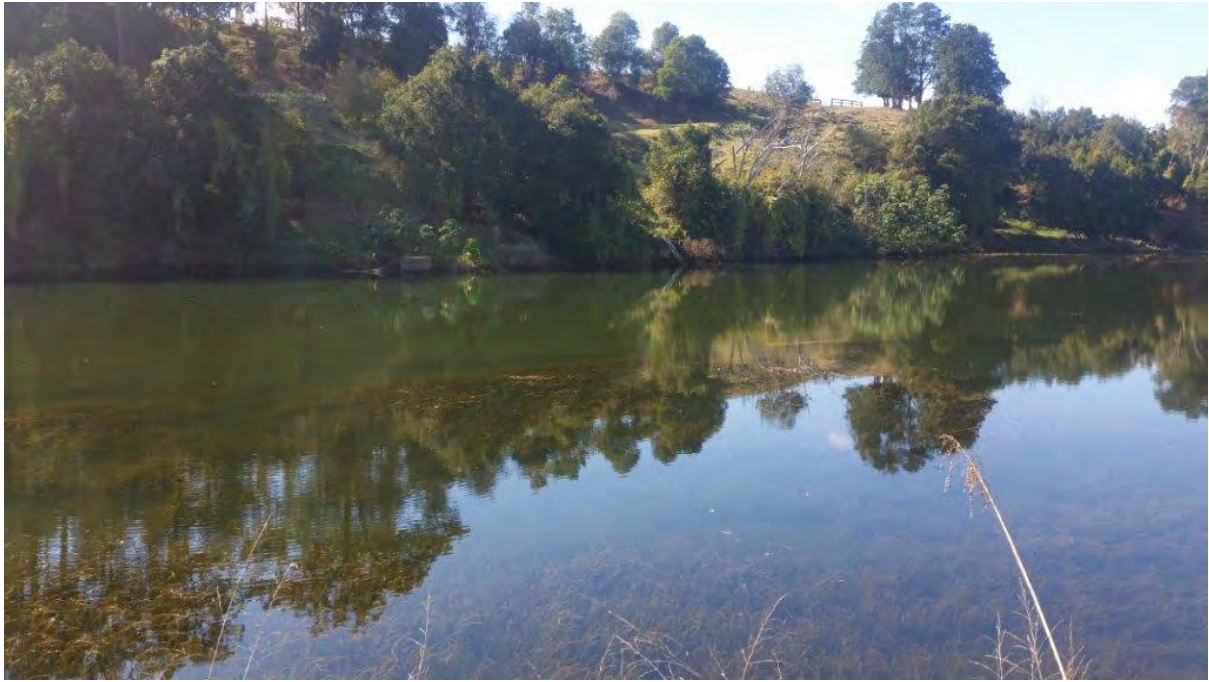
Photo 105 Manning River site, 99-01. Former site for Bootawa Dam offtake. Heavy macrophyte growth fouled with epiphytic algae. Spotted a platypus at this site. Large dairy on left bank (top of image) side with cattle access to riverbank just downstream of image.

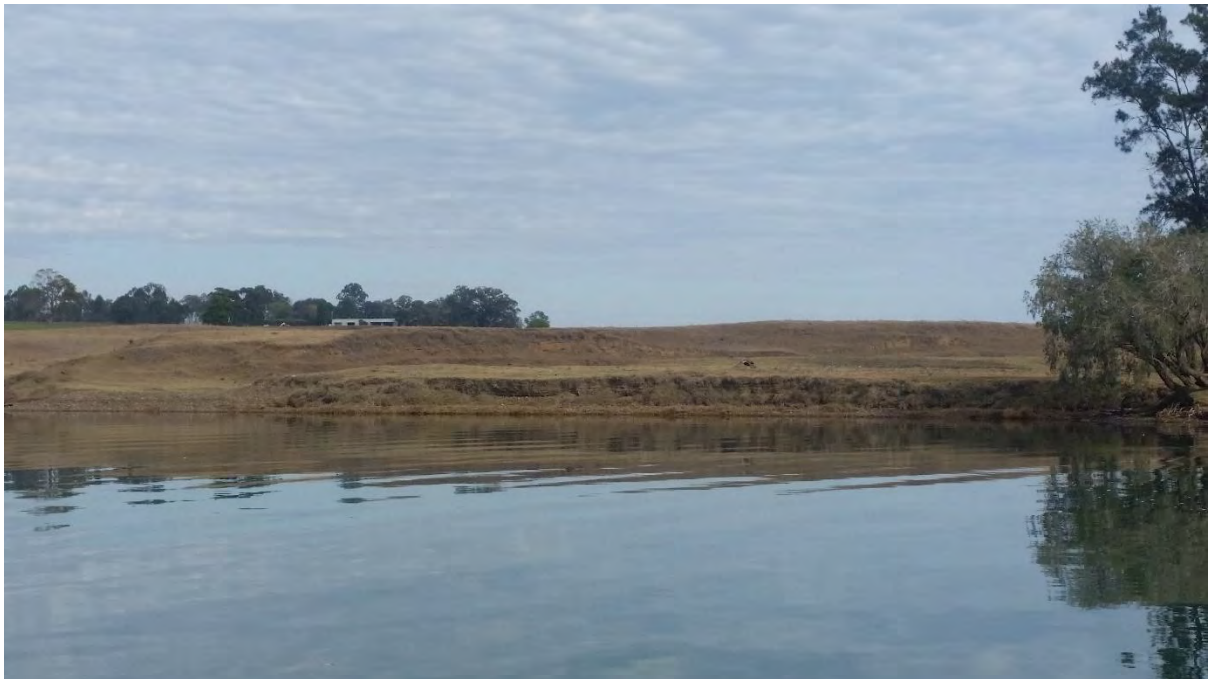
Photo 106 Manning River (Mondrook, subcatchment 108). Dry pastures with eroding banks. Cattle access riverbanks throughout subcatchment 108 (boat survey). Poor bank condition and little riparian vegetation for most of shoreline of subcatchment 108

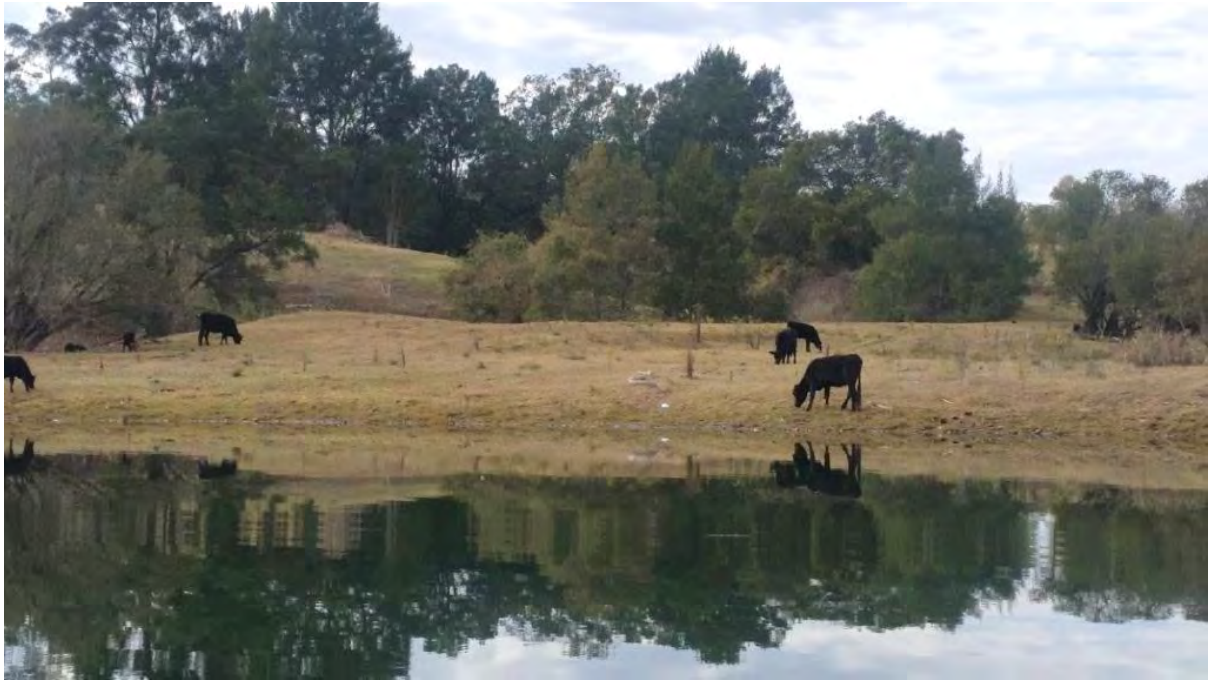
Photo 107 Manning River (subcatchment 209). Bare pastures, cattle accessing river bank, no riparian vegetation

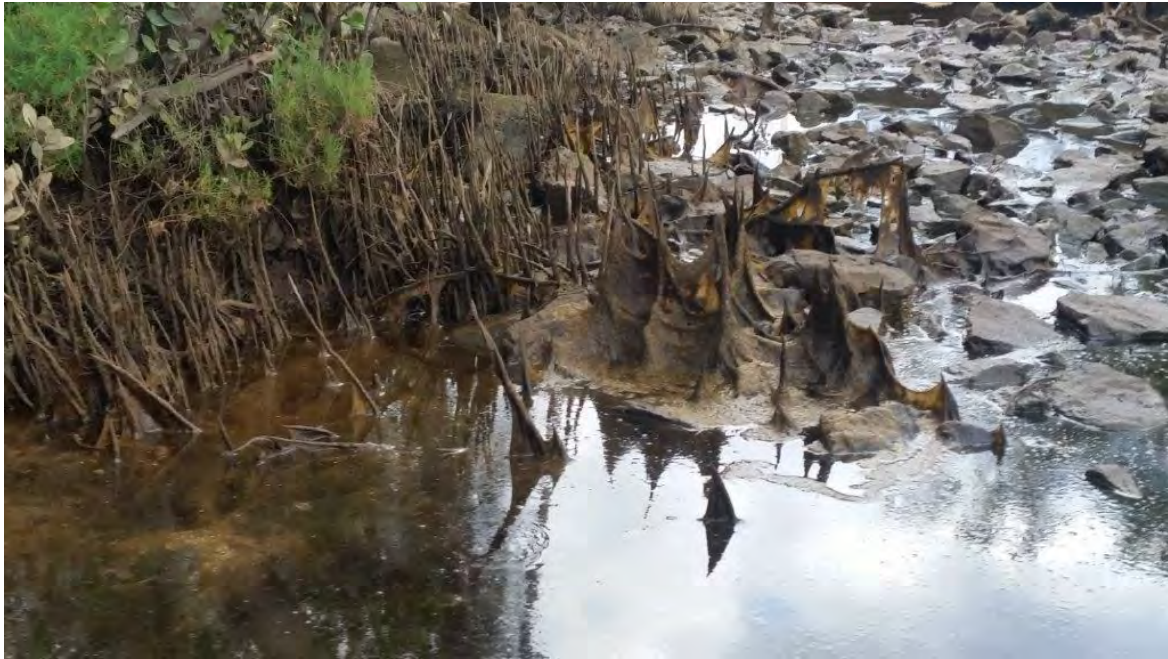
Photo 111 Manning River catchment – Sitts Creek (Glenthorne), site 220-1 (estuarine site)
Pneumatophores webbed in decomposing algae. No flow. Good cover of saltmarsh on left bank (top left). Adjacent pasture fenced off. Right bank (not shown). Cleared pasture in very poor condition adjacent to this site beyond a thin band of immature woody riparian vegetation.

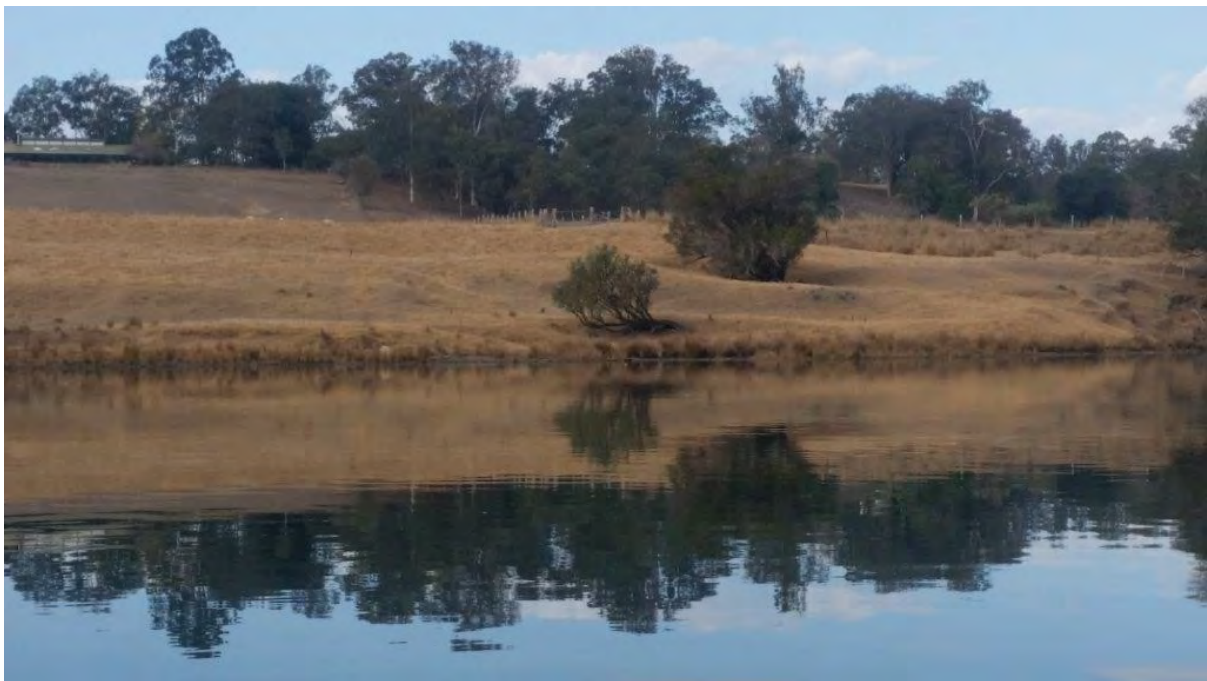
Photo 112 Manning River (subcatchment unknown). Bare pastures, no riparian vegetation. Sheep grazing (dead sheep on riverbank upstream).
