**MANNING
RIVER
ESTUARY &
CATCHMENT**

RAPID SITE ASSESSMENT 2020

Swanson, R. 2020. Manning River Estuary and Catchment RAPID SITE ASSESSMENT. A snapshot of stream condition in the Manning River Estuary and its catchment from the ground-truthing program. Environment, Energy and Science. NSW Government, Sydney.

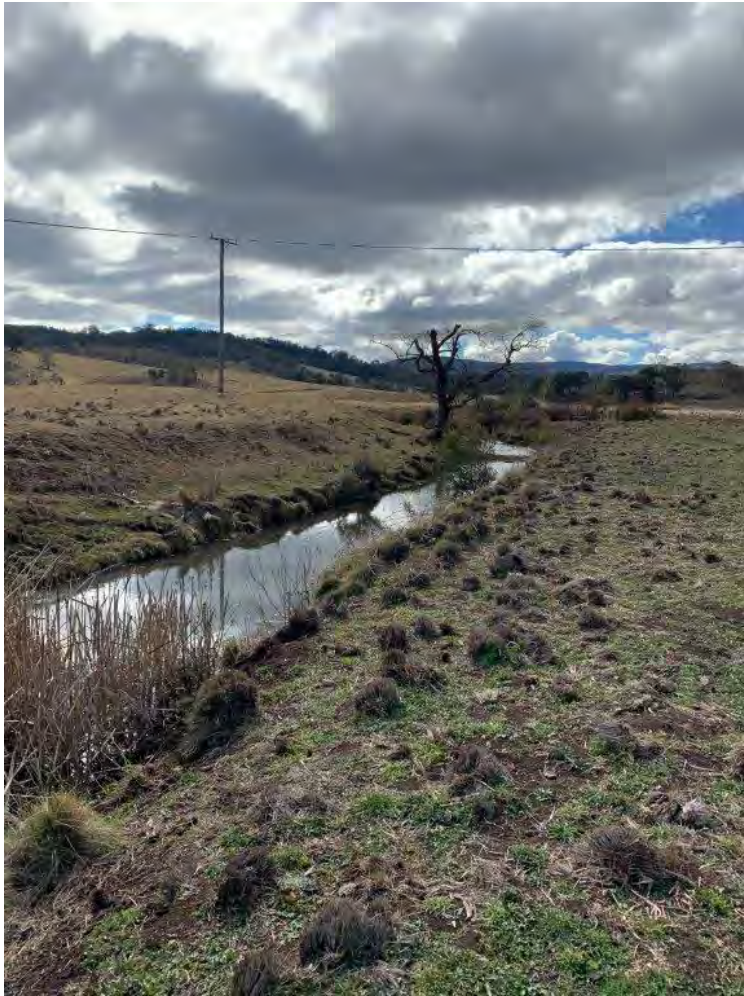
Photo 1 Nowendoc River at Nowendoc Road, site 64_05

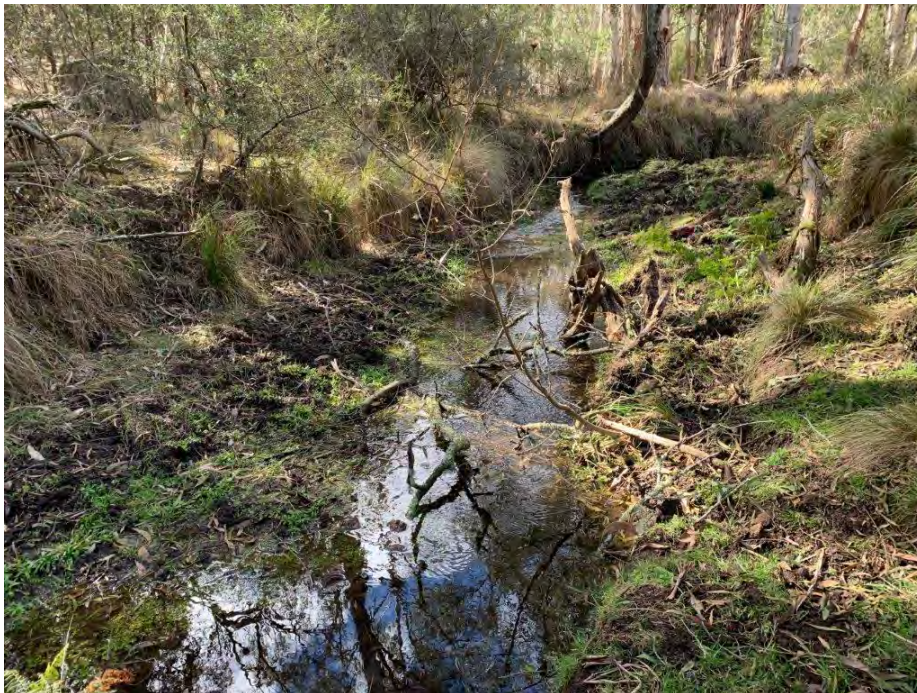
Photo 2 Nowendoc River catchment - Mukki Creek, site 64-07

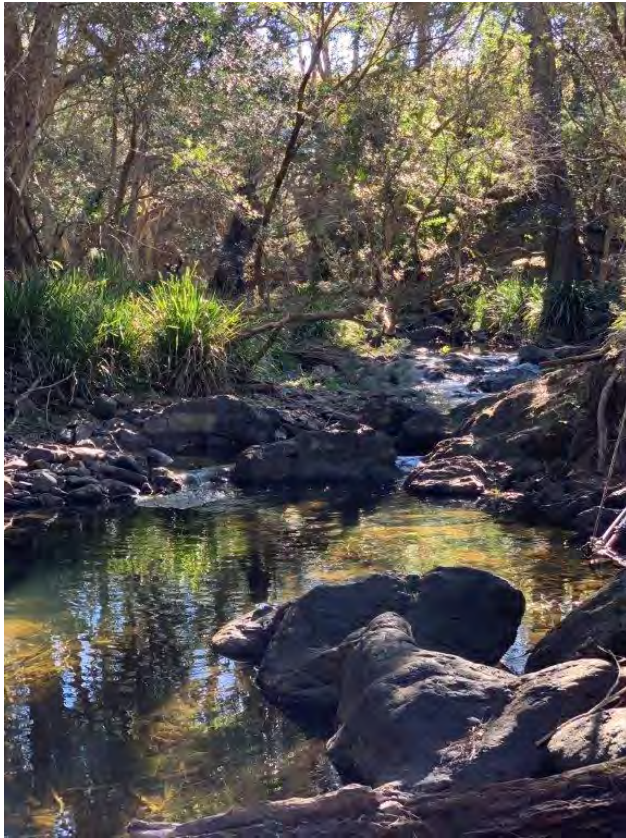
Photo 3 Nowendoc River, site 64-01. Bedrock substrate.

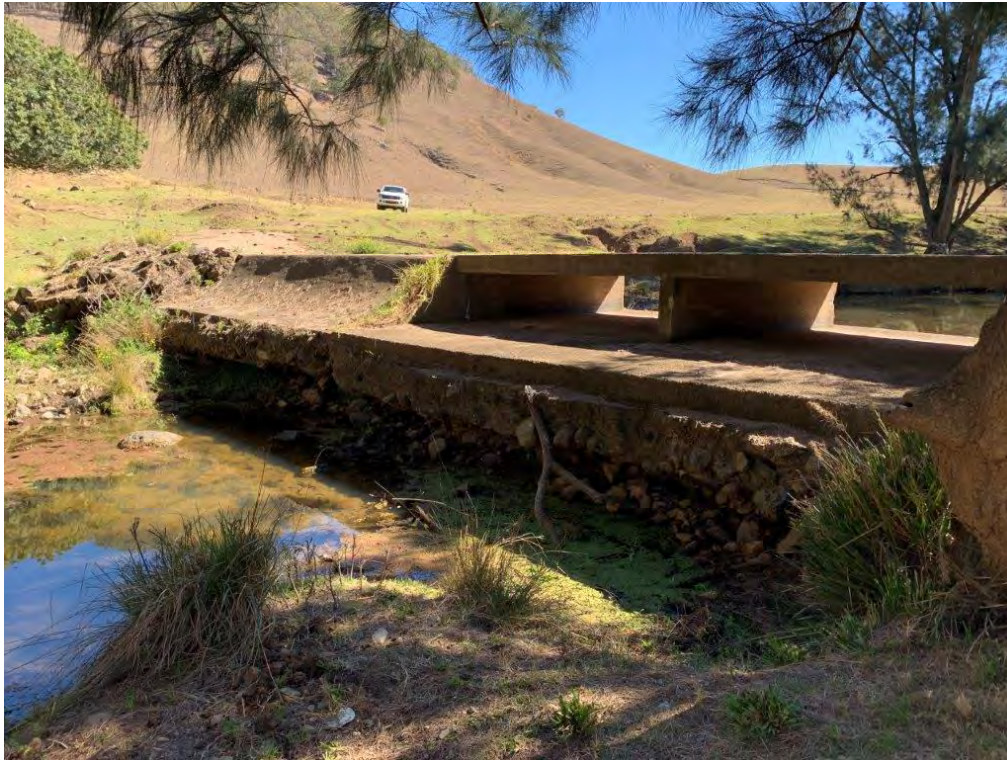
Photo 5 Nowendoc River catchment – Cooplacurripa Valley. Bare steep eroding slopes, cattle access, excessive algal and macrophyte growth (site 66-03)

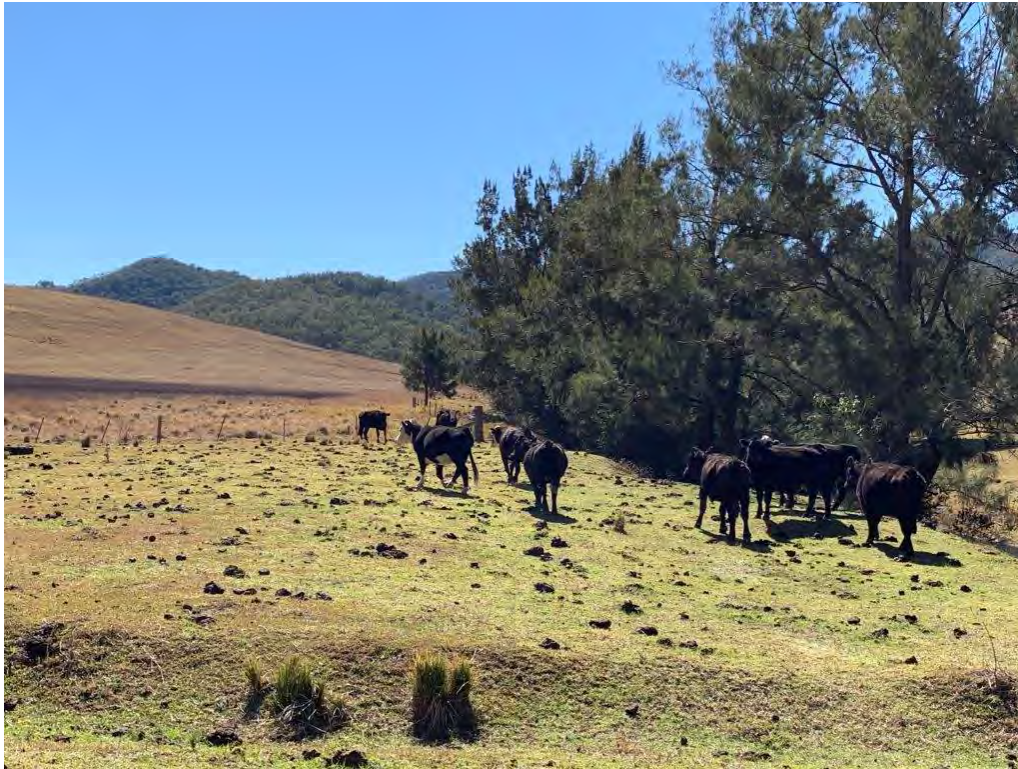
Photo 7 Nowendoc River catchment - Cooplacurripa River (Nowendoc Road), site 66-04. Large amounts of manure on banks with sparse riparian vegetation

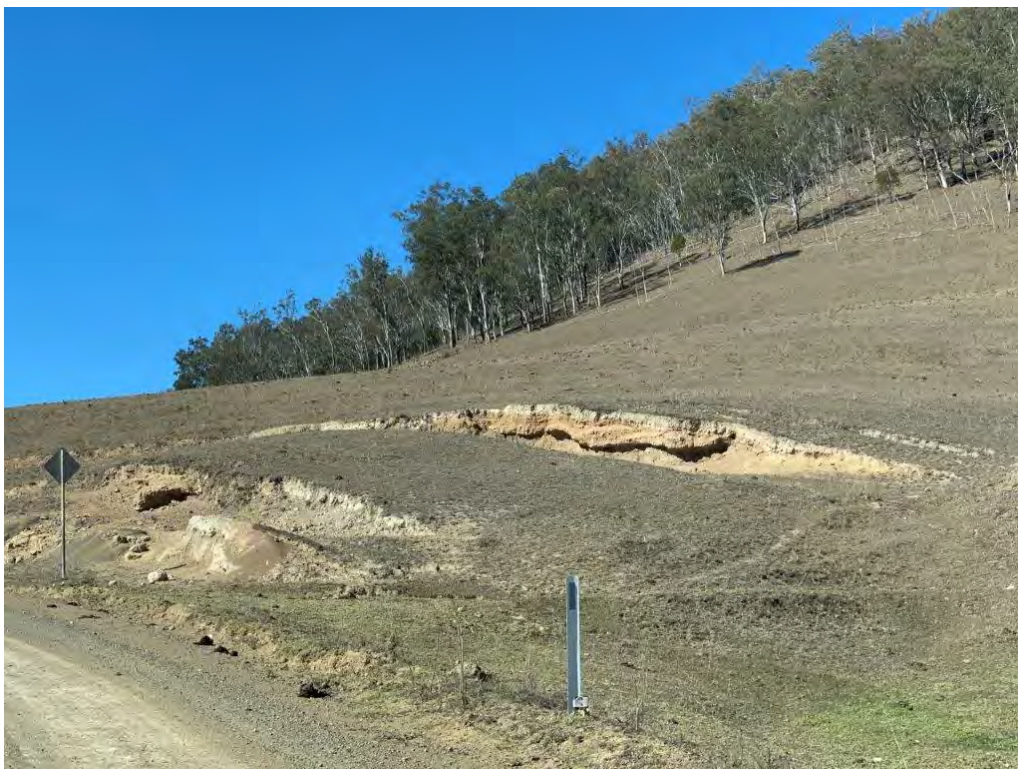
Photo 8 Nowendoc River catchment - gully erosion in Cooplacurripa Valley

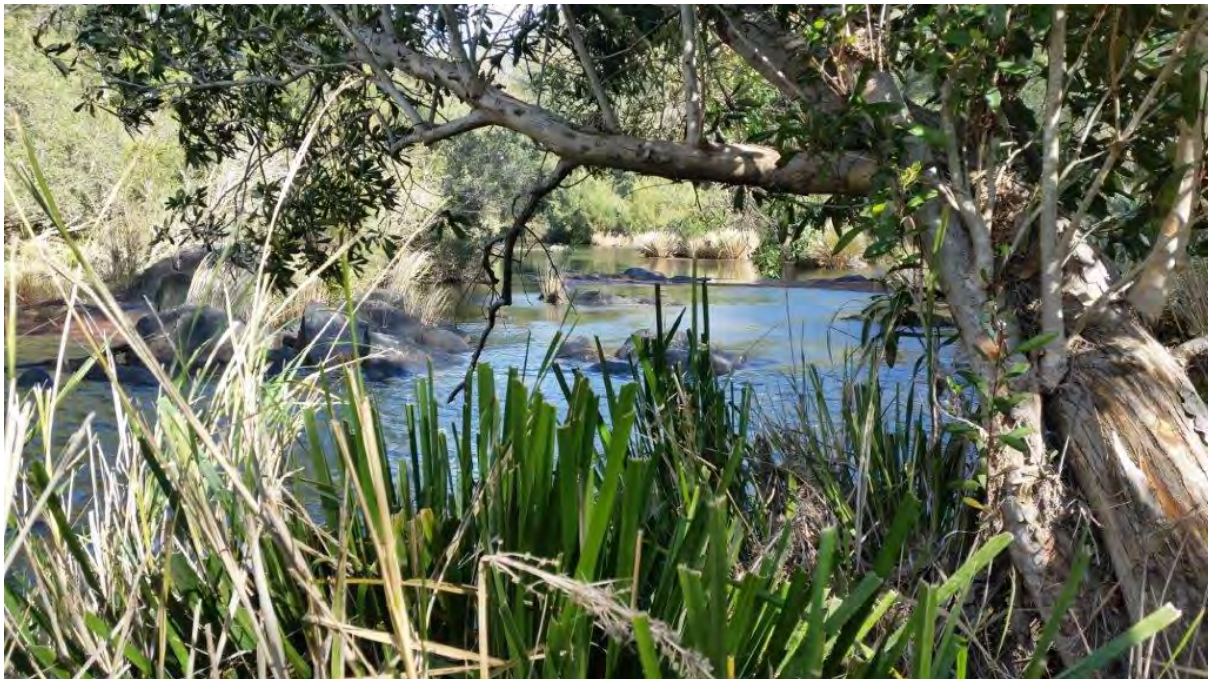
Photo 12 Nowendoc River at Dalrae - bedrock substrate, site 85-01. Good riparian vegetation however some cattle access (note grazed Lomandra in foreground)

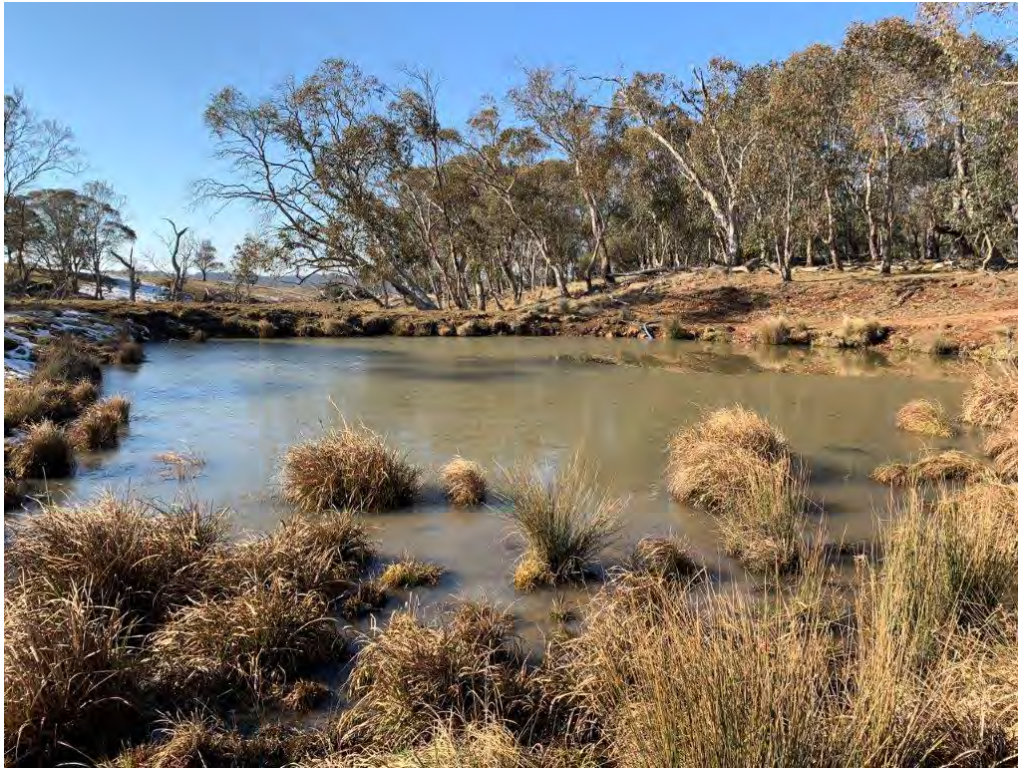
Photo 15 Myall Creek, site 68-01. Heavily impacted site.

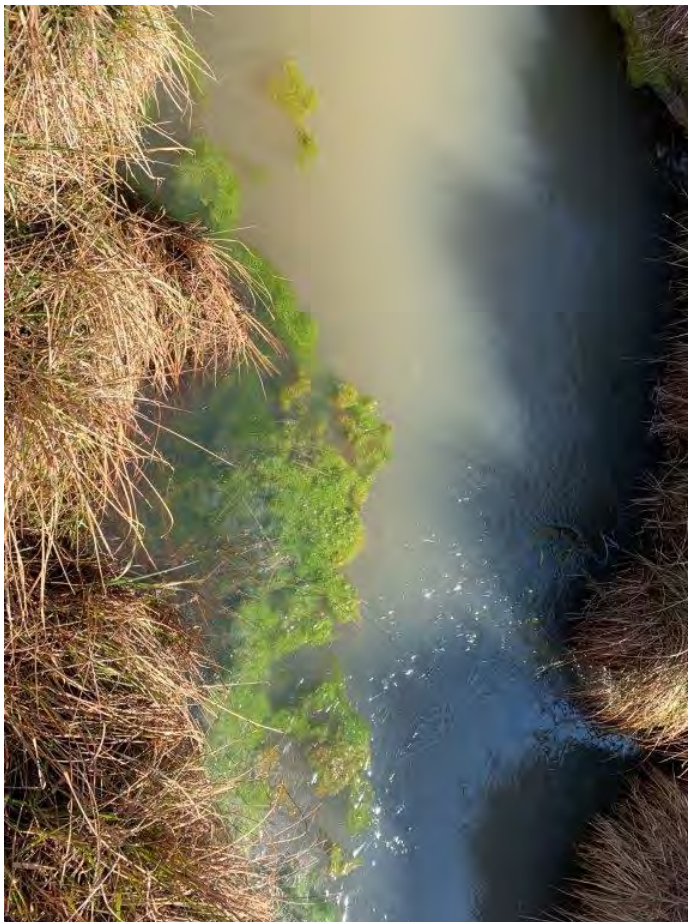
Photo 16 Myall Creek, site 68-01 showing algal growth and milky turbid water

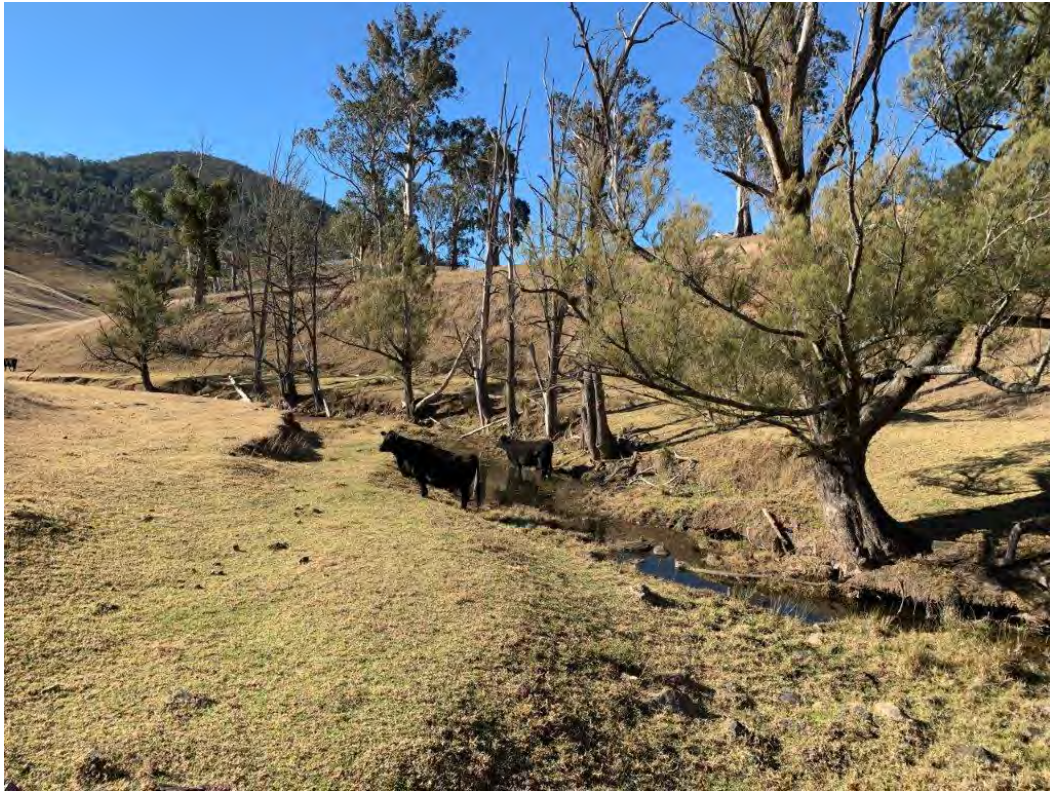
Photo 23 Barnard River catchment – Curricabark Valley (subcatchment 83). Cattle in springs outflow, clearing of riparian zones.

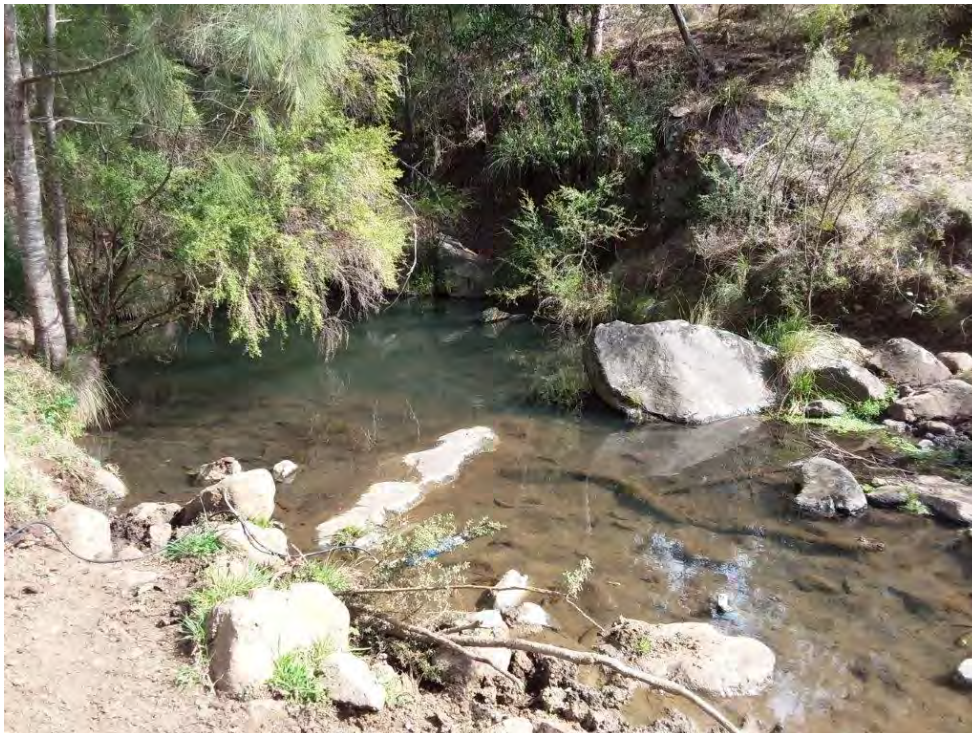
Photo 28 Upper Manning River catchment – site 90-06. Stream cloudy due to land clearing upstream. High pH due to limestone deposits

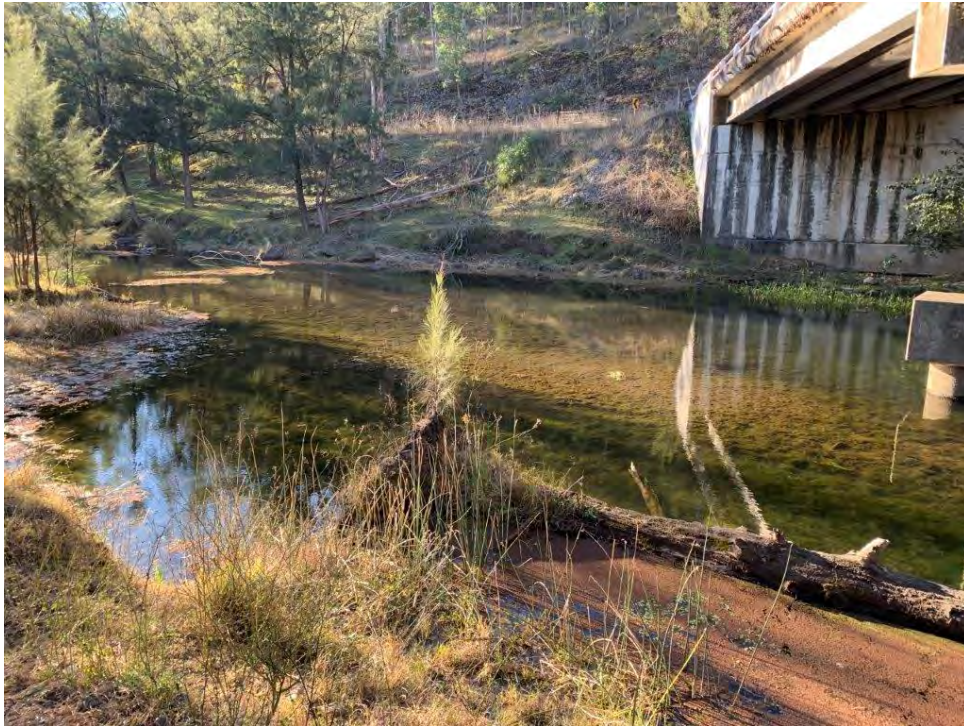
Photo 29 Upper Manning River catchment - Little Manning River, site 91-06. Eutrophic zone with excessive algal and macrophyte (*Azolla*) growth

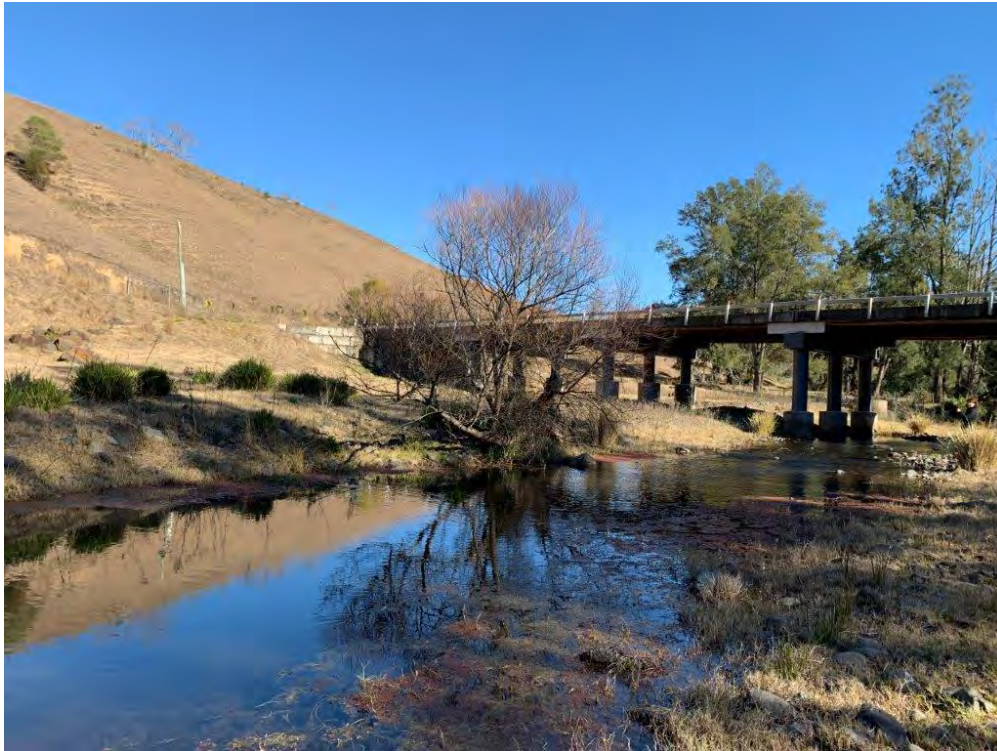
- Erodible bare slopes across catchment. Shallow rill erosion and gully erosion (91-14, Photo 31)
- Active stream-bed erosion noted at 92-04

Photo 31 Upper Manning River, 91-14. Note shallow rill and gully erosion on adjacent slopes

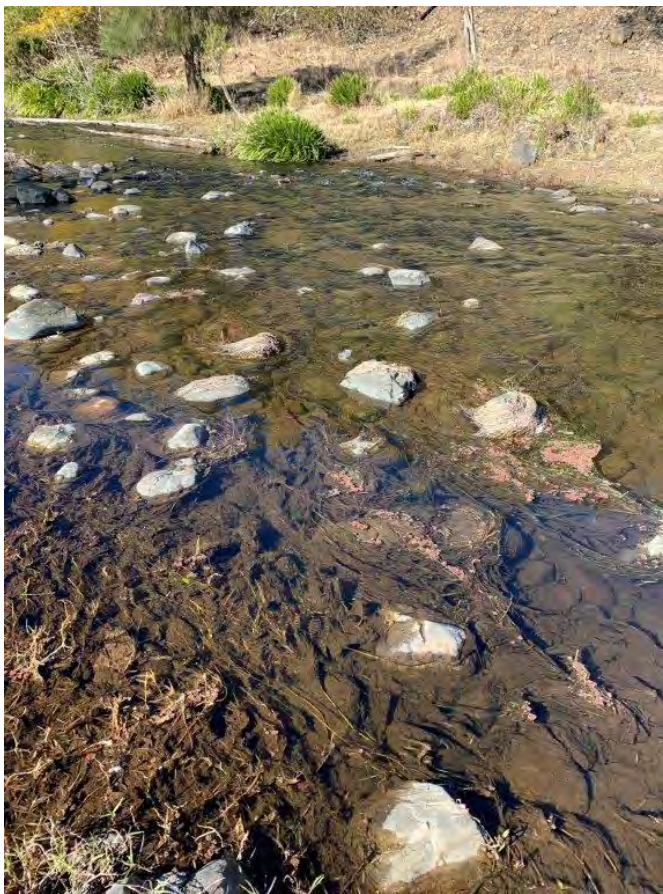
Photo 32 Upper Manning River, 91-14. Cattle access to stream, grazed Lomandra on banks

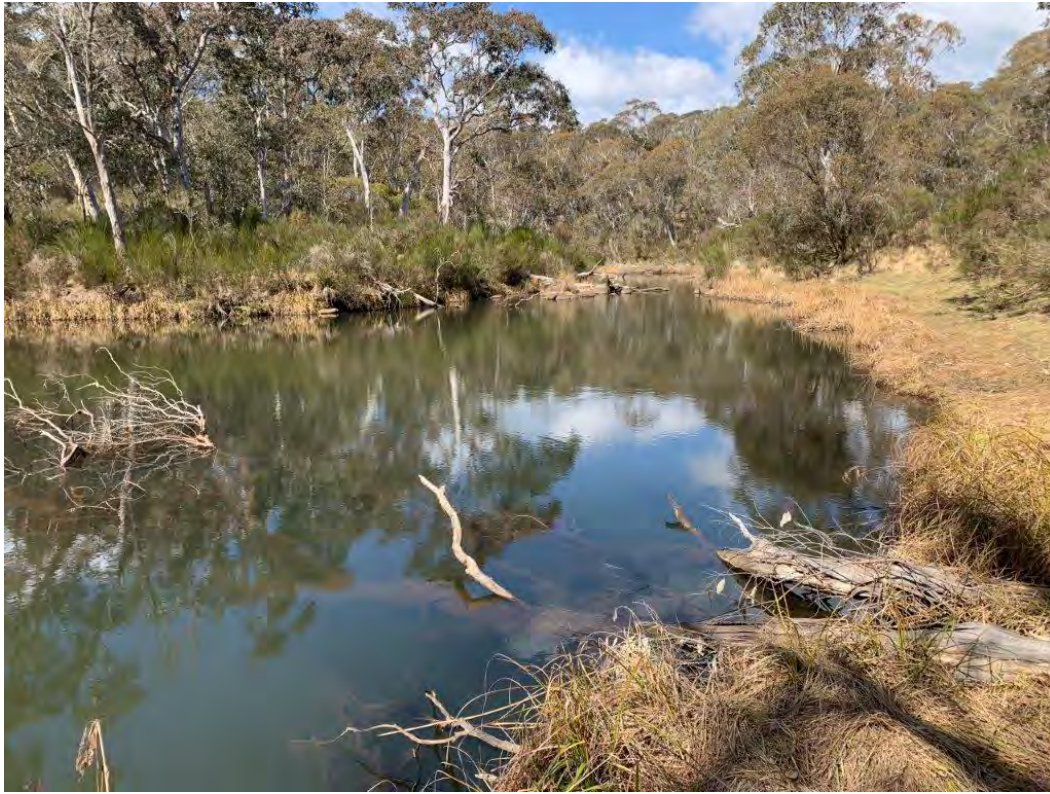
- Cattle accessing upland swamps (94-07, Photo 33) and streams (90-03, 91-14, 92-05)
- Large quantities of manure on bare slopes (90)

Photo 33 Upper Manning River at Watergate Camp - Upland swamp, site 94-07

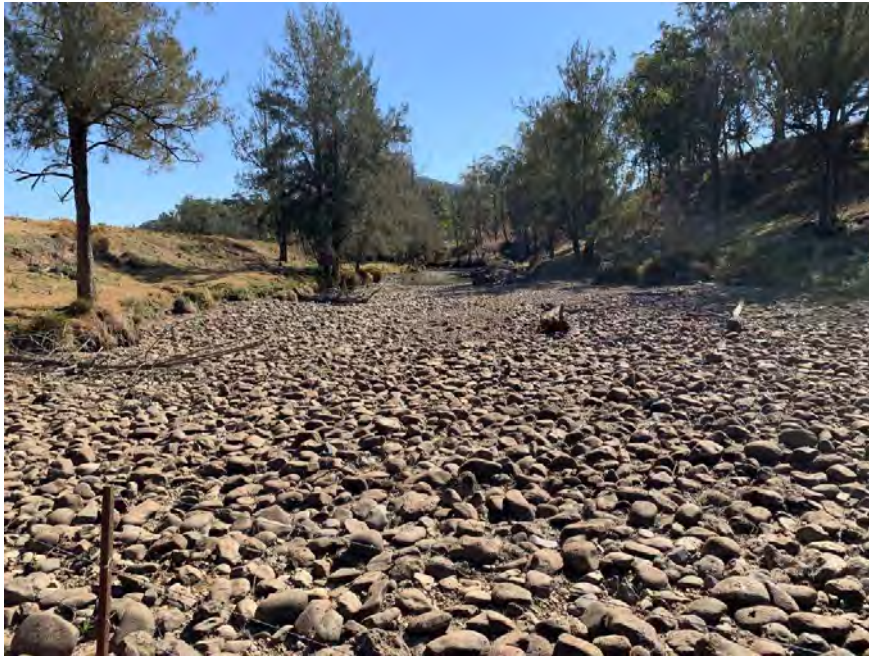
- One of the drier catchments. Spring fed pools in headwaters provide good water quality and high aquatic biodiversity (field observations) (109-10) but streams downstream have dried out (Photo 34)
- Isolated pools in grazing areas are in very poor condition, e.g., Craven Creek, extensive algal growth and exotic weeds dominate riparian vegetation (Photo 35)

Photo 34 Bowman River - one of the drier catchments, site 109-05

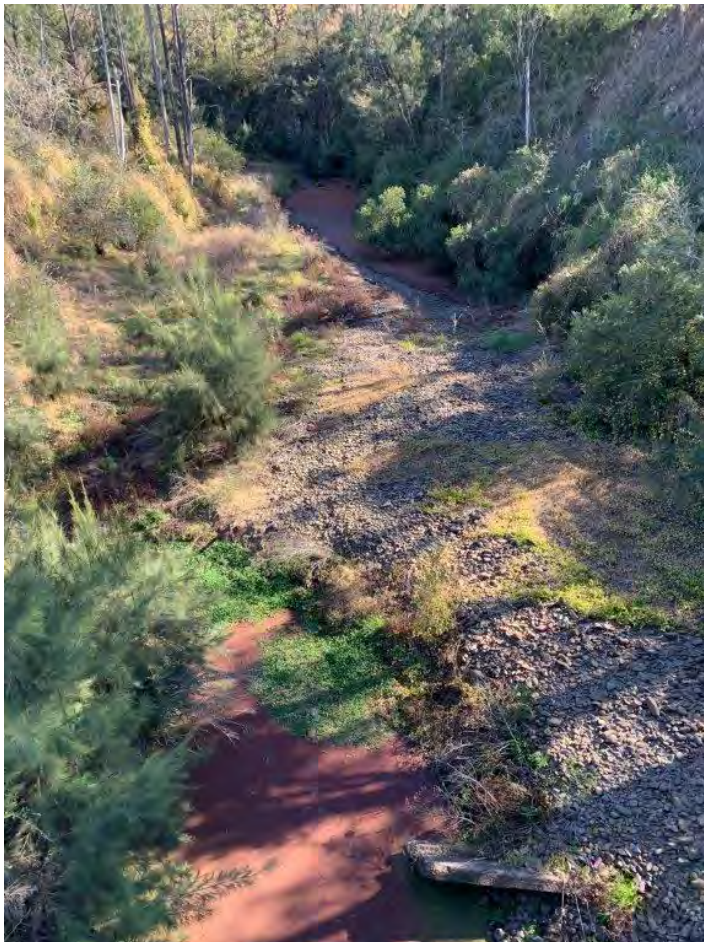
Photo 35 Bowman River on Kia Ora Rd, 109-03. Isolated pools with high nutrient loads, excessive macrophyte (*Azolla*) growth

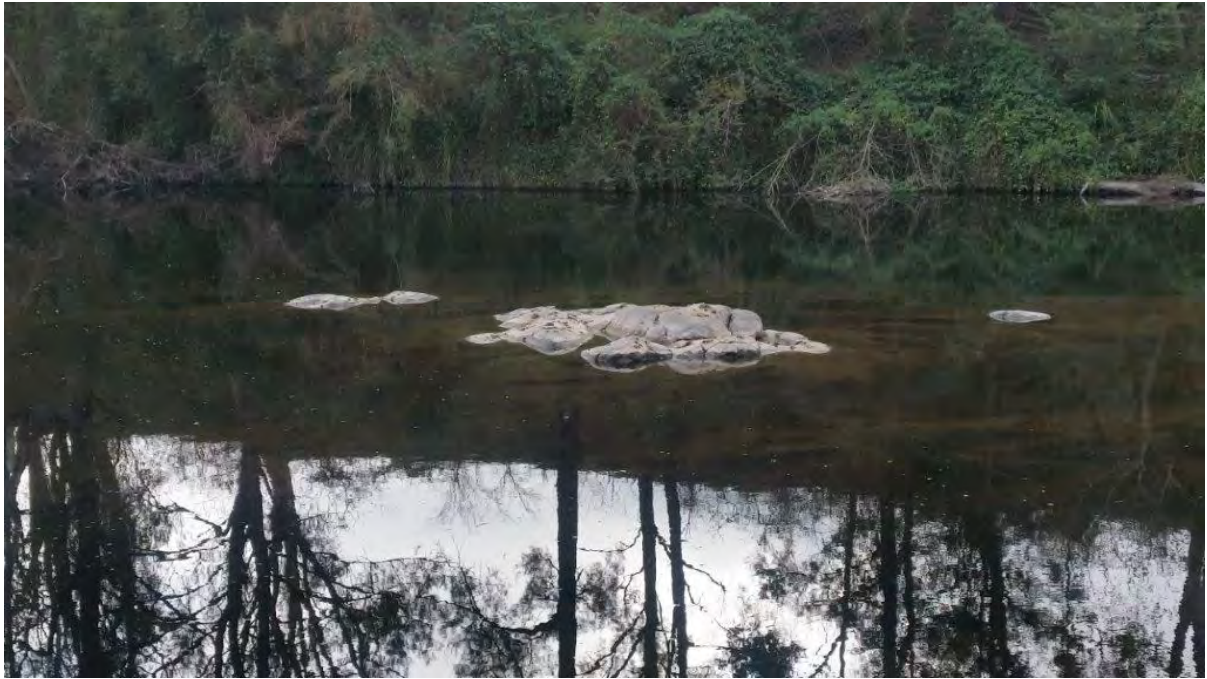
Photo 40 Barrington River at Relf's Landing, site 117-04. Note bedrock dominated river bed and extensive weed growth on left bank

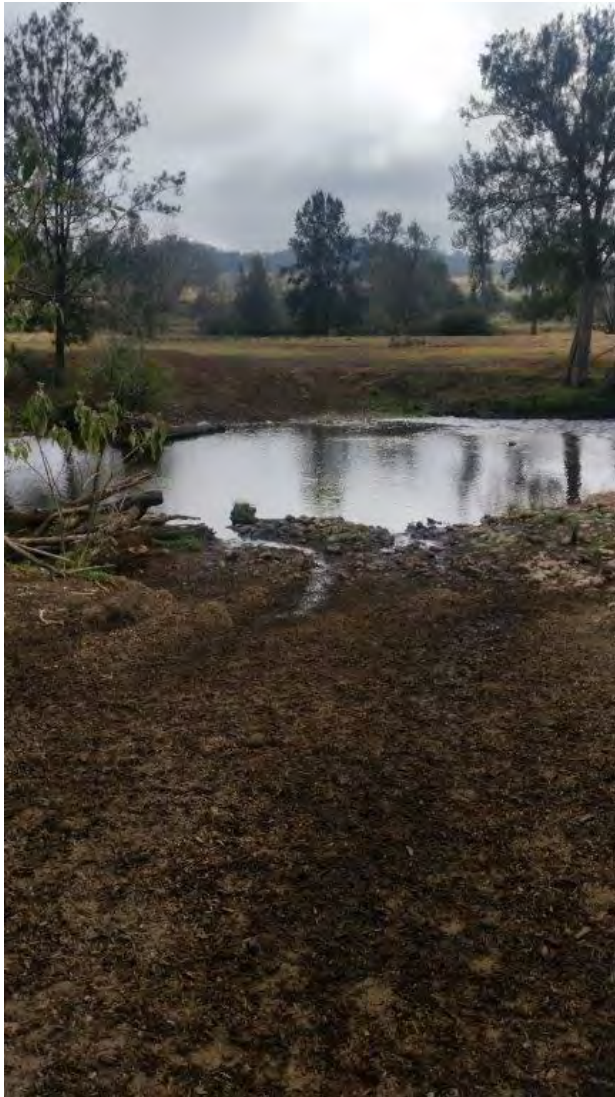
Photo 42 Barrington River, site 117-05. Hundreds of dairy cattle cross the river twice daily for milking.

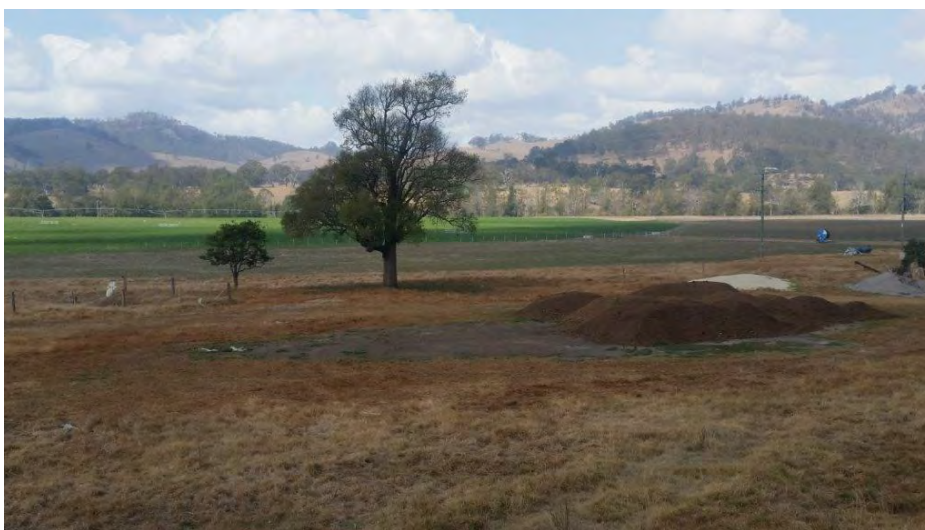
Photo 43 Barrington River subcatchment 117. Large irrigated property with irrigation pivots and stockpile of chicken manure to fertilise pastures.

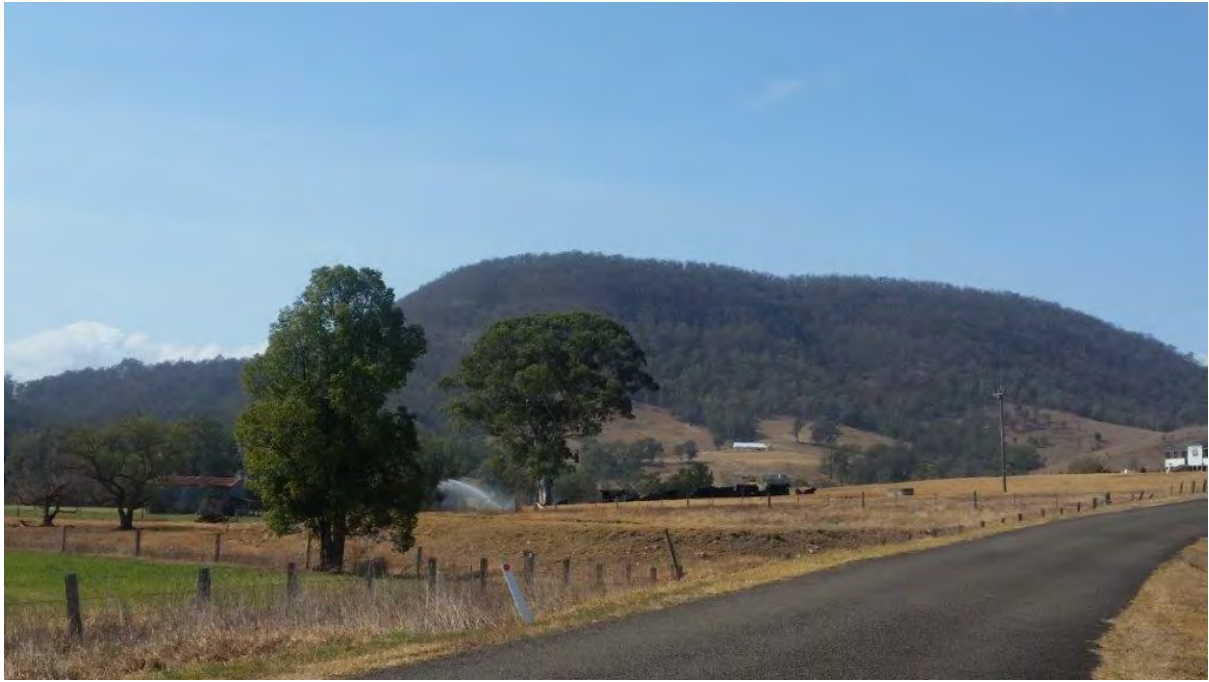
- Copeland Creek dry at 117-07, landowner said creek usually low flow all the time even in dry periods (Photo 44). The landowner upstream (117-08B) has diverted flow by digging big holes into creek line to access groundwater.
- Site 117-08B was assessed. An isolated pool has formed from digging into creek line and the soil removed from creek line lies next to it (Photo 45, 46). It was a heavily impacted site in very poor due to cattle access. This property (117-08B) should be investigated as this is highly illegal within the Water Sharing Plans and has led to no flow in the creek downstream at 117-07.

Photo 44 Barrington River catchment – Copeland Creek, site 117-07. Beef cattle and irrigated pastures. Creek dry at time of sampling, which landowner says usually always runs even in dry times. Flow has ceased due to illegal actions upstream at site 117-08B

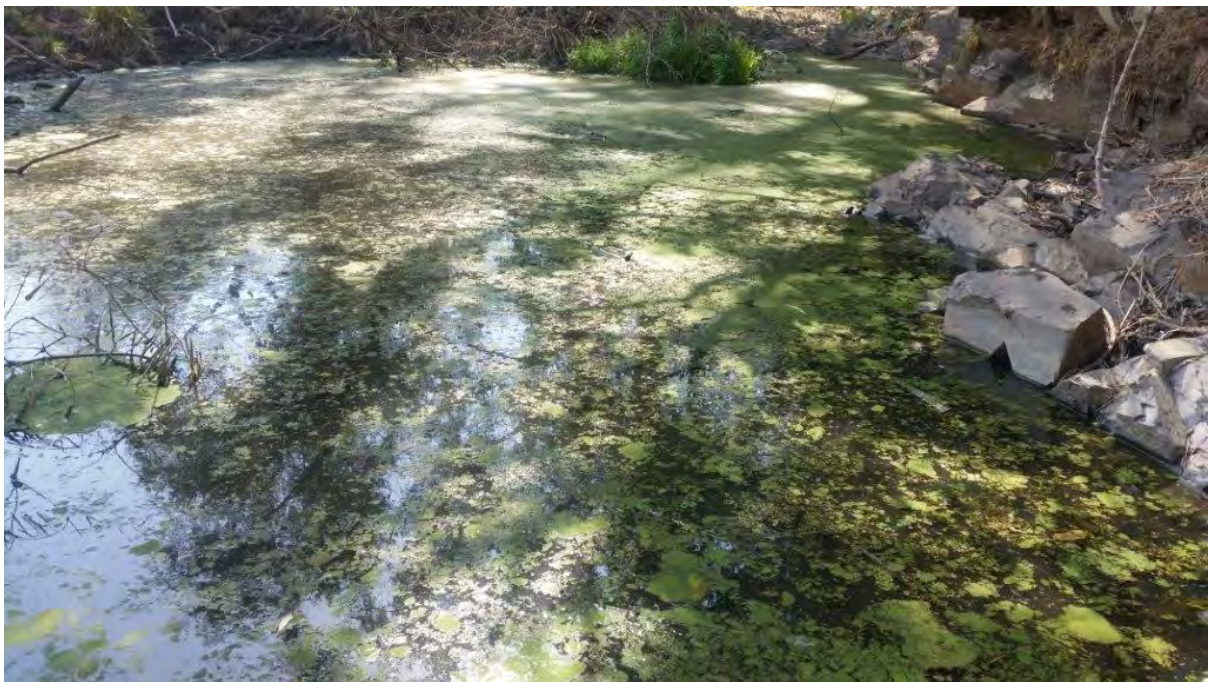
Photo 45 Barrington River catchment – Copeland Creek, site 117-08B. Isolated pool of water with very poor water quality and algal blooms. This pool has formed from landowner digging into creek bed (see Photo 46)

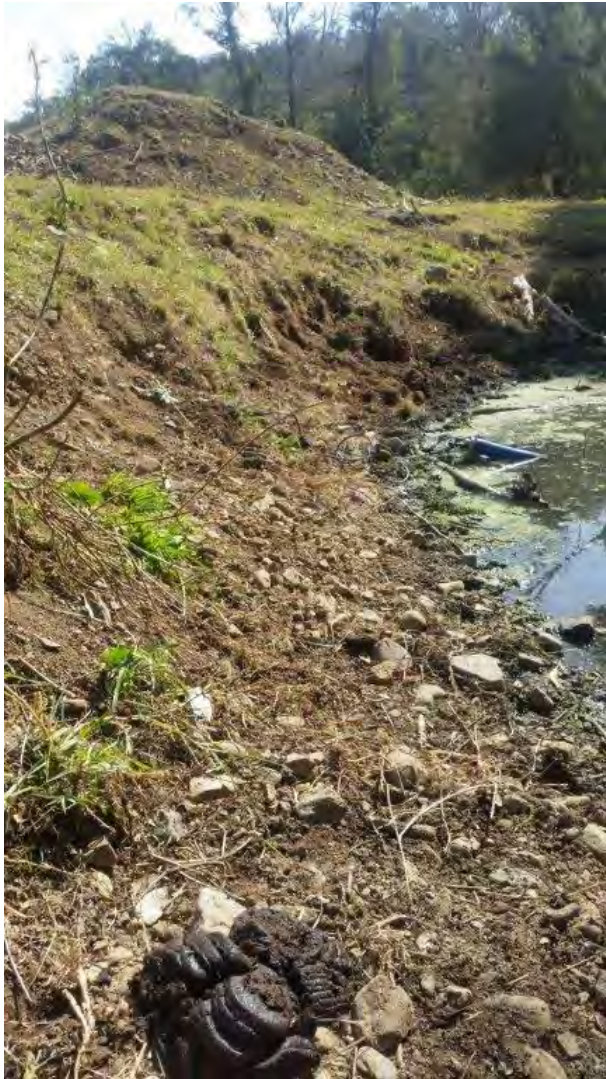
Photo 46 Barrington River catchment – Copeland Creek, site 117-08B. Spoil from landowner digging into creek bed. Very poor water quality in isolated pool due to cattle access

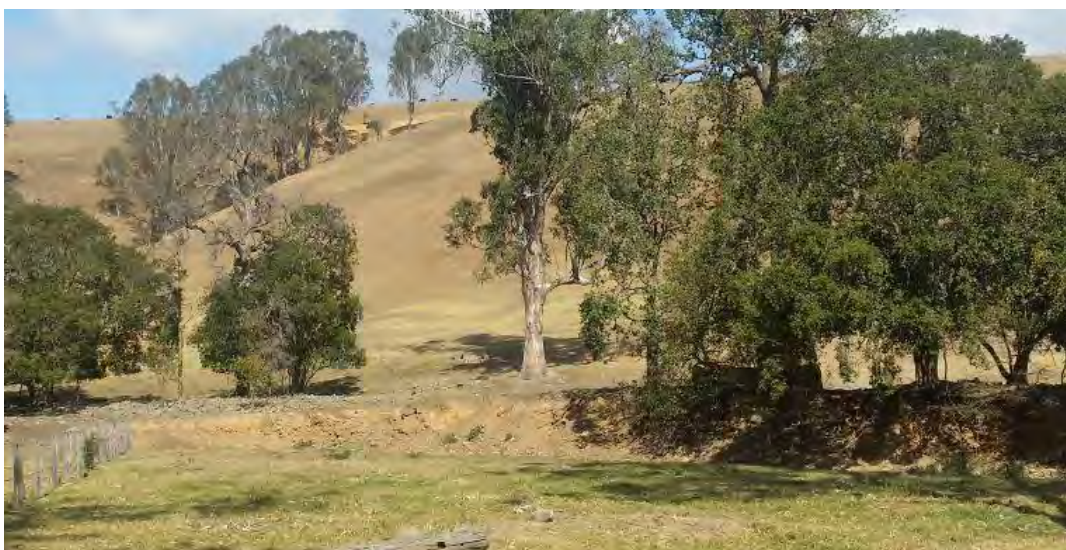
Photo 47 Barrington River subcatchment 117- site 117-08. Dry unvegetated creek line (foreground), bare steep hillslopes and severe gully erosion (background)

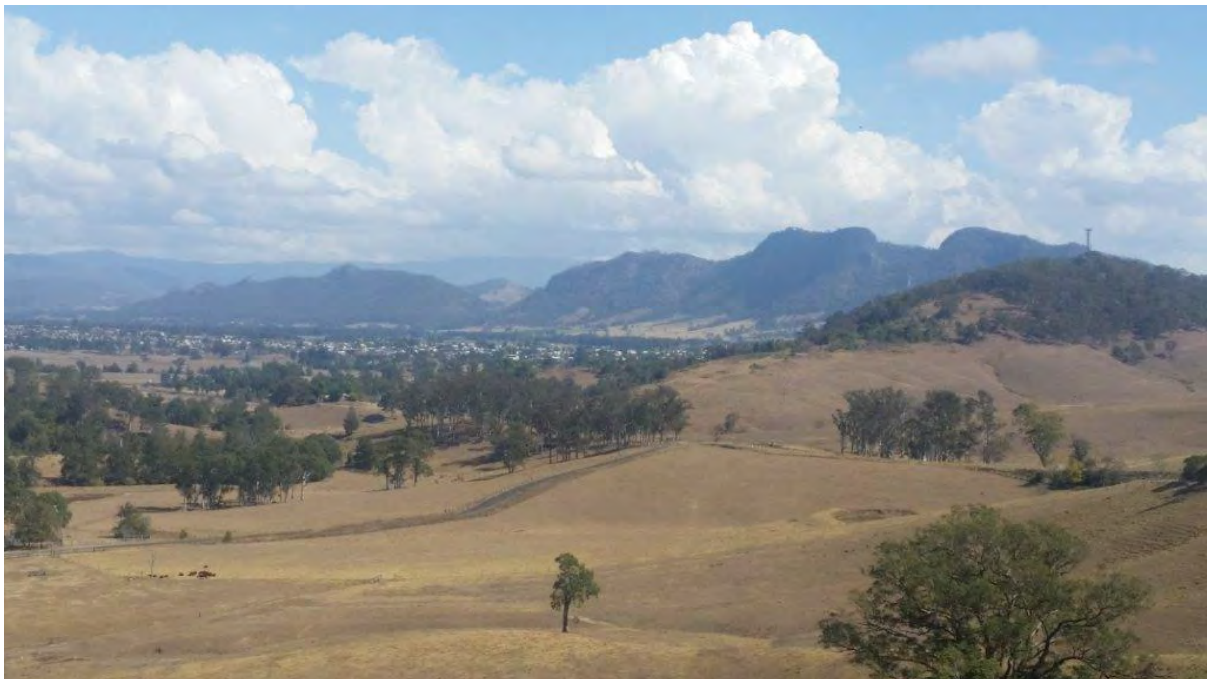
Photo 49 Gloucester Lookout (subcatchment 122) – bare slopes, cattle tracks (right hand side).

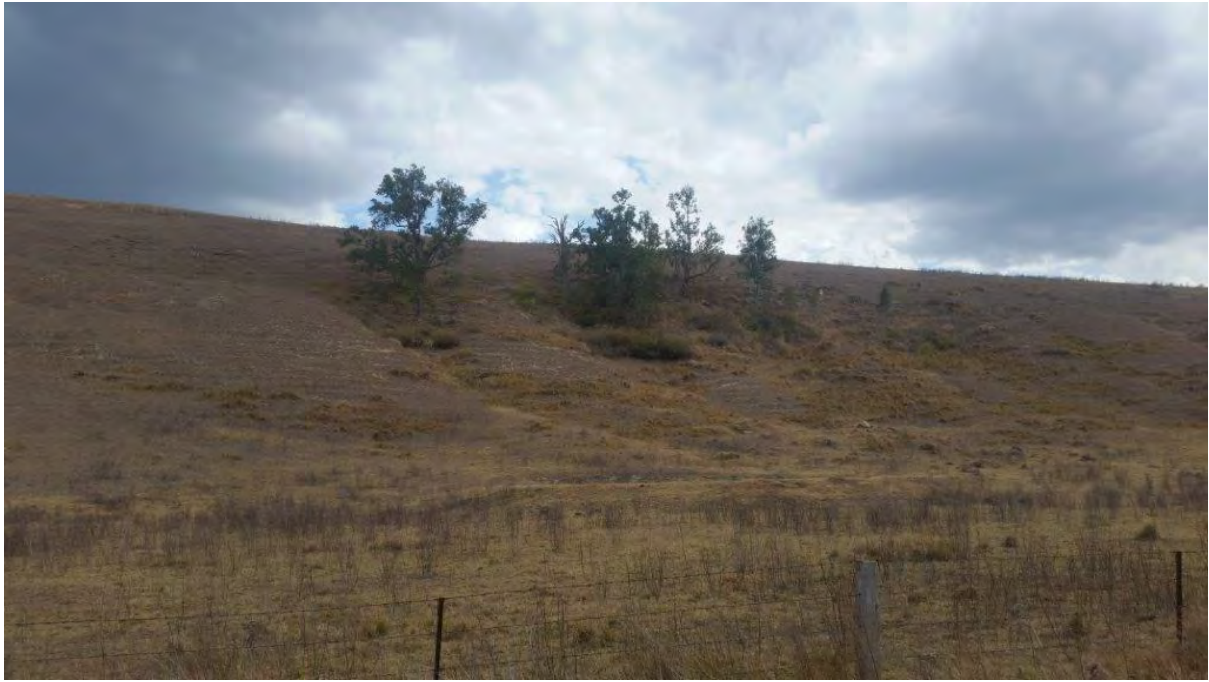
Photo 50 Gloucester River catchment, near site 122-14. Eroding hillslopes, cattle tracks.

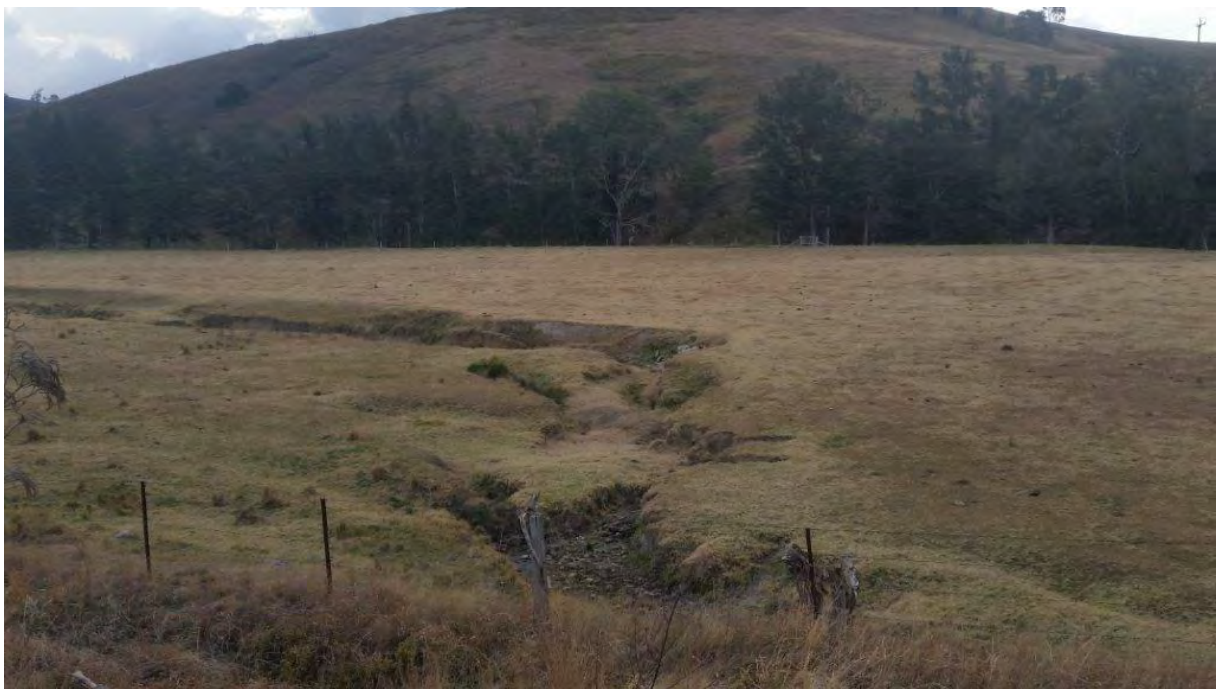
Photo 51 Gloucester River catchment – Berrico Creek, site 122-14. Dry unvegetated creek line in adjacent pasture. Eroding hillslopes.

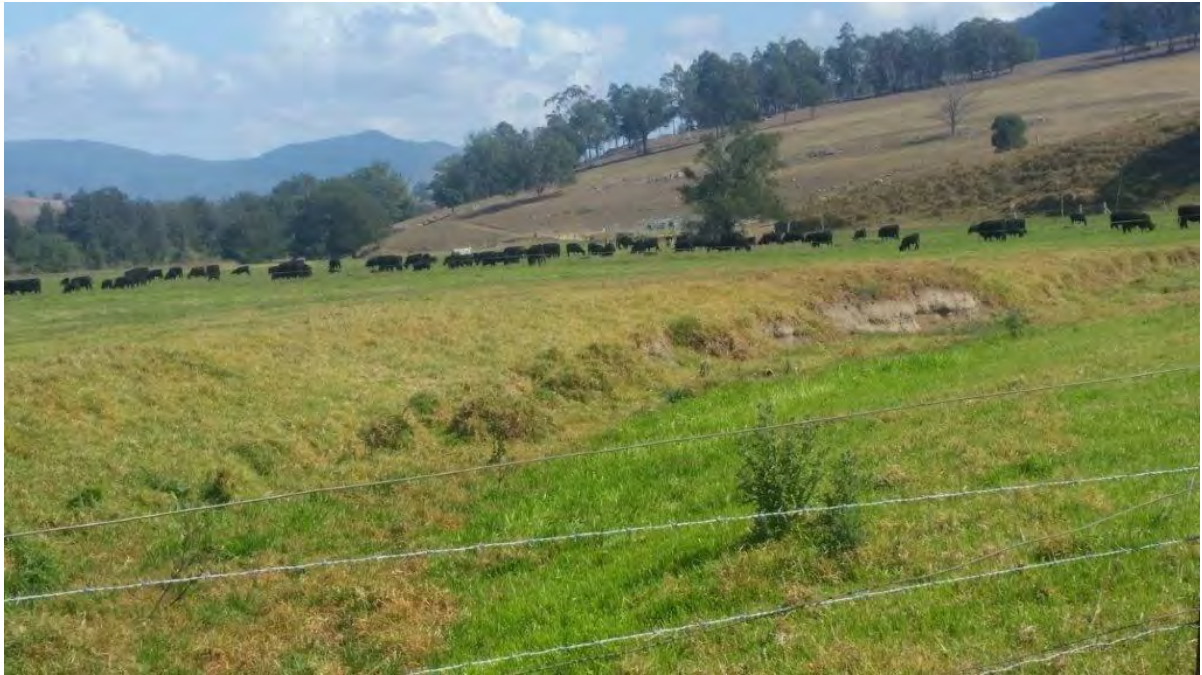
Photo 52 Gloucester River catchment, site 122-07. Unvegetated creek line, typical of catchment.

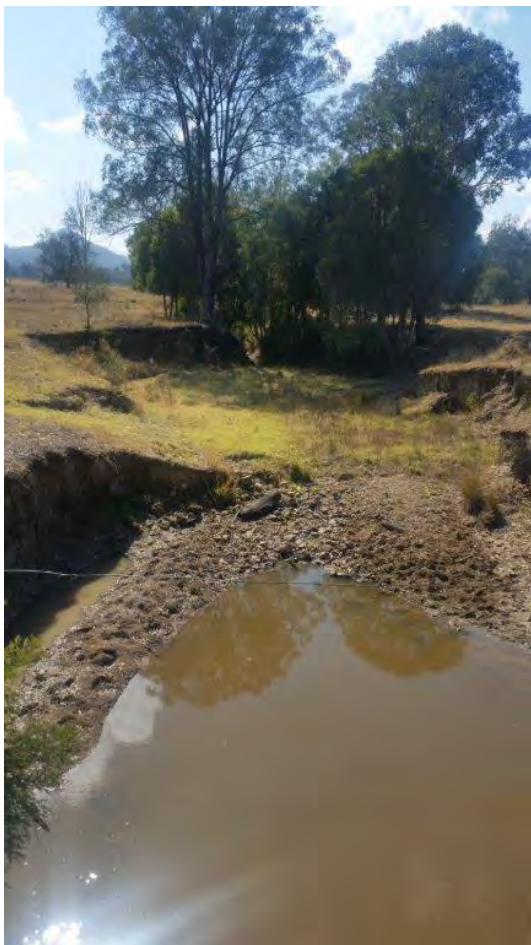
Photo 53 Gloucester River catchment. Sandy Creek, site 122-02. Isolated pool with cattle access, unvegetated banks

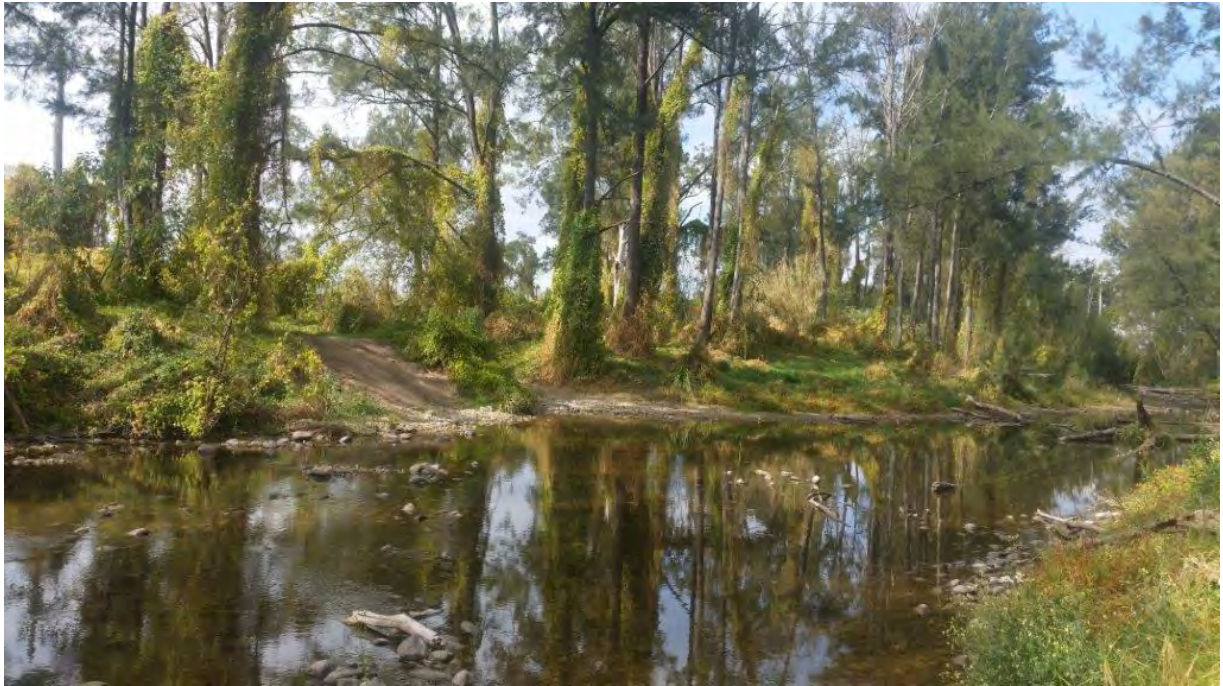
Photo 54 Gloucester River, Wellards Lane crossing, site 122-01. Riparian vegetation infested with balloon vine.
