**MANNING
RIVER
ESTUARY &
CATCHMENT**

RAPID SITE ASSESSMENT 2020

Swanson, R. 2020. Manning River Estuary and Catchment RAPID SITE ASSESSMENT. A snapshot of stream condition in the Manning River Estuary and its catchment from the ground-truthing program. Environment, Energy and Science. NSW Government, Sydney.

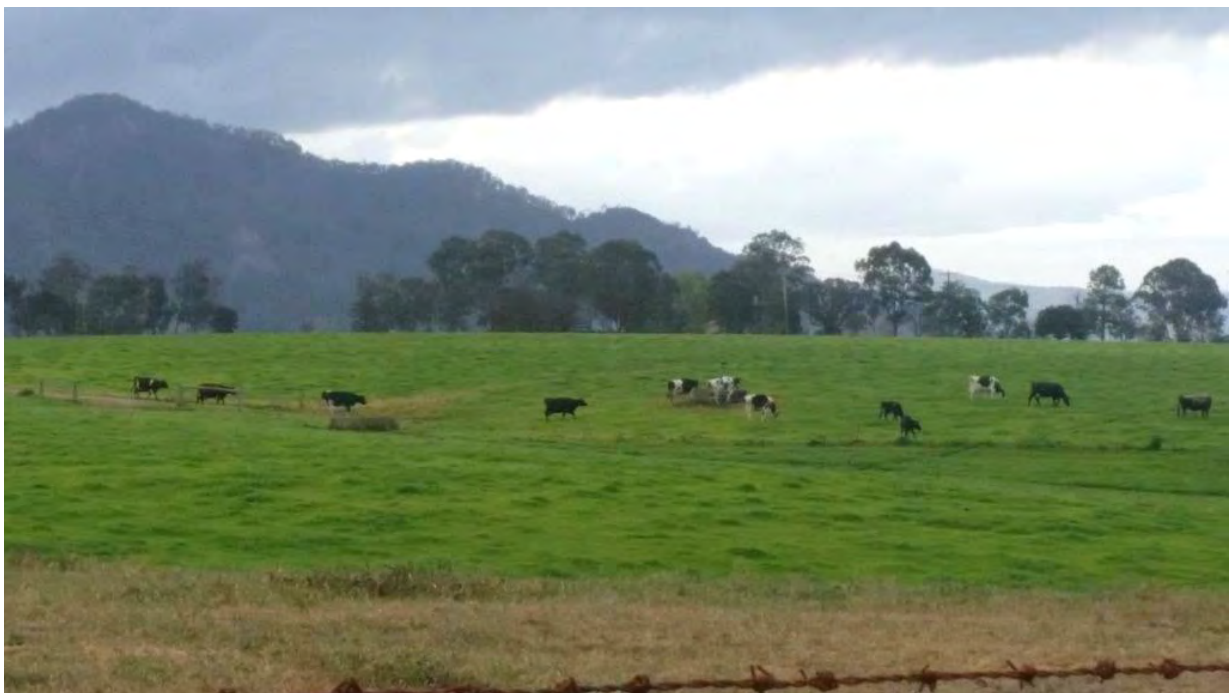
Photo 55 Gloucester River subcatchment 122, Dairy farm at Faulkland

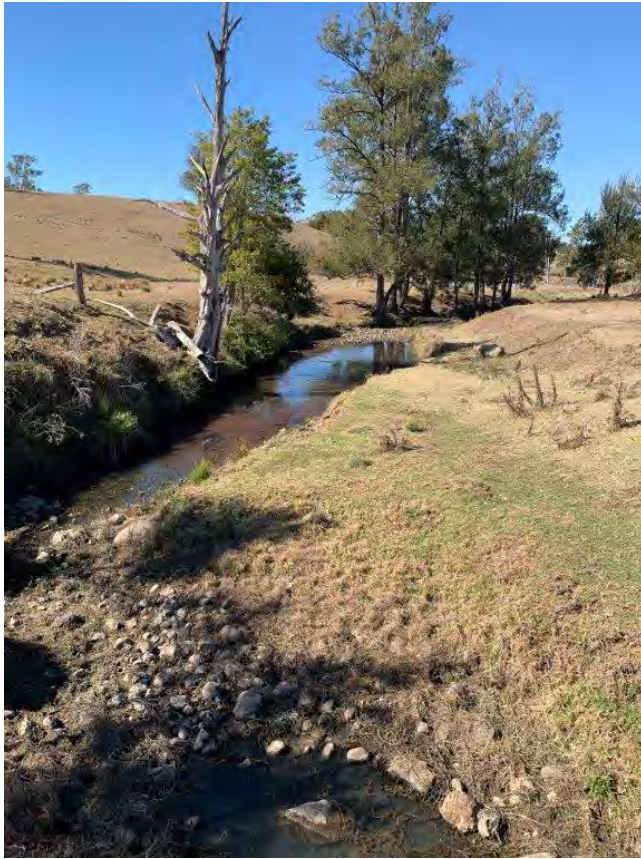
Photo 58 Gloucester River catchment - Buliac Creek, site 98-03b. Isolated pool with excessive algal and macrophyte growth.

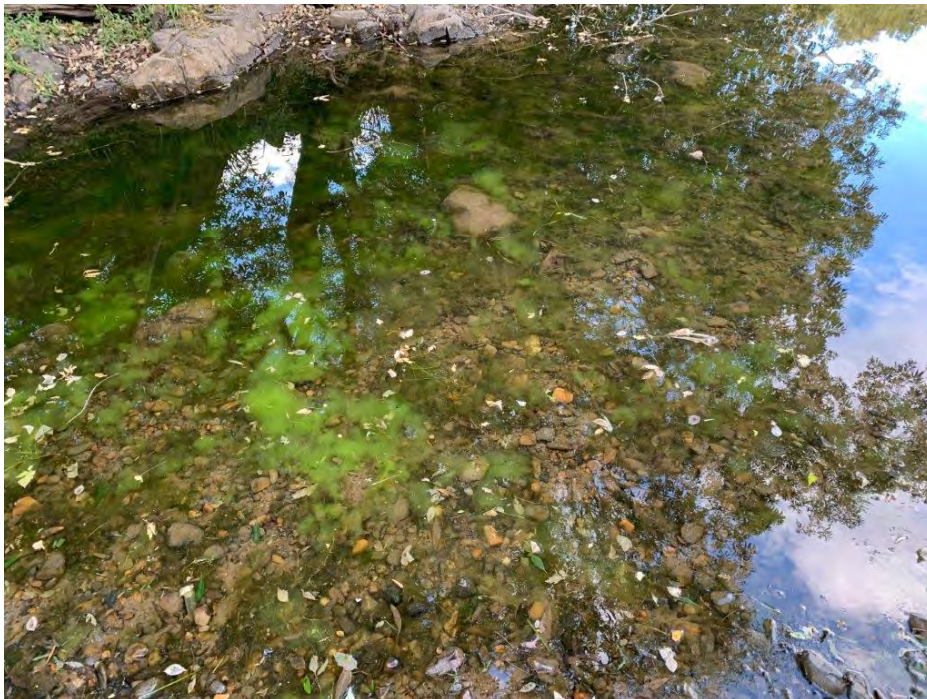
Photo 59 Gloucester River at Callaghan Creek Rd, site 98-01. A lot of filamentous algal growth downstream of intensive farming in Gloucester (Barrington 117 and Avon 121) and Gloucester STP discharge

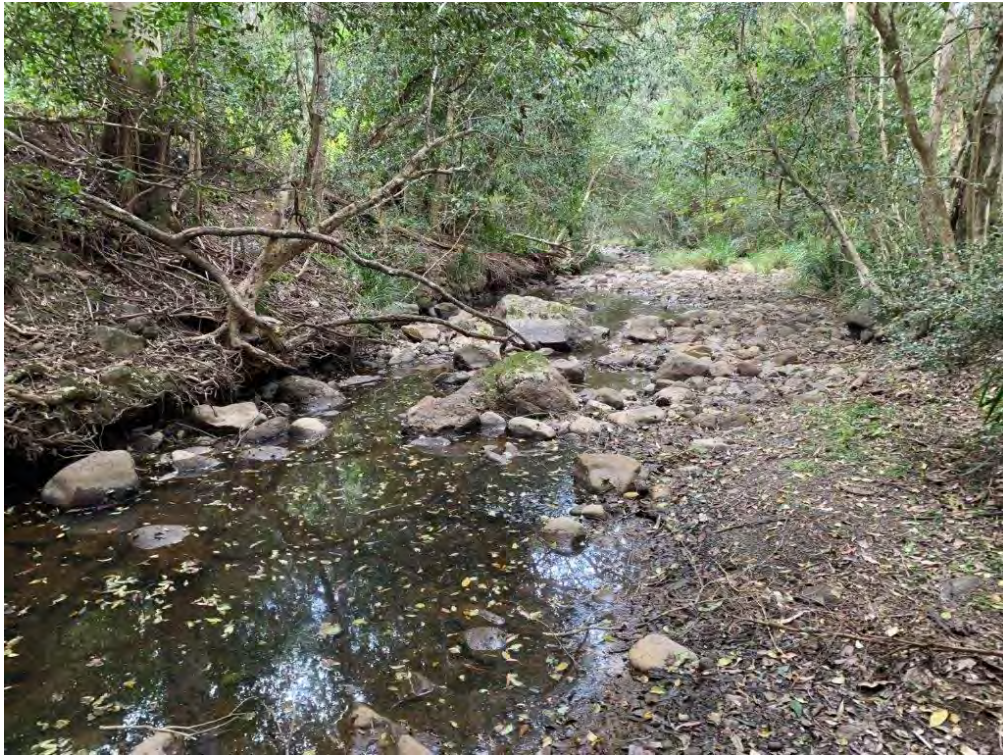
- No flow in many streams, not many headwaters (Photo 60, 62, 63)
- Highly impacted permanent spring fed pools with no flow and high nutrients (algae) in lower catchment (Photo 62)
- Good riparian vegetation in upper catchment (Photo 60). Exotic species dominate riparian vegetation in lower catchment

Photo 60 Upper Avon River, site 123-14

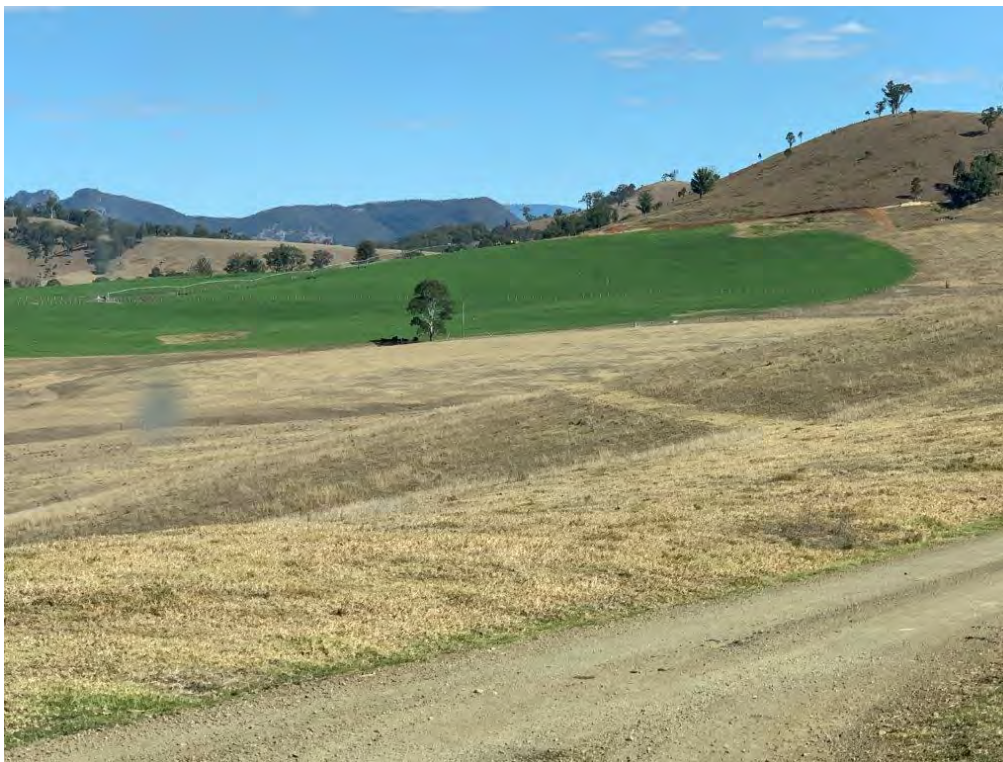
- Forested areas and a large mine in subcatchment 123
- Grazing and intensive cattle farming throughout catchment (Photo 61)

Photo 61 Avon River catchment – irrigated fertilised pasture (note pivot at rear)

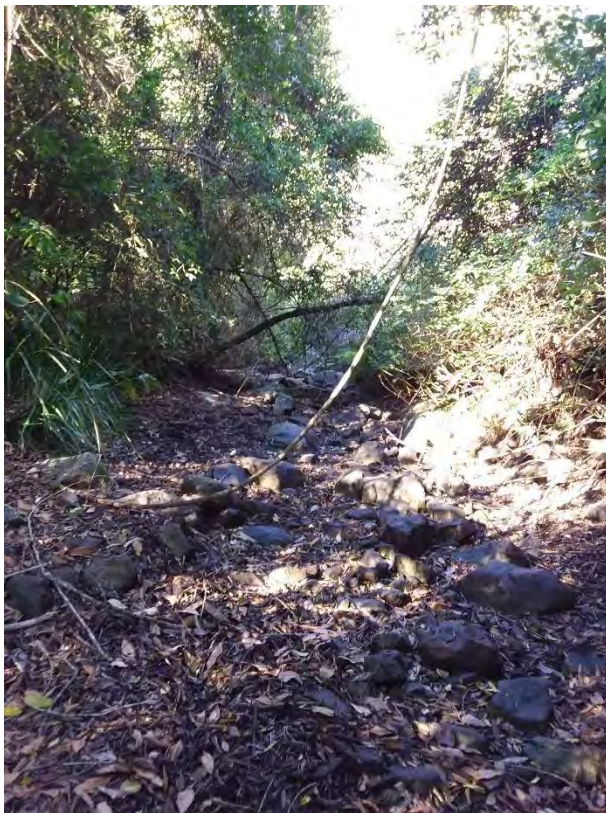
- Most sites no flow, isolated spring-fed pools with high nutrients (algal growth) and elevated conductivity (Photo 66, 67)
- Stable banks with minor erosion and undercutting at most sites. Banks in poor condition at 113-05 (Photo 68)
- Minimal disturbance of riparian zones with good longitudinal continuity ((Photo 64, 65)
- Native vegetation generally well represented in canopy, shrub layer and groundcover

Photo 65 Burrell Creek – Mulligans Lane, site 112-03. No flow, cobble bed, good riparian vegetation

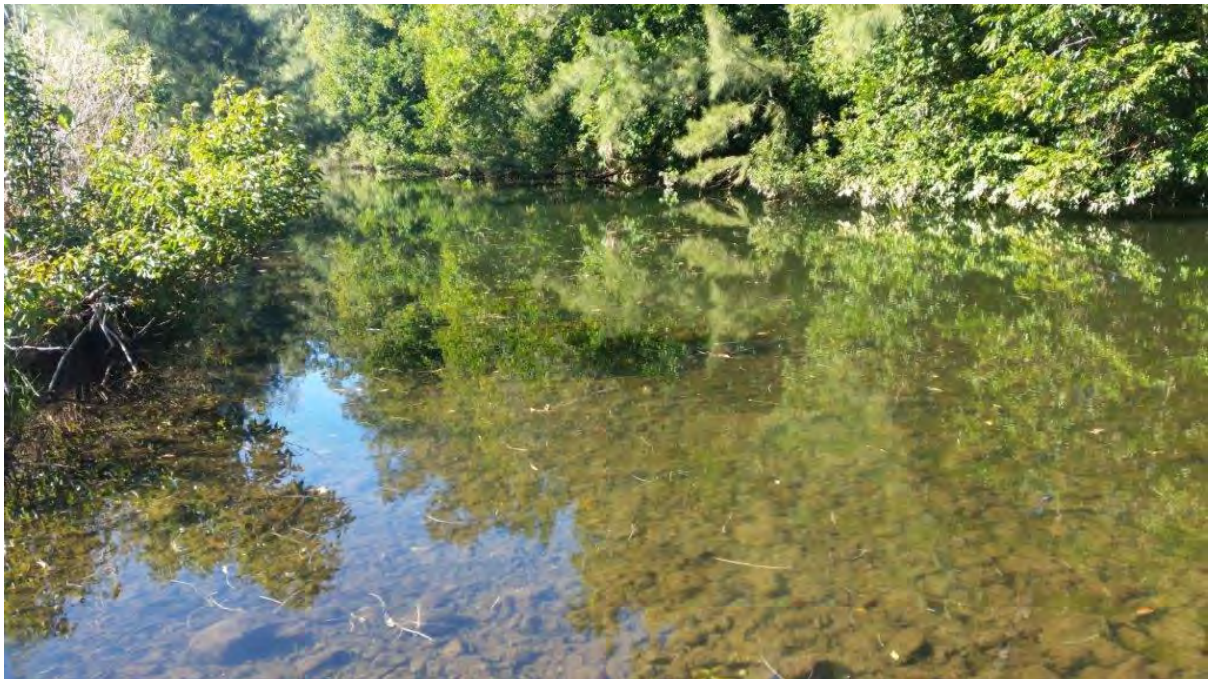
- Upstream sites in 86 (Gunyah Rd crossing, Bobin) and 89-04 (Cappara Ck, Hoads Bridge) had extensive riparian vegetation, very low flow but good water quality (Photos 69, 70)
- Cobble dominant substrate (<30% cover) at most sites. Bedrock dominated at site 97-07 (Photo 72)
- A lot of algal growth in Dingo Creek in 89 and 97, and at Marlee site in 86.
- Extraction from Dingo Creek for domestic use noted frequently (Photo 71)
- No flow / isolated pools in tributaries (Deep Ck, Betibombi Ck, Big Run Ck; Photo 74).

Photo 70 Dingo creek at Gunyah Rd crossing, site 86-06. Good riparian vegetation.

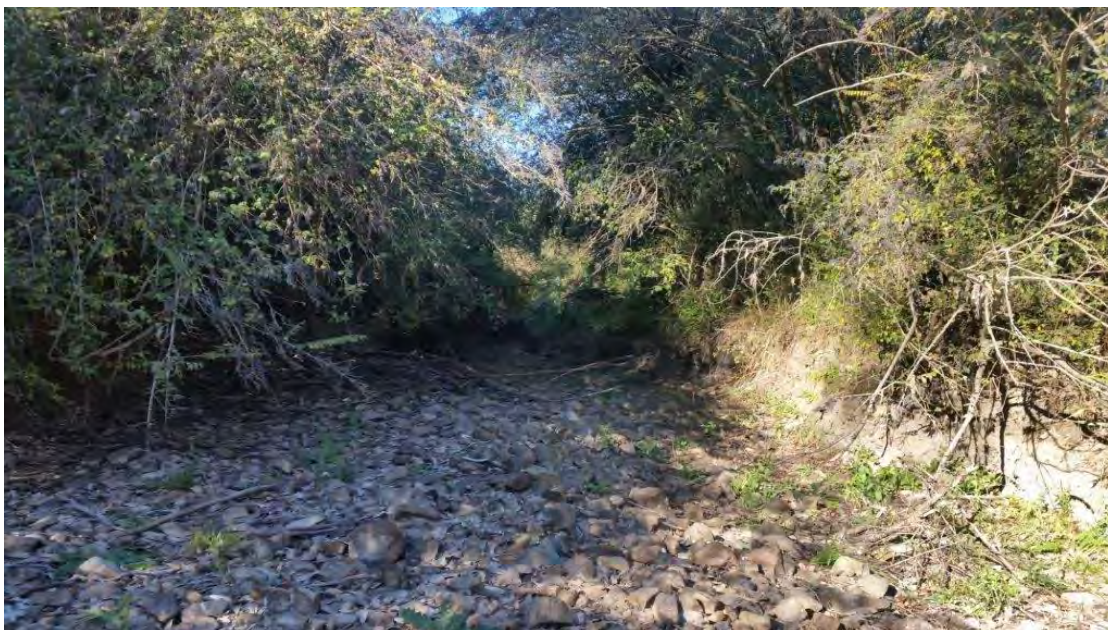
Photo 74 Dingo Creek catchment – Deep Creek - site 89-01. No flow, riparian vegetation dominated by exotics (Willow and Privet)

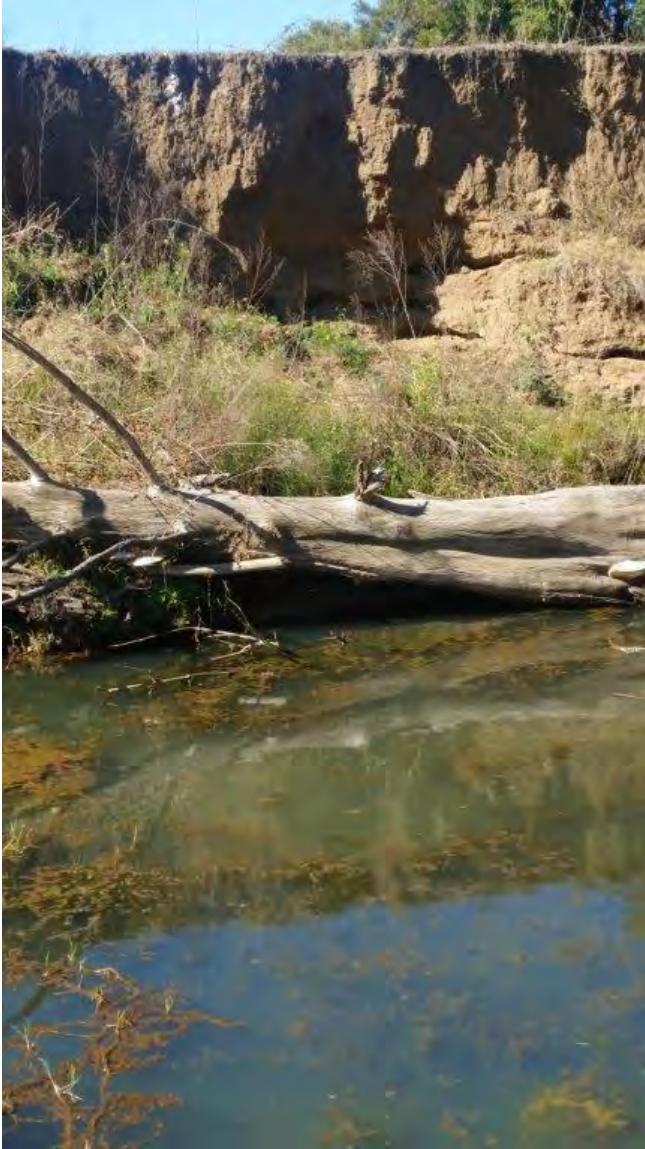
- Forest in upper catchment is steep and prone to erosion (Nearmap).
- Bare pastures were common in 89.
- Streambank erosion noted in 89 (tributaries) and at 86-01 (Photo 75)

- Cattle access evident at some sites (86-01, 97-06; Photo 75).
- Effects of fertiliser use for pastures/crops were evident at many sites (e.g. algal growth, Photo 75, 76)

Photo 75 Dingo Creek at Middlebrook Rd crossing, site 86-01. Cattle access, vertical banks with heavy erosion. Low flow. Excessive algal growth in isolated pools.

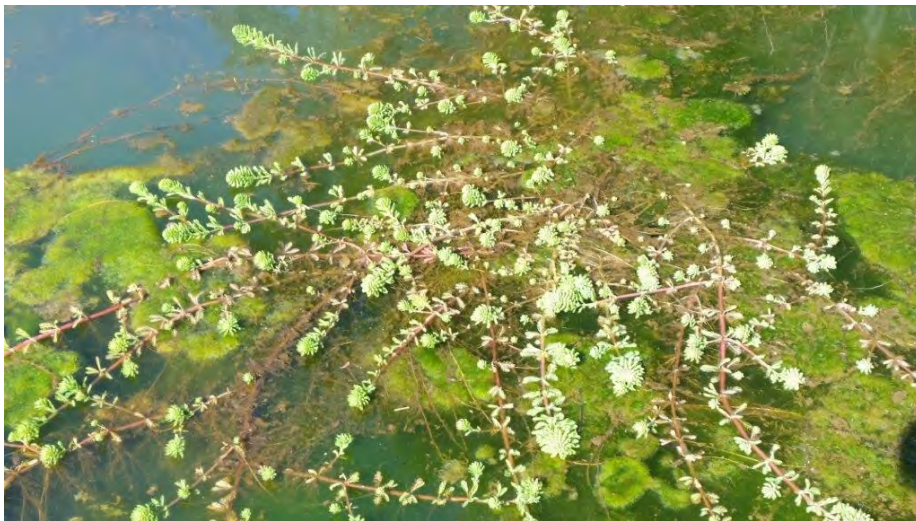
Photo 76 Dingo Creek at Middlebrook Rd crossing, site 86-01. Excessive algal growth and exotic macrophytes in isolated pools with high nutrient loads

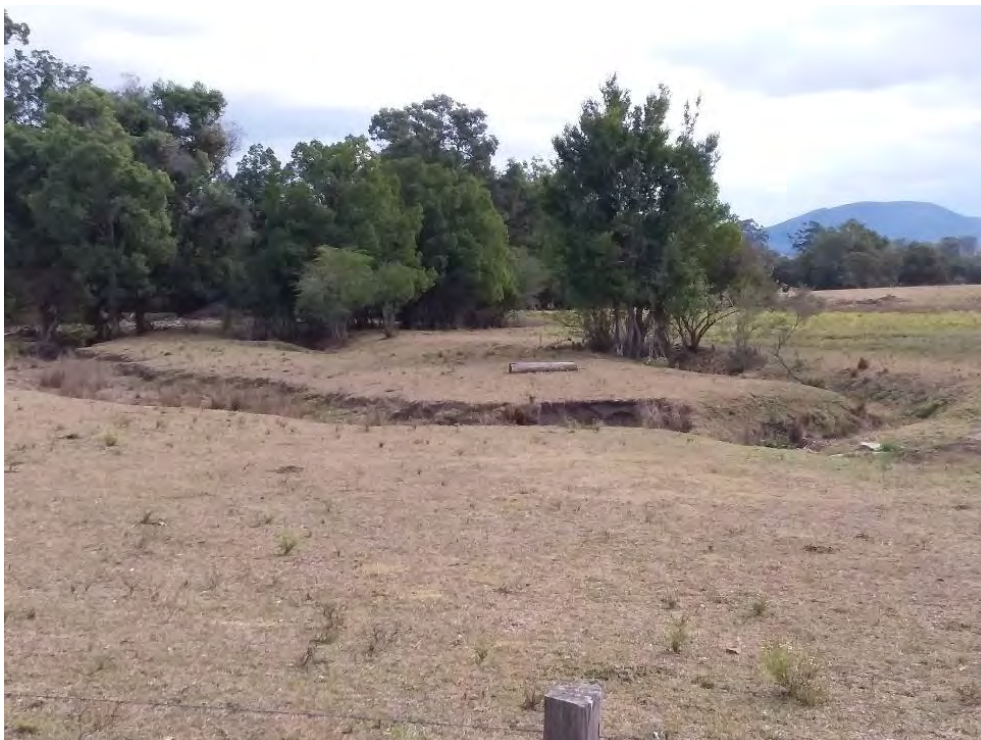
Photo 78 Cedar Party Creek catchment, unnamed creek near Youngs Rd, site 95-06. Unvegetated creek lines on private property

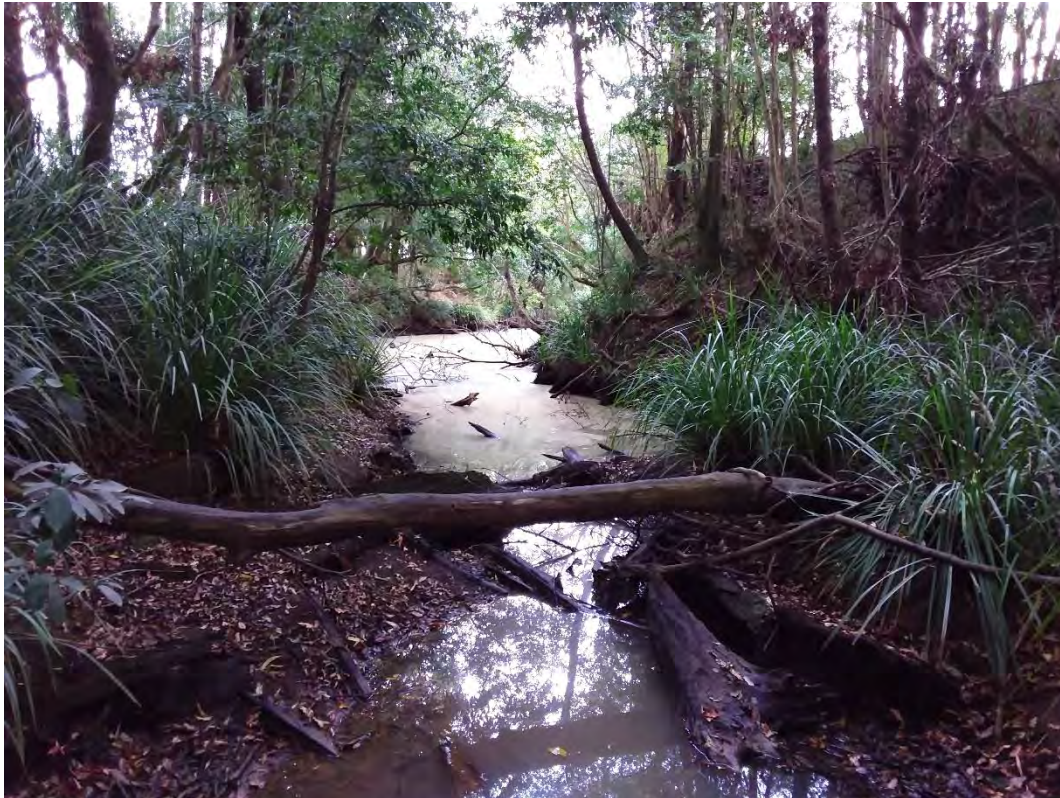
Photo 79 Cedar Party Creek catchment, – Killabakh Creek, site 95-08. Good riparian vegetation but no flow, turbid pools of water with decomposing algal bloom

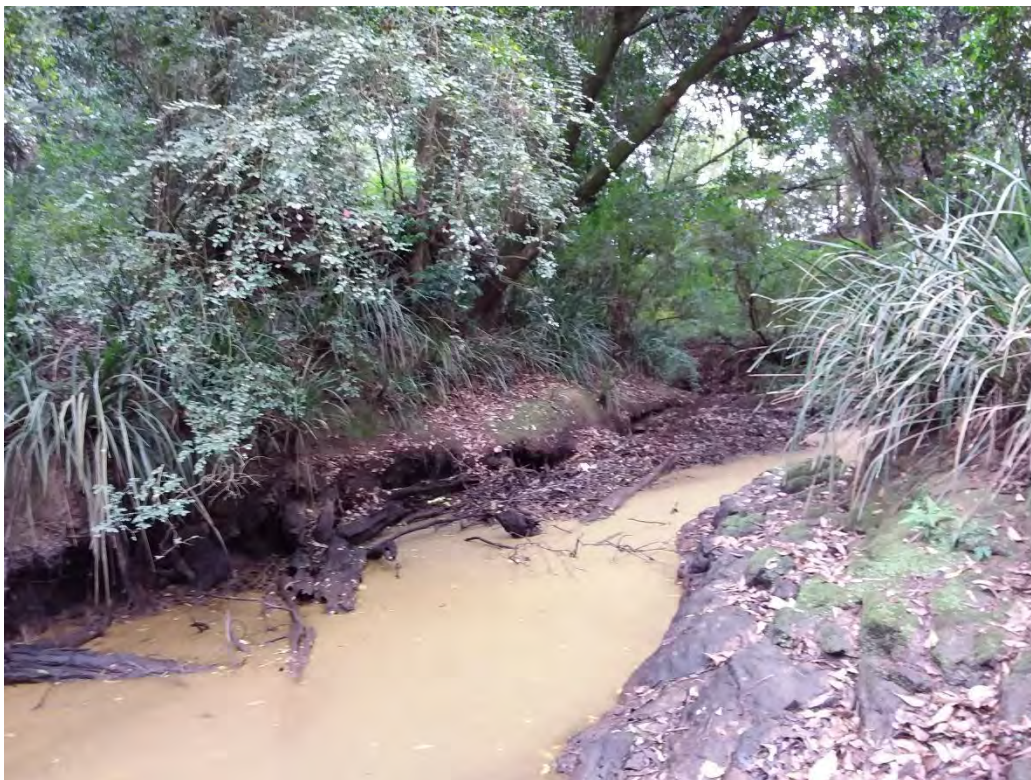
Photo 80 Cedar party Creek catchment – Killabakh Creek, site 95-11. Good riparian vegetation but no flow, turbid pool of water. Adjacent land use cleared, unvegetated creek lines similar to Site 95-07

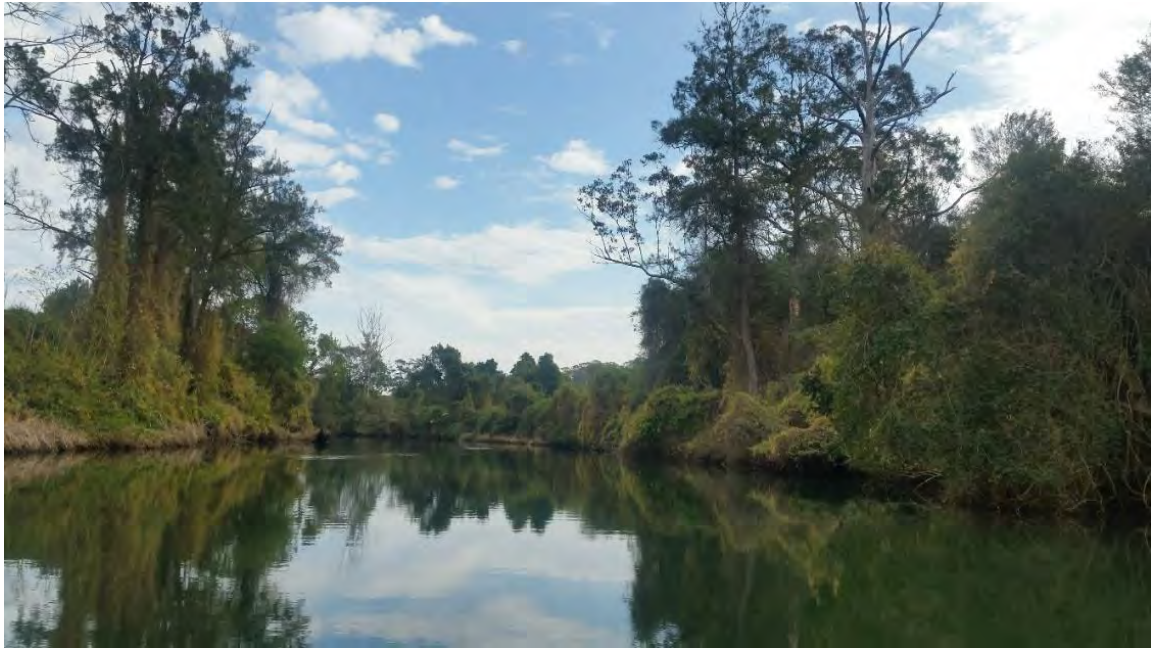
Photo 81 Cedar Creek, near confluence with Manning River. Riparian vegetation infested with exotic weeds such as balloon vine

- Cedar Party Creek (95) at Manning Rivers had extensive riparian vegetation but was dominated by exotic shrubs. Riparian vegetation in the downstream of Cedar Party Creek is completely overgrown with balloon vine and other exotic weeds (Photo 81).

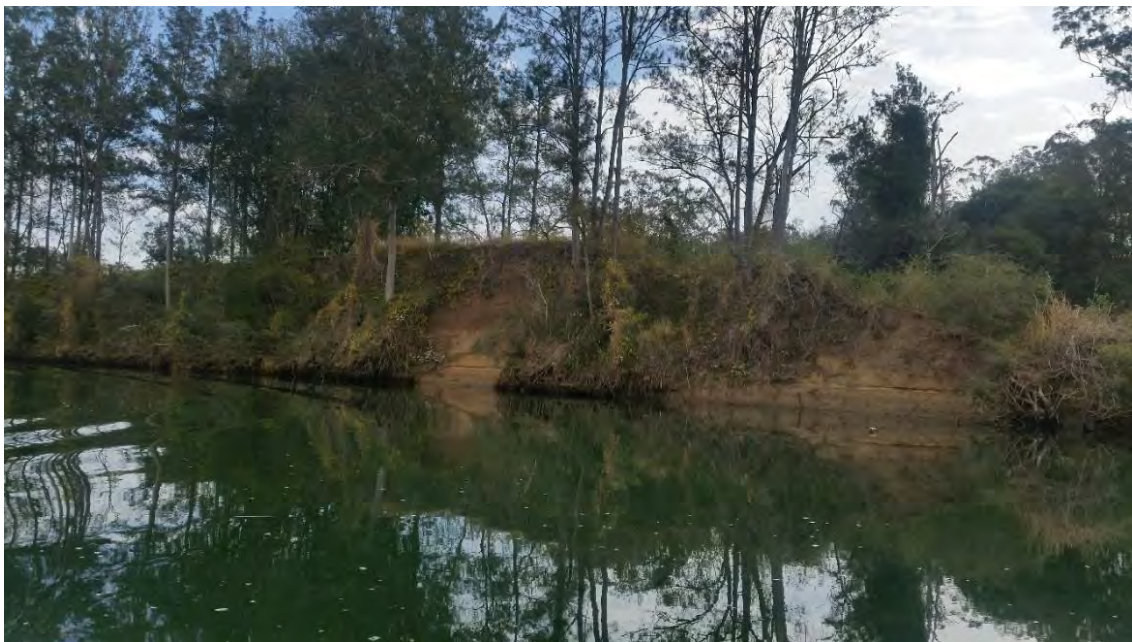
- Streambank erosion (slumping, undercutting) at small unnamed creeks (95-02, 95-07). Undercutting/steep banks at other sites
- Bank erosion on Manning River at confluence with Cedar Party Creek (Photo 82)

Photo 82 Cedar Party Creek confluence with Manning River (eroding banks)

- Localised erosion where a section of bank (~10 metres) is completely gone was noted at subcatchments 95 (Cedar Party, Photo 82) and at 208 (Dumaresq Is., Photo 118)

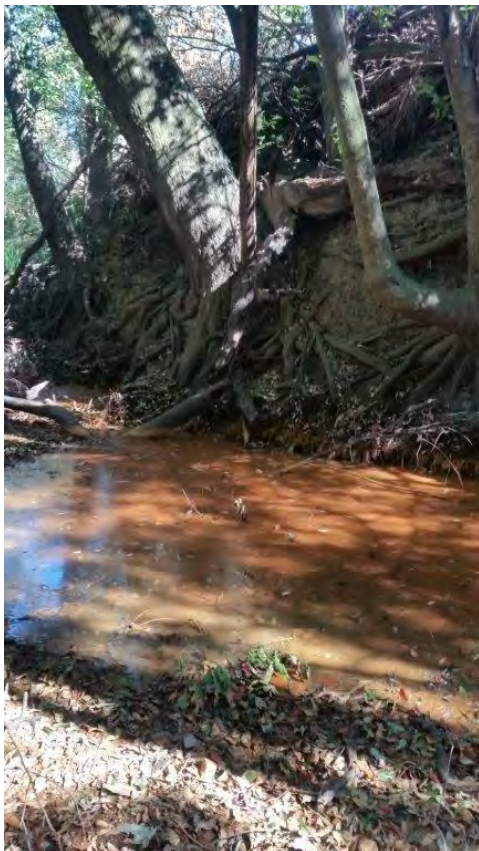
Photo 84 Lansdowne River, site 88-10. Adjacent to dairy farm, turf farm and poultry farm. Isolated pool with reddish hue indicative of iron release from acid sulphate soils

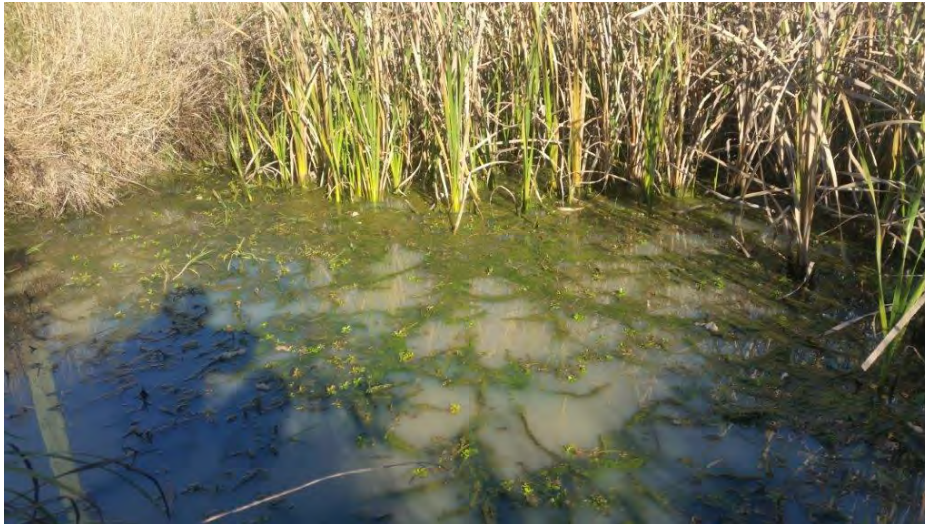
Photo 85 Lansdowne River catchment, unnamed creek at Lansdowne Road, site 88-02. Milky appearance in isolated pool indicative of acidic input. High nutrient load, thick epiphytic algal growth.

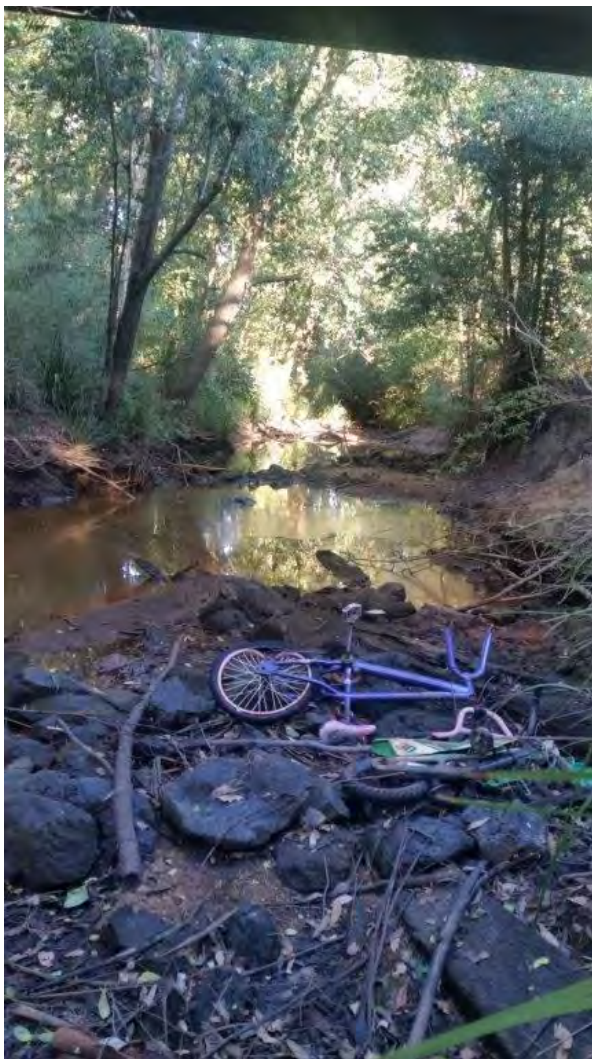
Photo 86 Lansdowne River catchment - Cross Creek, site 88-06. Acid sulphate soils, erosion of banks, rubbish (road crossing).

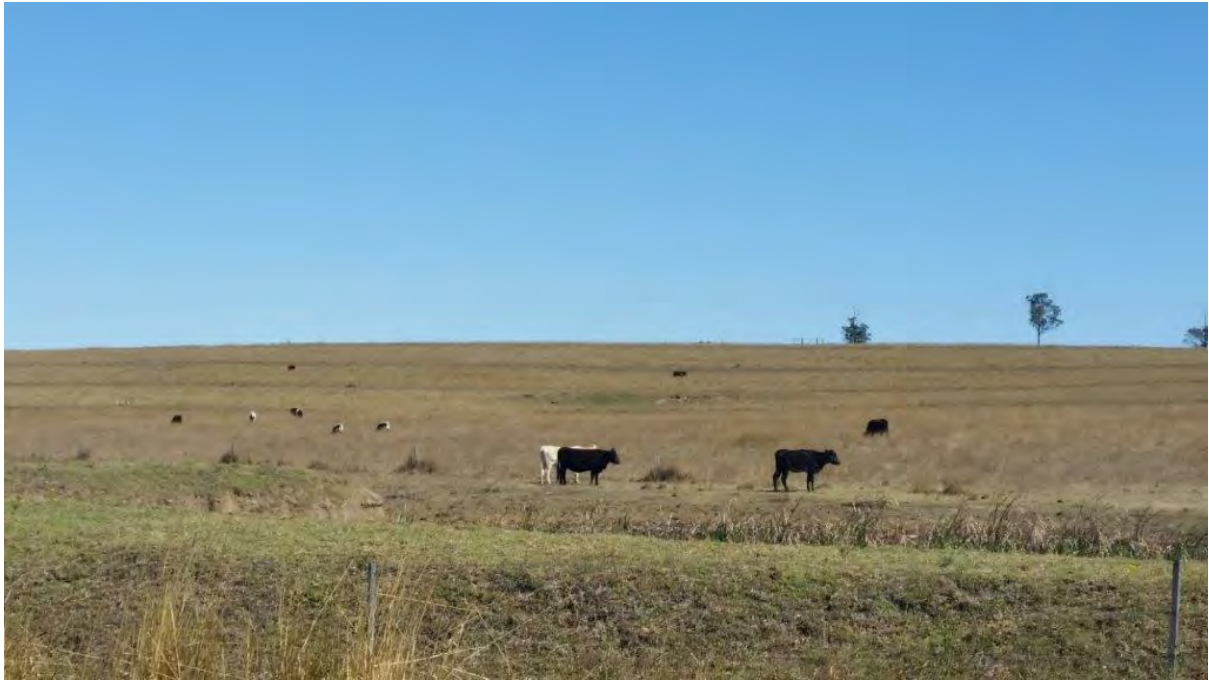
- Dry bare pastures with minimal groundcover were noted in 88 (Photo 87).

Photo 87 Lansdowne catchment 88. Cleared pastures with low stocking density.

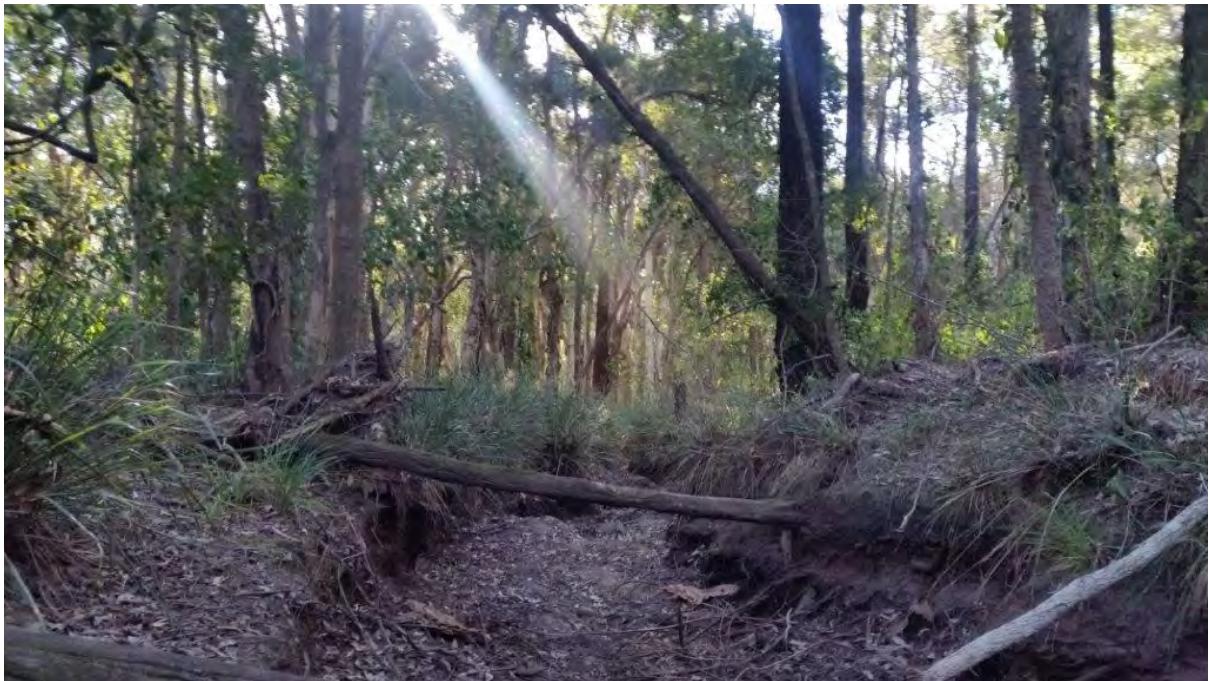
Photo 88 Lansdowne River catchment - Pontibark Creek, site 223-01. Good diversity of native canopy layer. No flow, undercutting of banks.

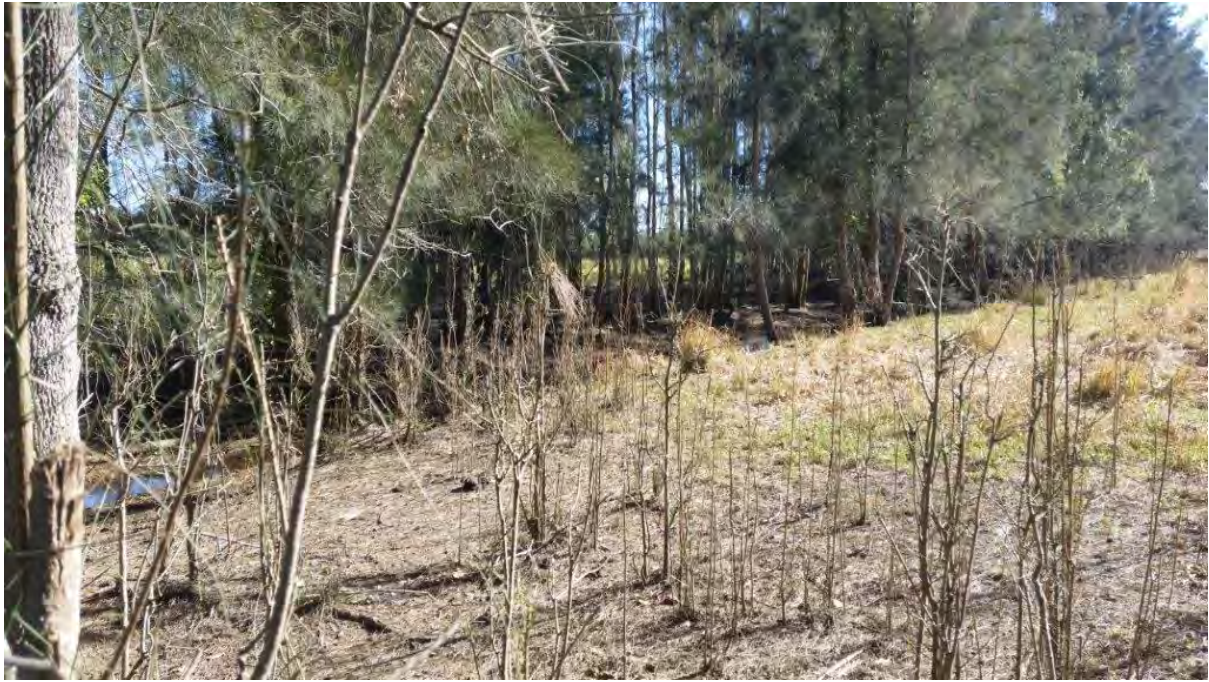
Photo 89 Lansdowne River catchment, Dickensens Creek, site 223-02. Very low flow, cattle access, poor riparian vegetation.

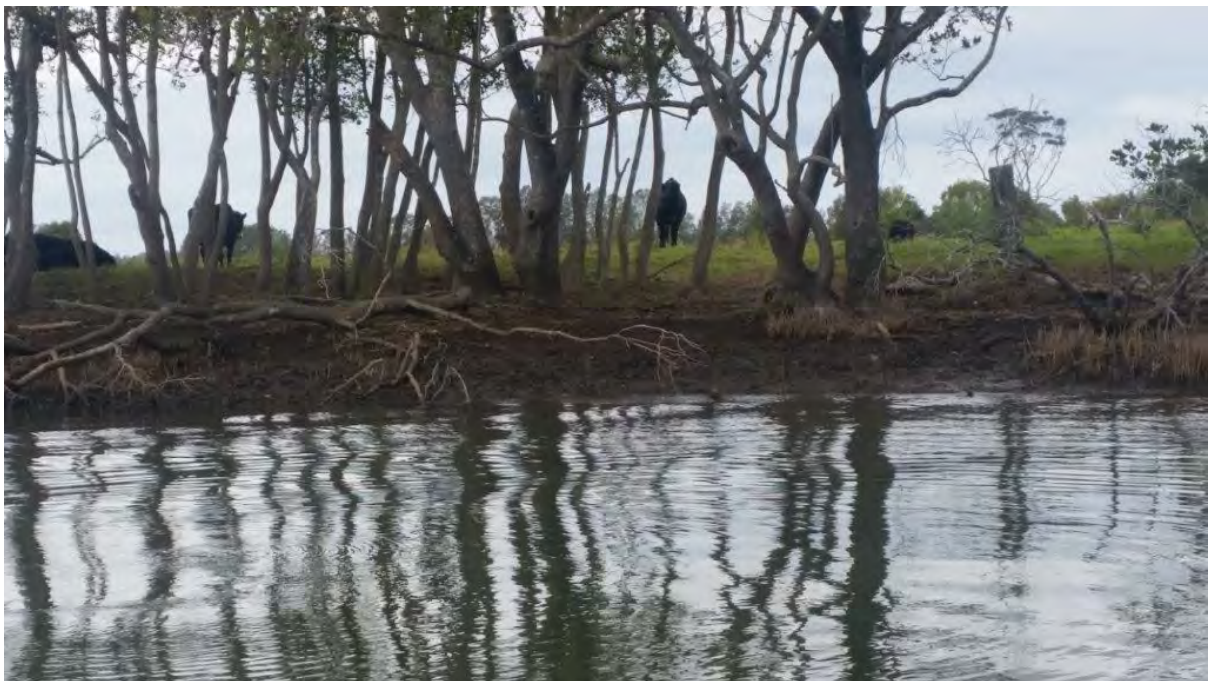
- Cattle access to creek/river noted at one site in 88 and two sites 223.
- Cattle in riparian zone /on riverbank common siting during boat trip (Ghinni Ghinni Creek, Photo 90)

Photo 90 Lansdowne River catchment – Ghinni Ghinni Creek. Cattle access to banks of creek was a common sighting.

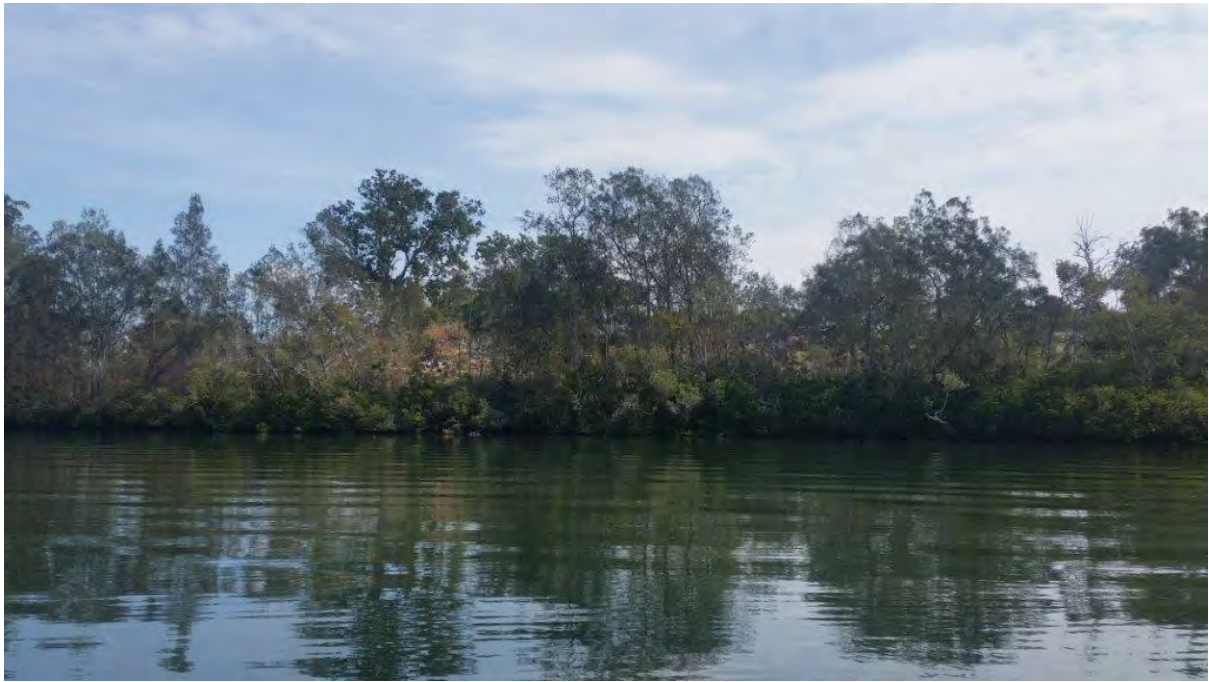
Photo 91 Dawson River – Cemetery site 103-02. Mangroves and good riparian vegetation.

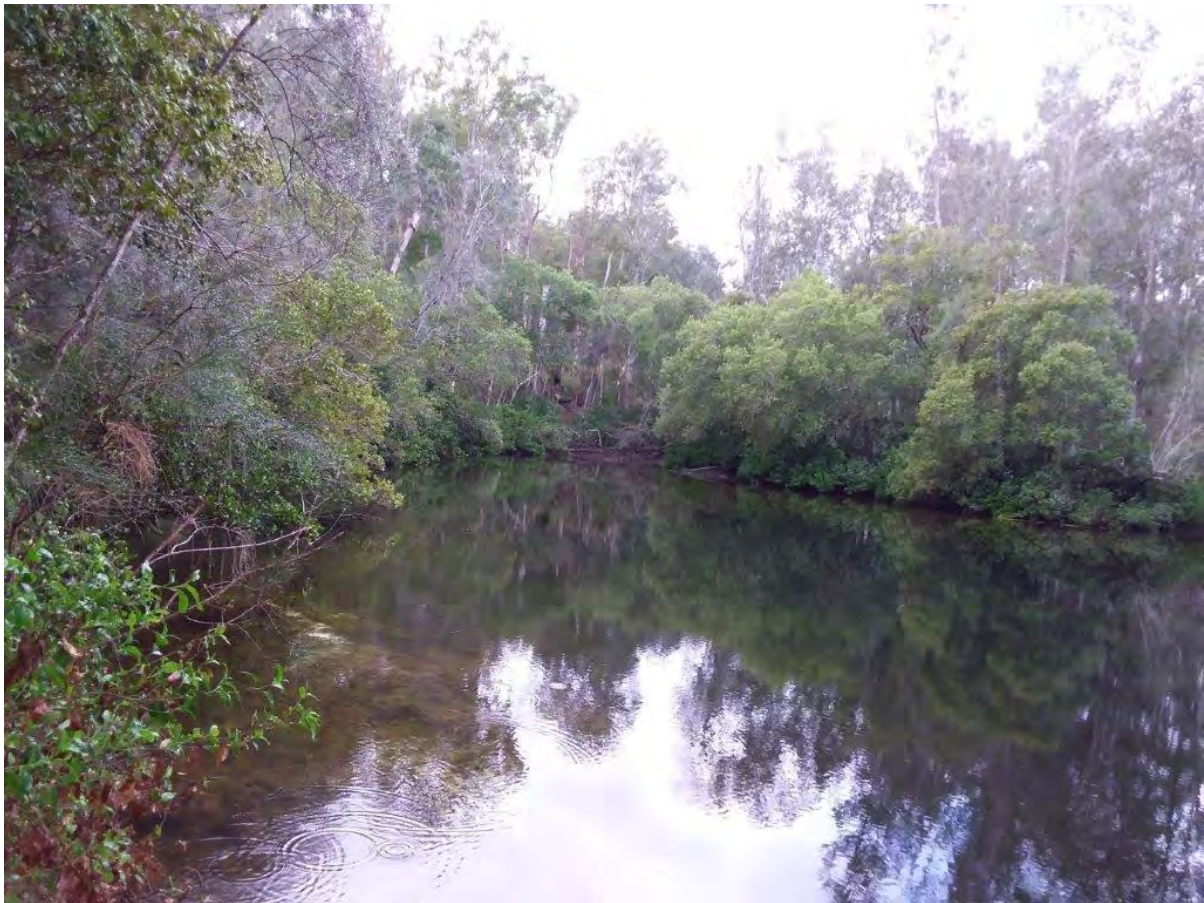
Photo 92 Dawson River at Brimbin Reserve. Extensive native riparian vegetation and good water quality.

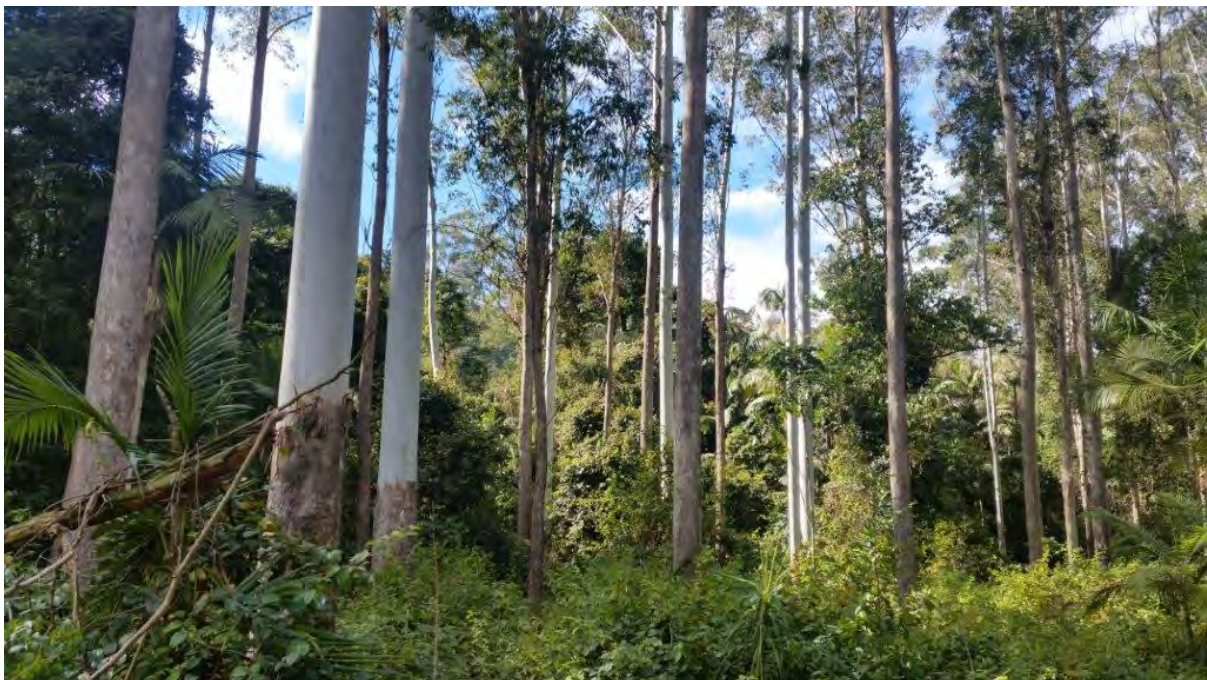
Photo 96 Cattai Creek – upper catchment. Lush riparian vegetation at site 93-05. Did not sample, vegetation too thick and no flow.

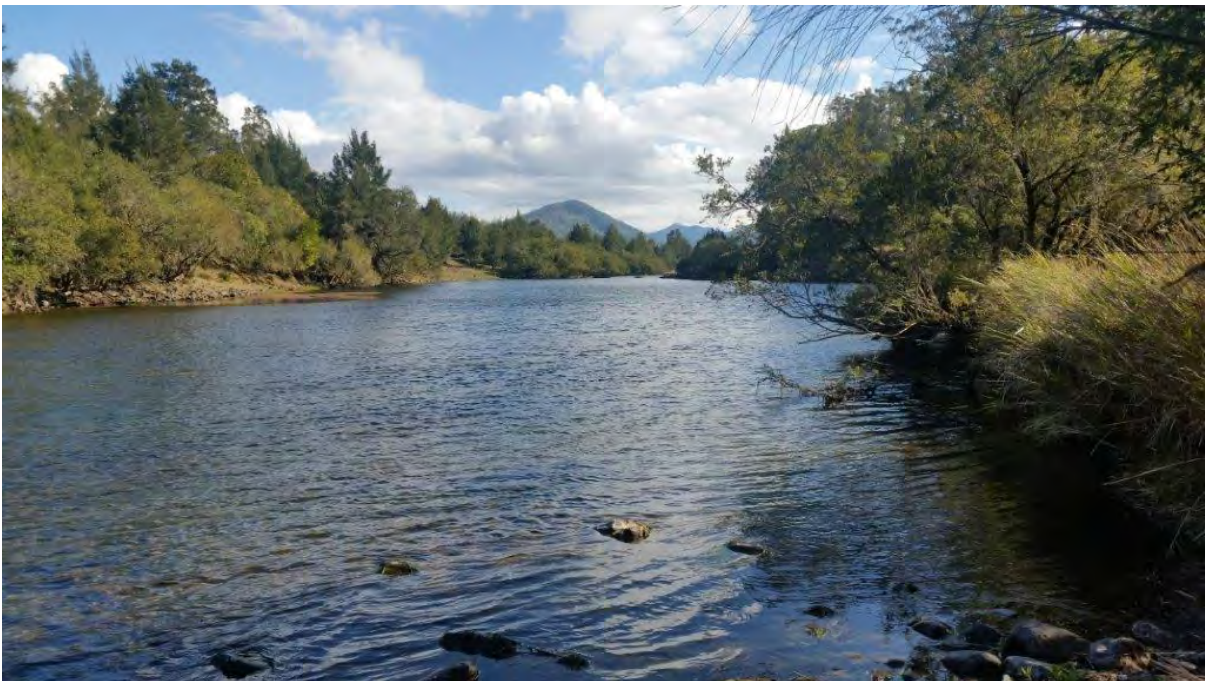
- 106 – Bakers Creeks, highly impacted permanent spring fed pools with no flow, very little intact riparian vegetation (Photo 97)
- Good water quality in the Manning River and throughout the estuary at most sites due to no recent inputs from overland flow (Photo 98, 210, 222). Reaches near dairy farming however

Photo 98 Manning River, site 105-14. Good native riparian vegetation and water quality. Cattle access river here (Lomandra grazed, pugging, macrophytes and algae near shore).

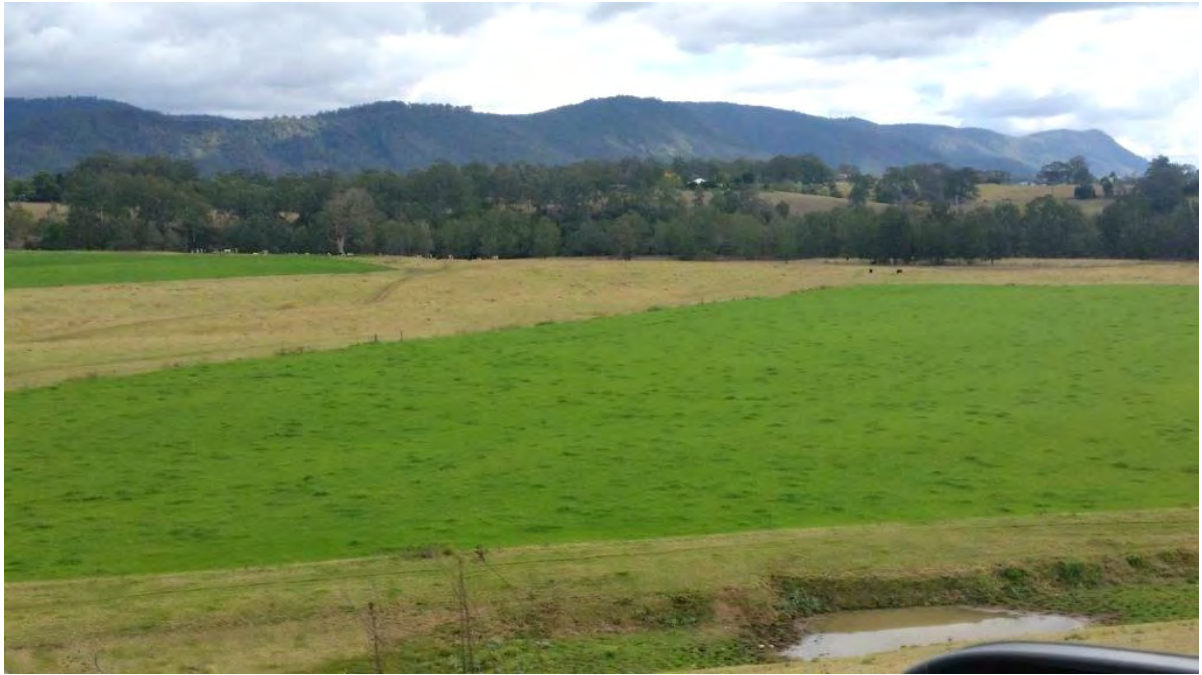
Photo 99 Manning River – site 105-1. Irrigated fertilised pastures at large dairy farm

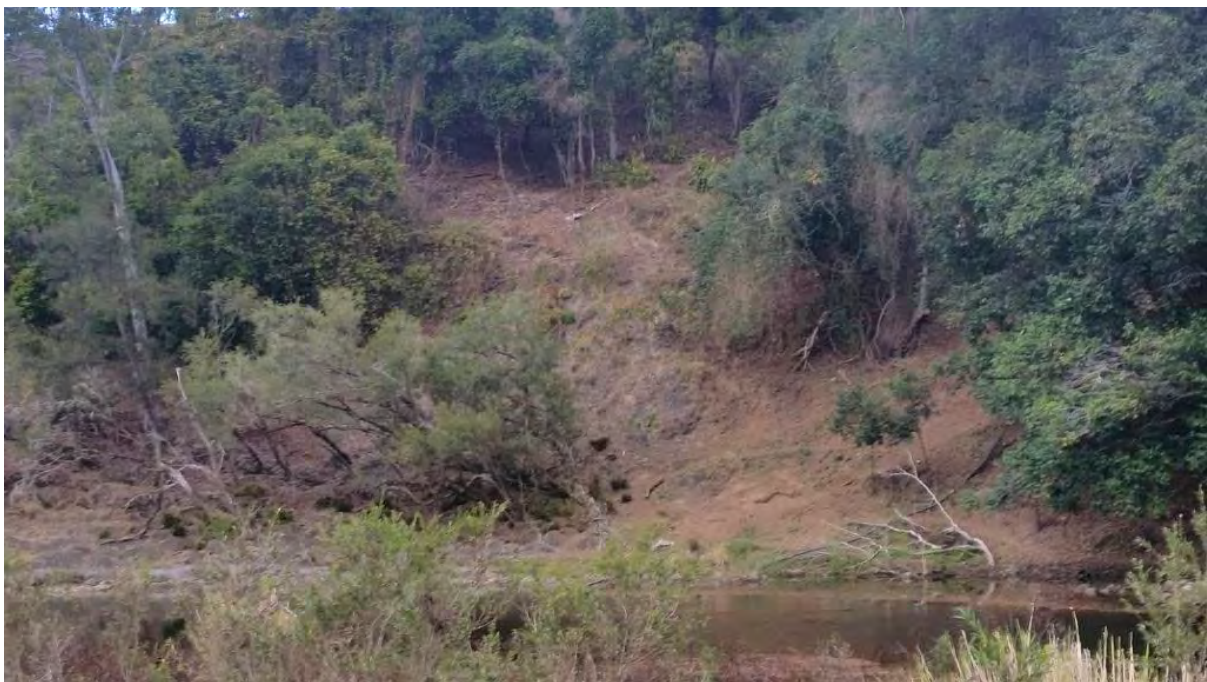
Photo 100 Manning River – site 105-1. Hillslope and bank erosion
