**MANNING
RIVER
ESTUARY &
CATCHMENT**

RAPID SITE ASSESSMENT 2020

Swanson, R. 2020. Manning River Estuary and Catchment RAPID SITE ASSESSMENT. A snapshot of stream condition in the Manning River Estuary and its catchment from the ground-truthing program. Environment, Energy and Science. NSW Government, Sydney.

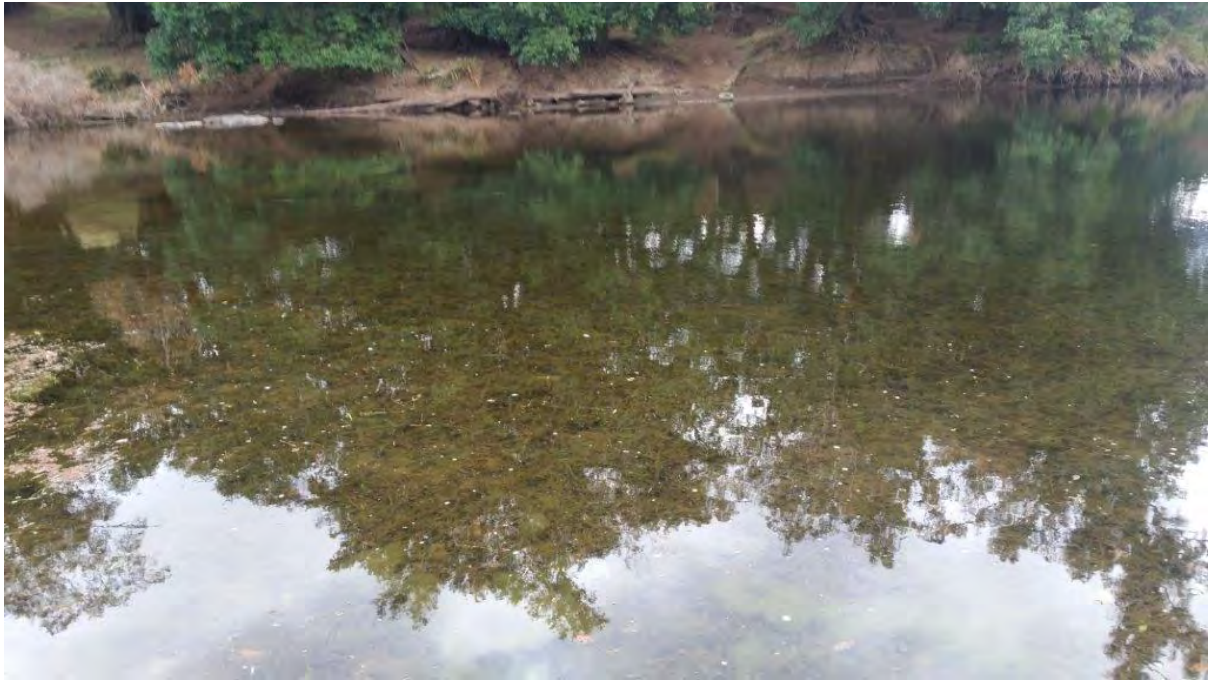
were severely eutrophic, with excessive macrophyte growth and algal growth (subcatchments 99, 105; Photos 101, 102, 105)

Photo 101 Manning River – site 105-1. Eutrophic zone as indicated by excessive macrophyte (submerged) and epiphytic algae.

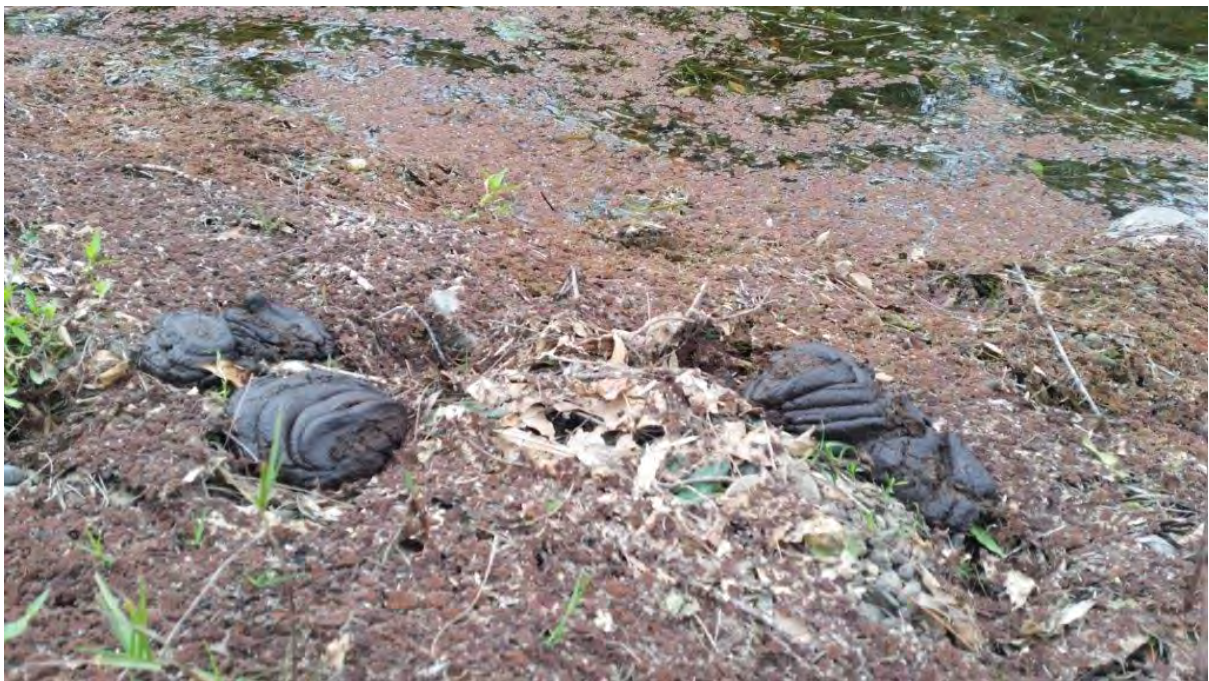
Photo 102 Manning River – site 105-1. Shoreline of macrophyte Azolla and manure

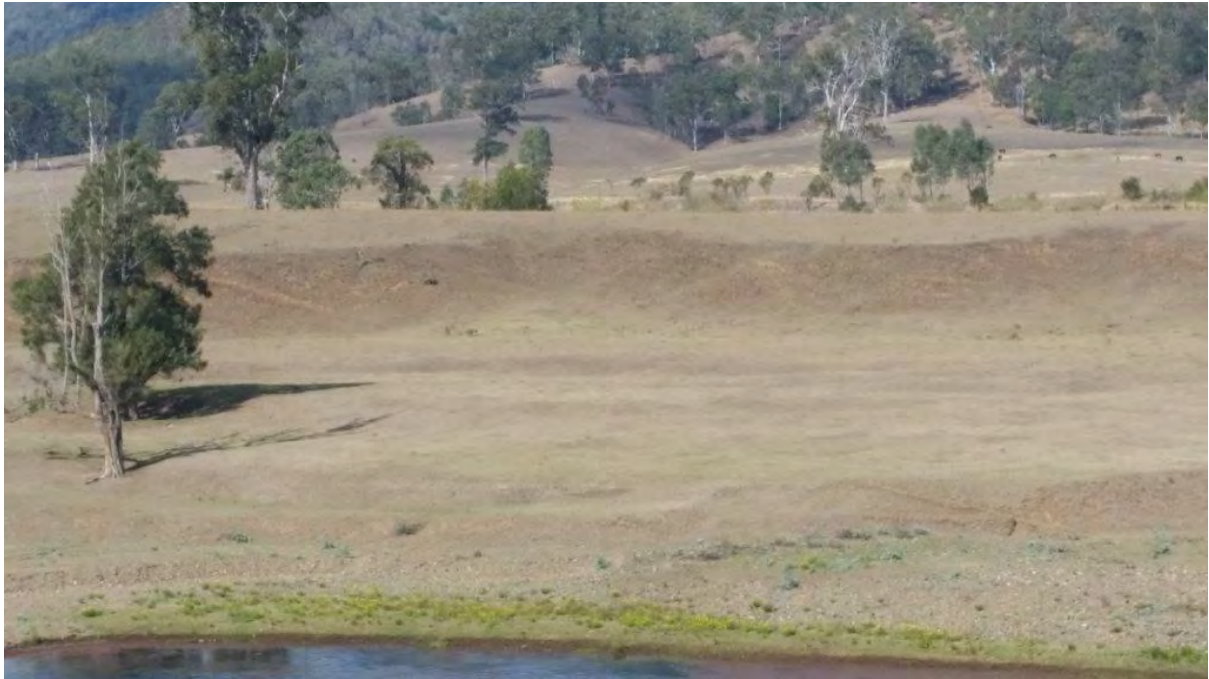
Photo 103 Manning River, site 105-3. Bare eroding hillslopes and gully erosion. No riparian vegetation

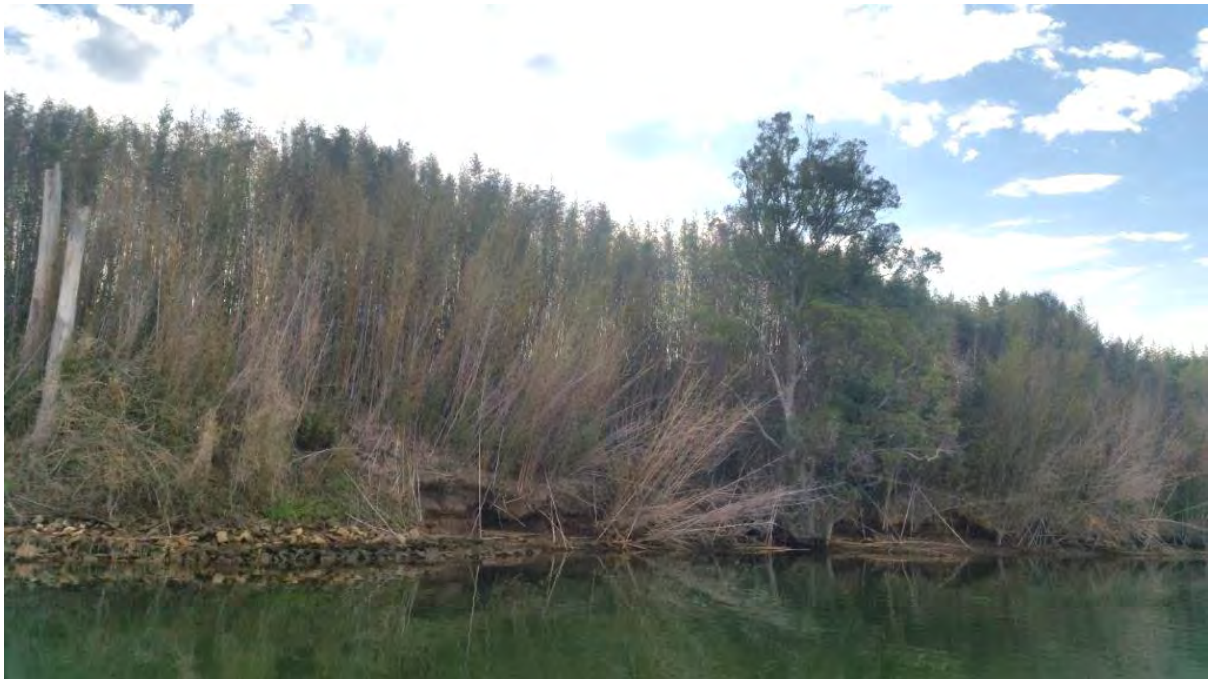
- One section of the riverbank at 209 is overgrown with Bamboo and a giant reed (Photo 108).
- Good native riparian vegetation occurs in some sections of subcatchment 220 including native grasses (220 Glenthorne, Photo 110)

Photo 108 Manning River (subcatchment 209). Riverbank overgrown with bamboo and a giant reed

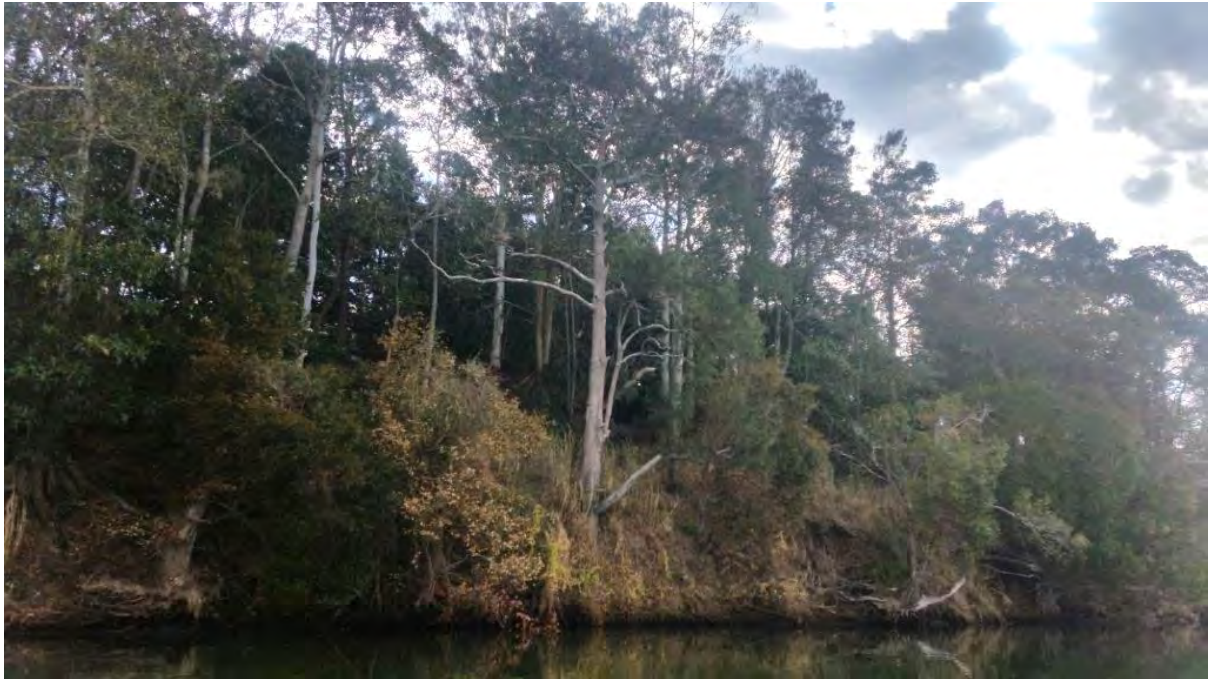
Photo 109 Manning River – Cedar Party Creek subcatchment 95. Good riparian vegetation, predominantly native canopy and exotic shrubs.

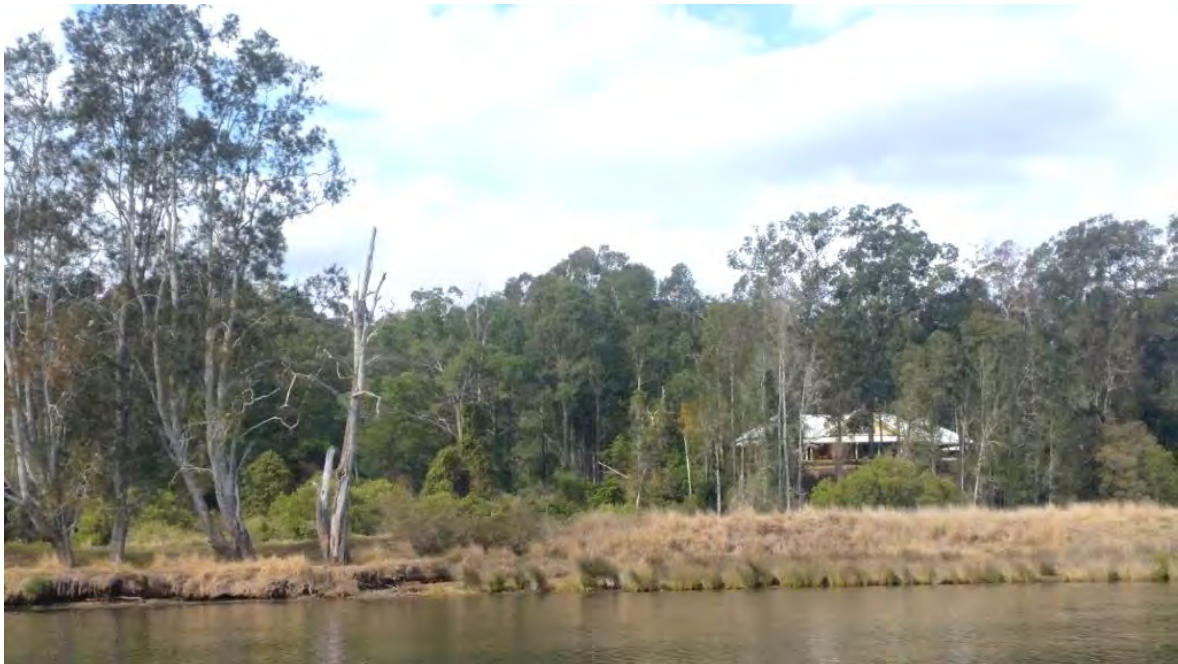
Photo 110 Manning River – (subcatchment 220). Good riparian vegetation – native canopy and ground cover.

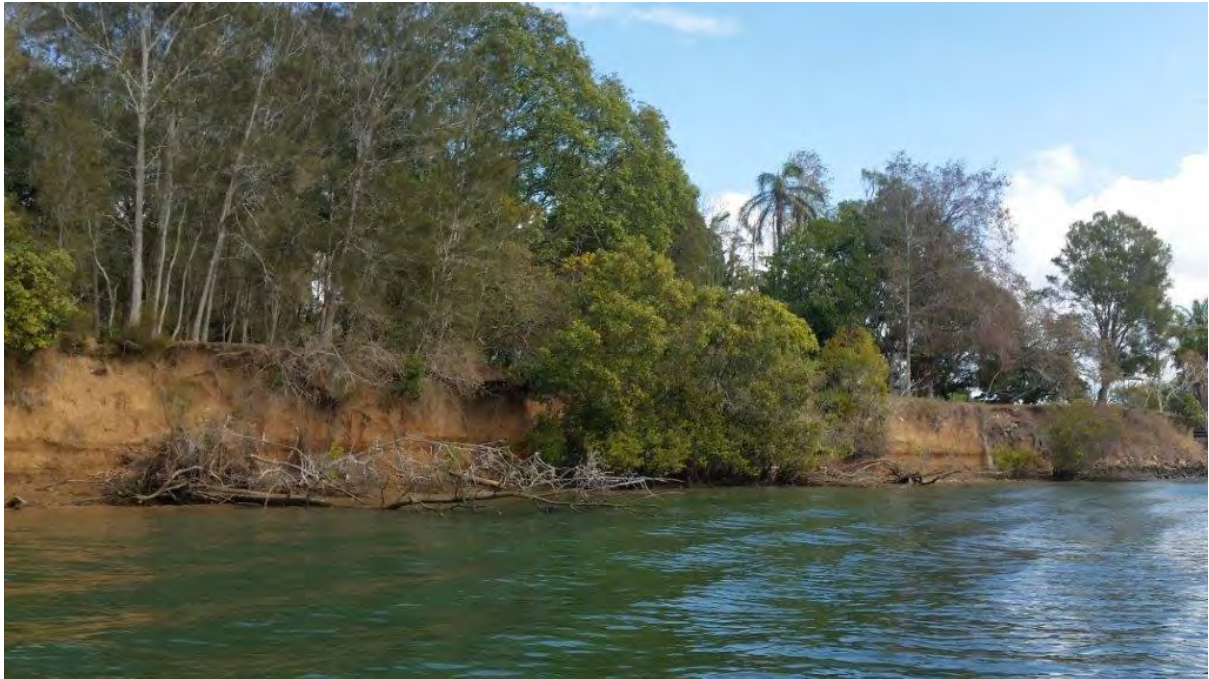
- Banks are severely eroded along the shoreline of subcatchments 114 (Photo 113) which has led to the loss of riparian vegetation (Photo 114). Bank erosion in South Channel subcatchment 210 (Oxley Is.) adjacent to dairies (e.g. site 210-04, Photo 116). Landowners noted their frustration at not being allowed to intervene and prevent further erosion.

Photo 113 Manning River South Channel (subcatchment 114). Heavy erosion of banks has led to loss of riparian vegetation (Photo 111)

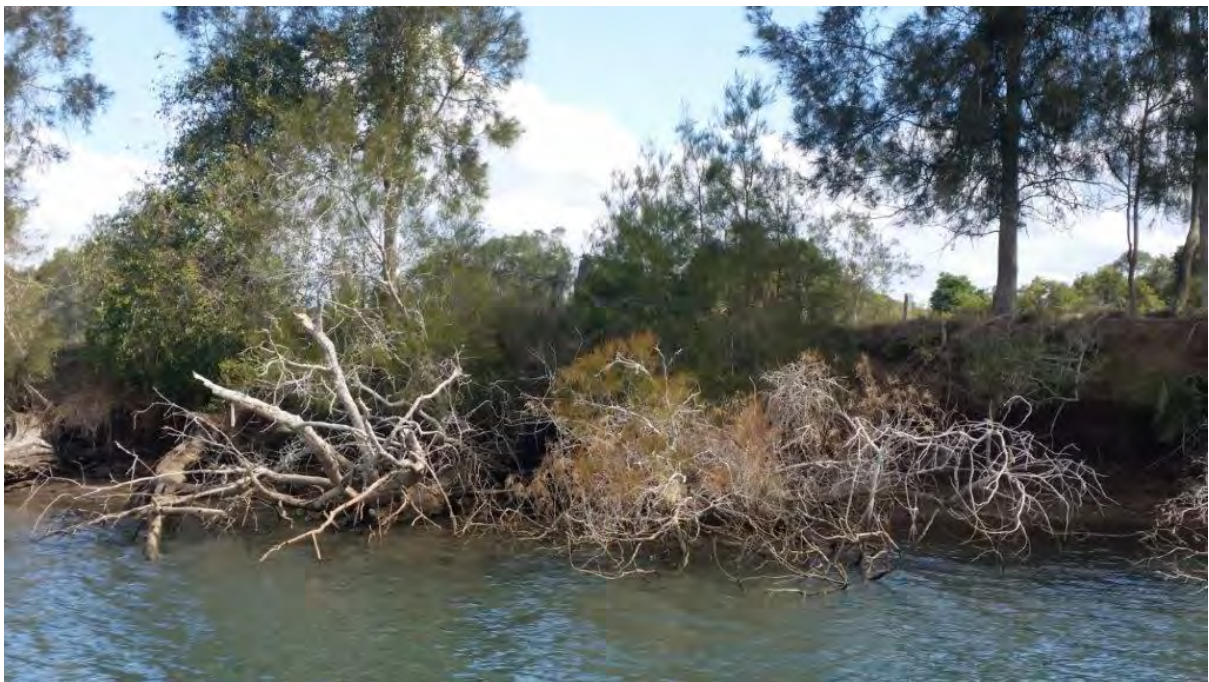
Photo 114 Manning River South Channel (subcatchment 114). Erosion of banks (photo 110) has led to loss of riparian vegetation.

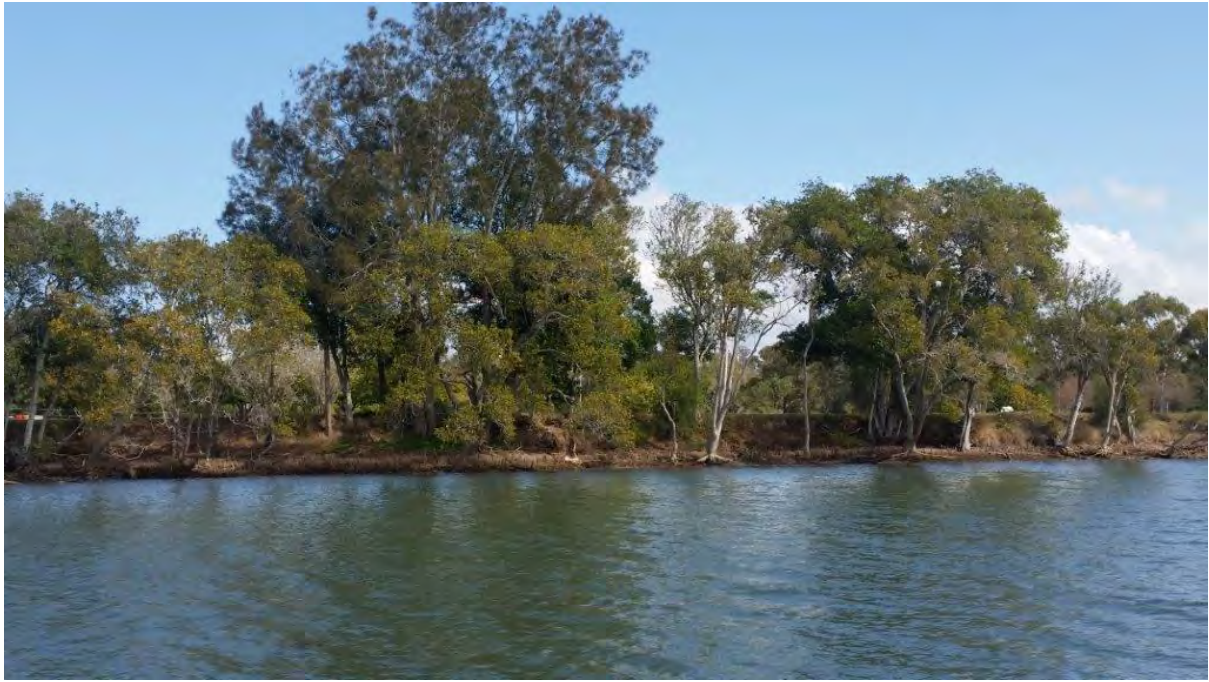
- Mangroves occur throughout the estuary and provide some protection of bank structure where they occur (88, 93, 220, 222, 224; Photos 115, 122, 124). Continuity of mangroves along the shoreline can be patchy and the band width rarely exceeded 10m. Even though present, mangroves at this density provide limited protection of shorelines from erosional forces of high flows and boat wash

Photo 115 Manning River South Channel (subcatchment 222). Banks are eroding but mangroves appear to be providing some protection of banks

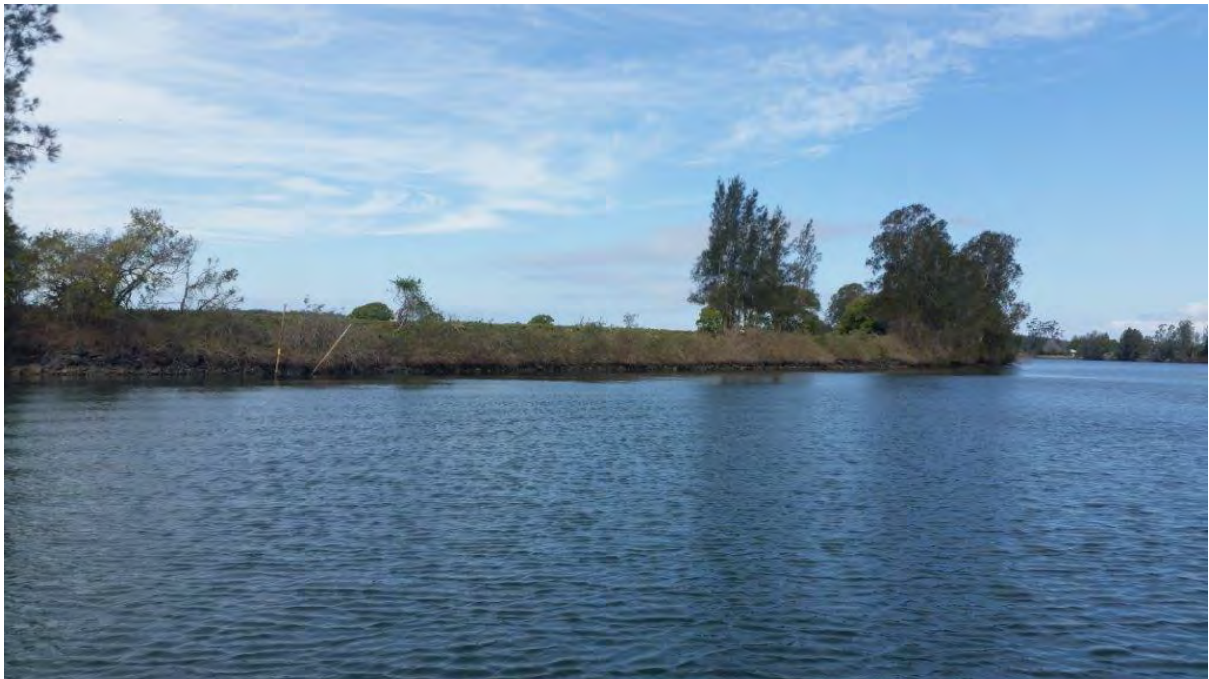
Photo 116 Manning River South Channel (Oxley Is. subcatchment 210). Pastures, no fencing. Steep banks with minimal riparian vegetation, exotic shrubs. Eroding banks.

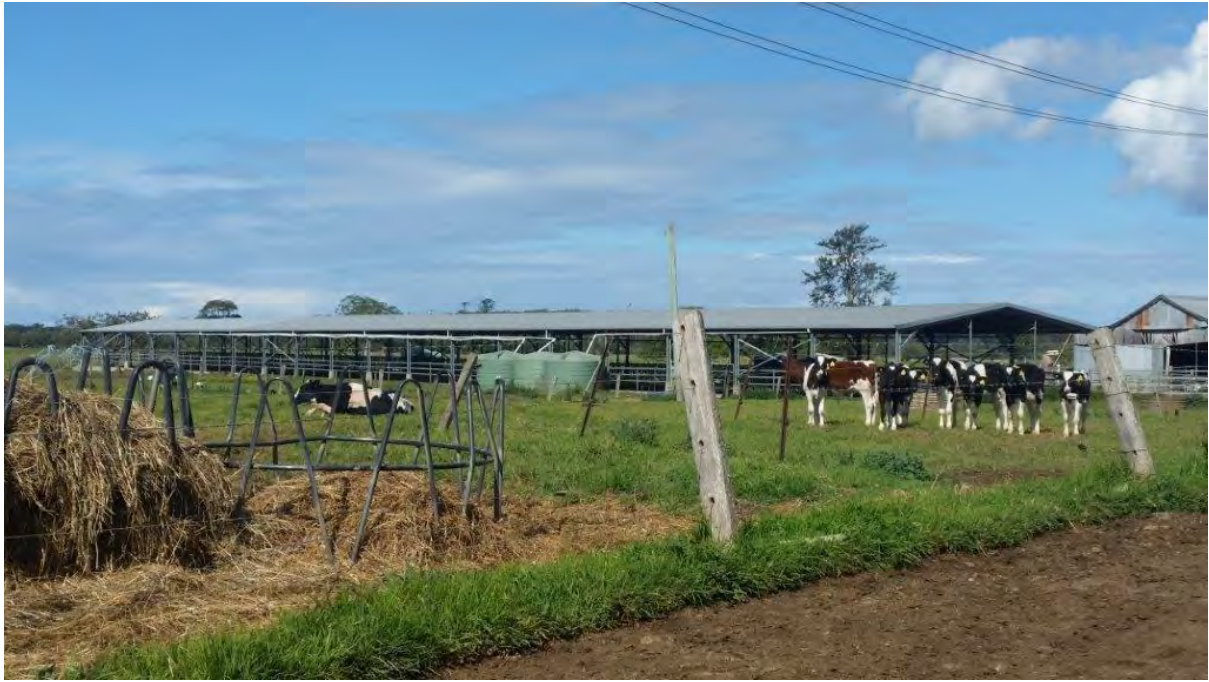
Photo 117 Manning River South Channel (Oxley Is. subcatchment 210). Dairy farm at site 210-04.

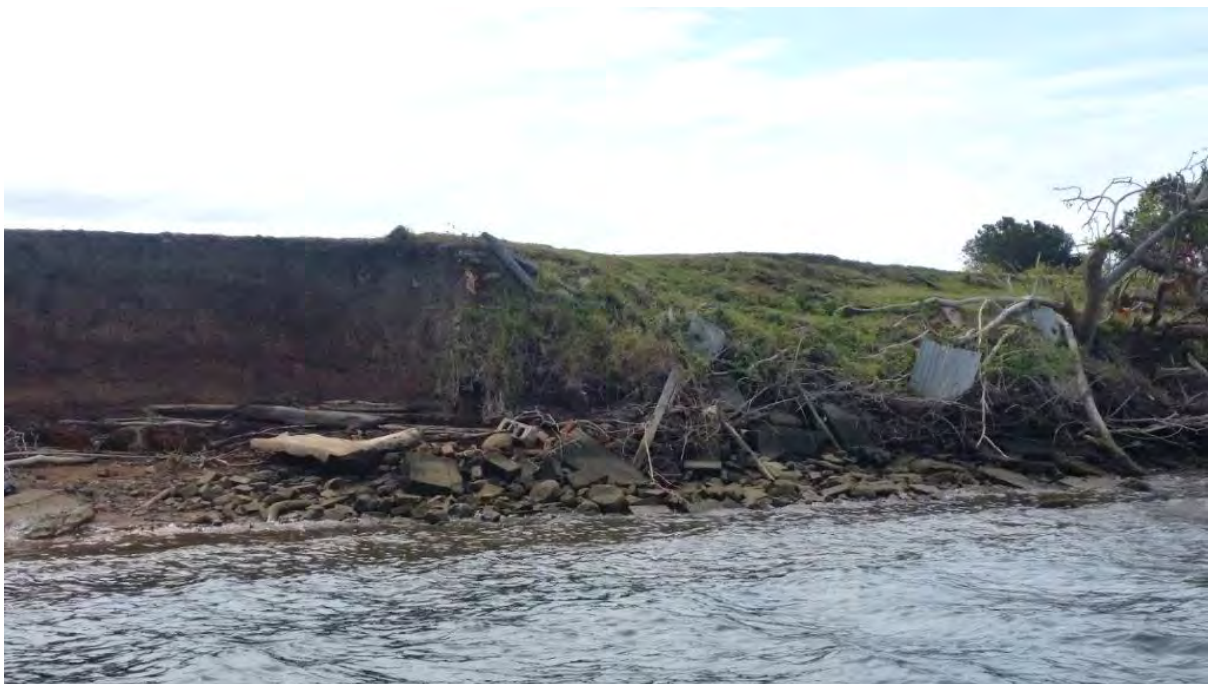
- Localised erosion where a section of bank (~10 metres) is completely gone was noted at subcatchments 95 (Cedar Party, Photo 82) and at 208 (Dumaresq Is., Photo 118)

Photo 118 Manning River – Dumaresq Is. (subcatchment 208). Bank collapse, building/domestic waste along shoreline, possible attempt to prevent further erosion.

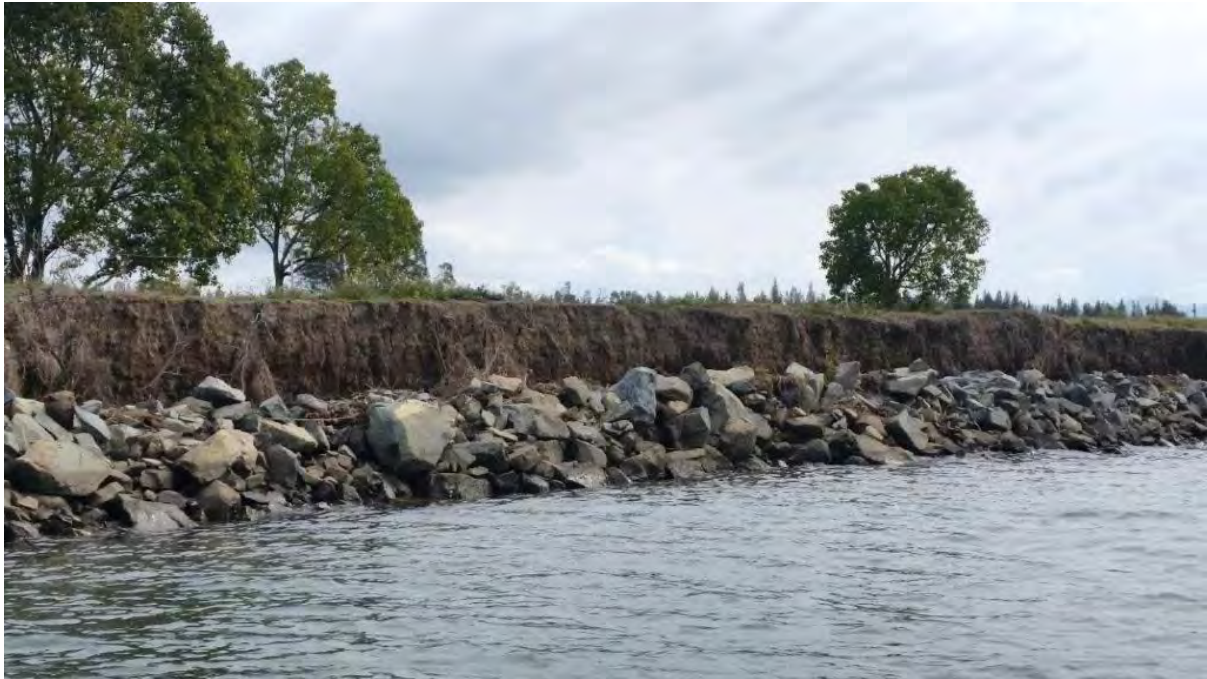
- Banks are severely eroded along the shoreline of subcatchments 205 and 207. Rock revetments have been built to minimise further erosion from storm surges and boat wash (Photo 119).

Photo 119 Manning River – Jones Is. subcatchment 205. Severe erosion of banks – rock revetment to reduce wash, further erosion.

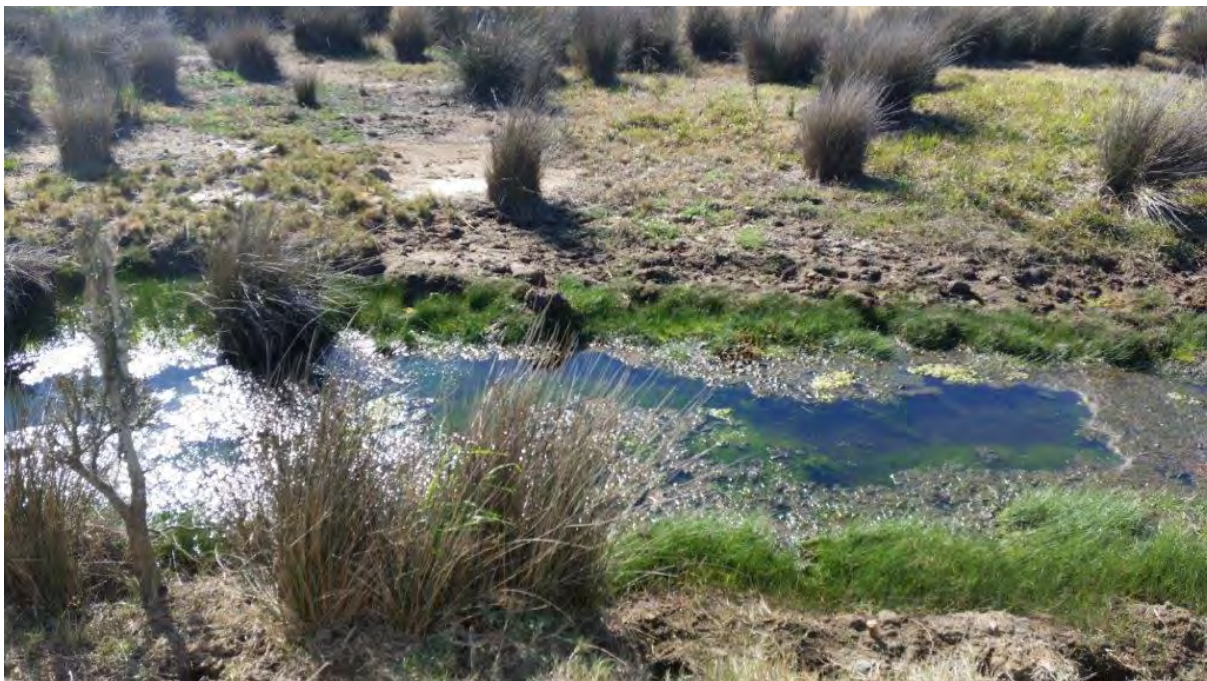
- Tributaries / creek lines usually had poorer water quality than main channel of river/estuary due to localised runoff from adjacent land use, reduced flows and cattle access (Photo 120, 122)

Photo 120 Manning River/Lansdowne River catchment – creek line leading directly to estuary (Jones Is. site 205-03). Cattle access and dense growth of filamentous algae. Poor land practice on this property with much potential to improve.

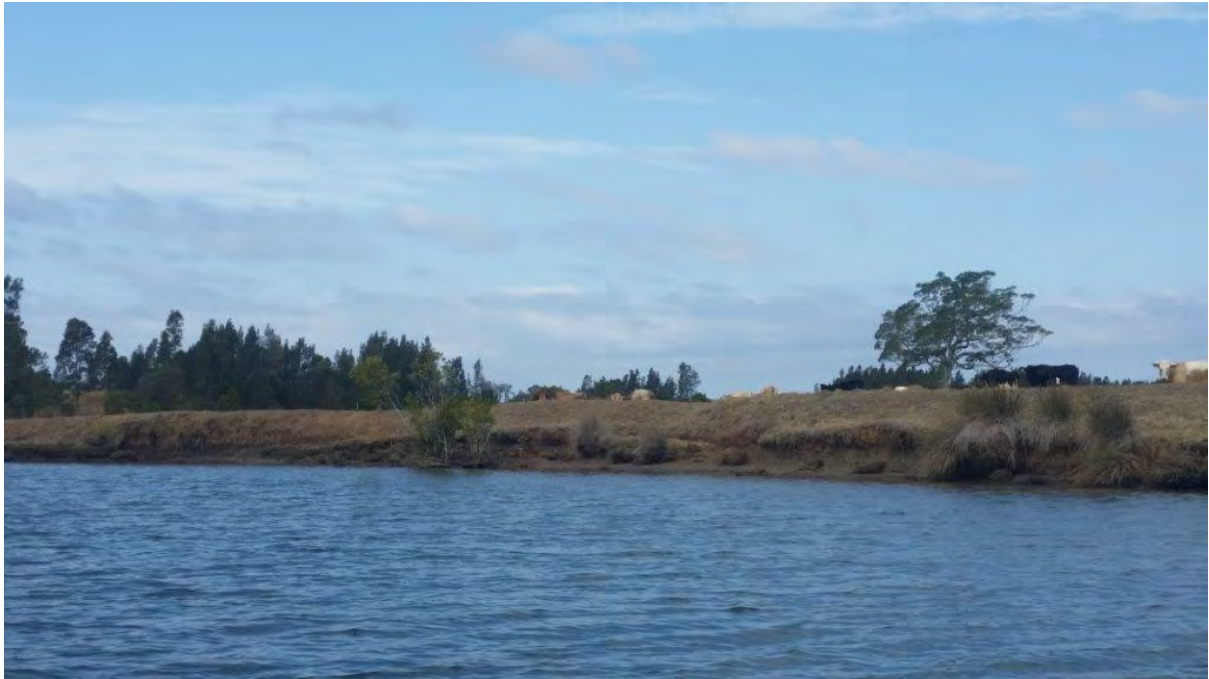
Photo 121 Manning river/Lansdowne River subcatchment 88 (downstream at estuary). Cattle have access to river bank, with eroding banks and minimal riparian vegetation

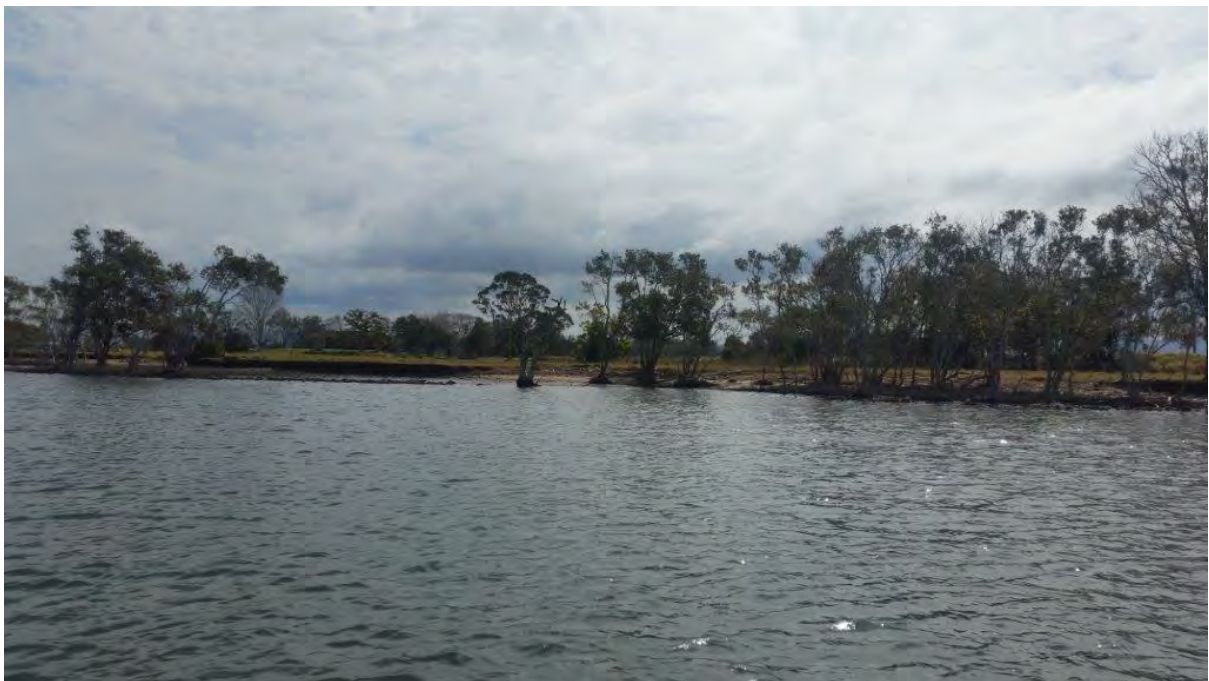
Photo 122 Manning river/Cattai Creek subcatchment 93 (downstream at estuary). Cattle have access to river bank, with eroding banks

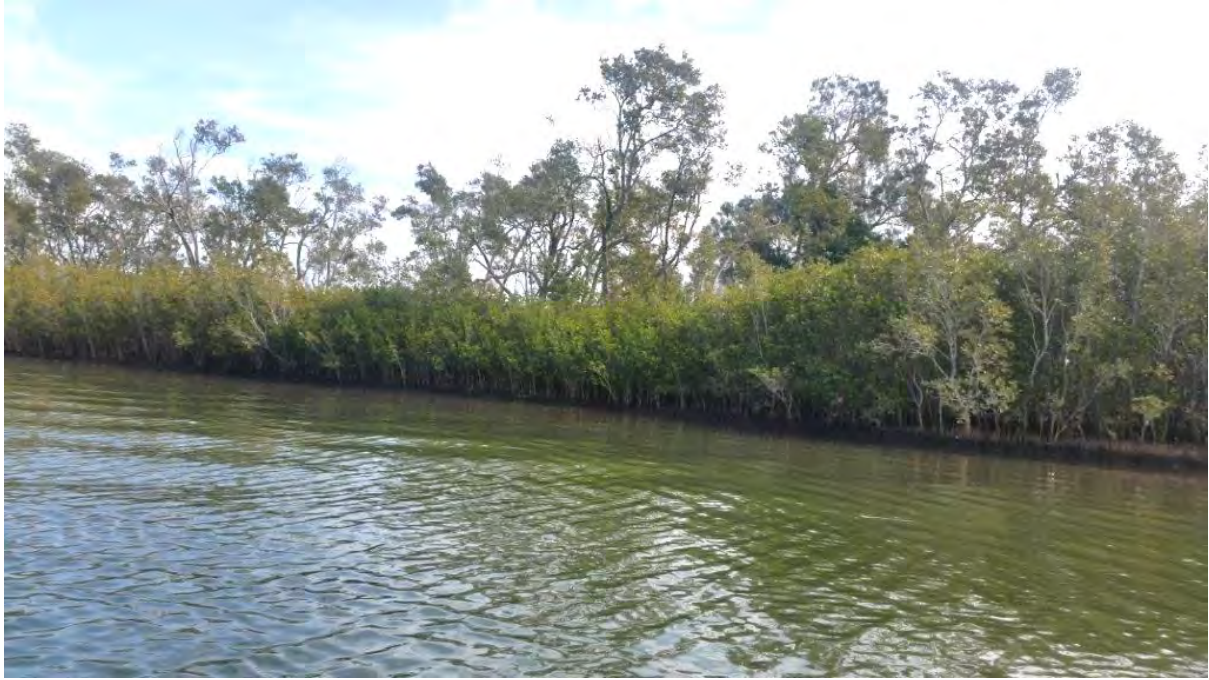
Photo 123 Manning River/Cattai Creek – Mamboo Is. Dense distribution of mangroves.

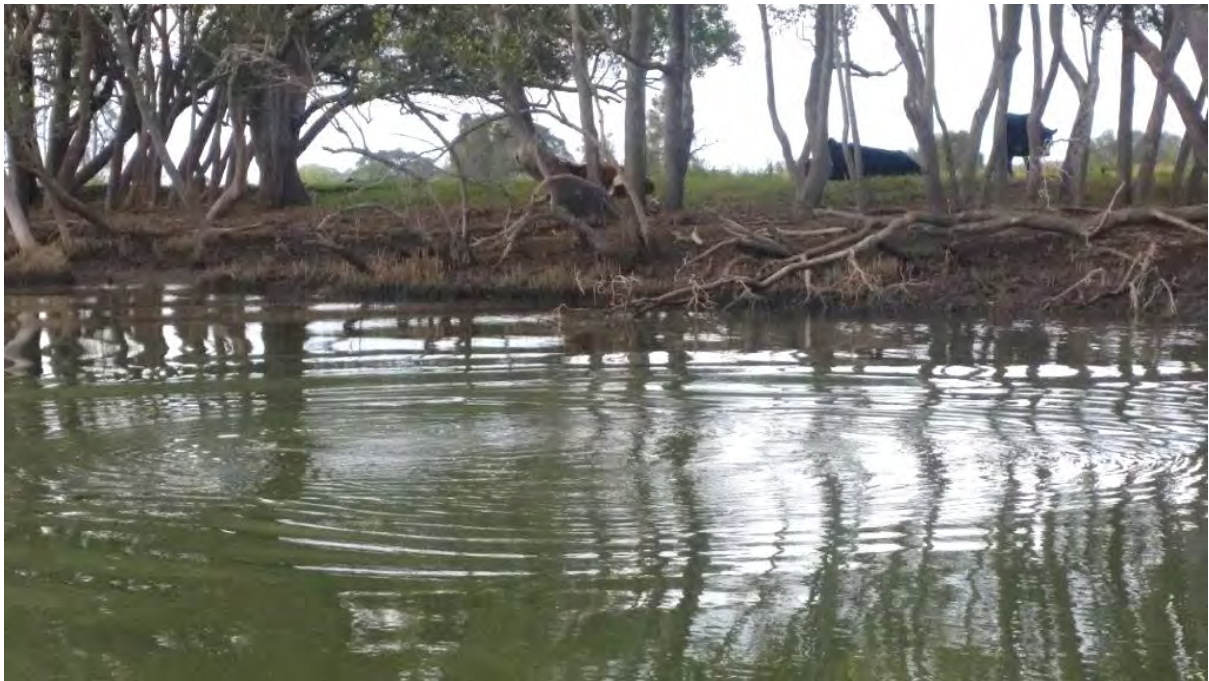
Photo 124 Manning River/Ghinni Ghinni Creek (subcatchment 223) - wake of a river dolphin, cattle on banks
